## Gipaanda Greenhouses 2 year Follow-up Delta

**2003**

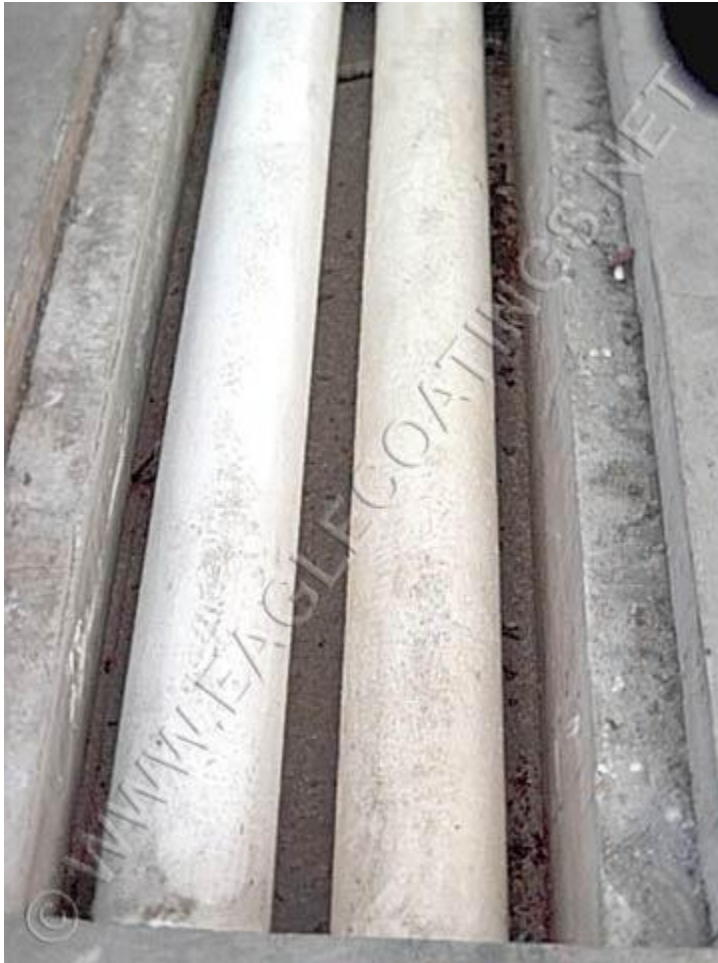
These heating pipes from GIPAANDA Greenhouses were uncovered for the first time since a protective coating system comprised of [RUSTGRIP](#)® and [SUPERTHERM](#)® was applied two years ago. Today we may apply our new [HSC](#)® [COATING](#)®

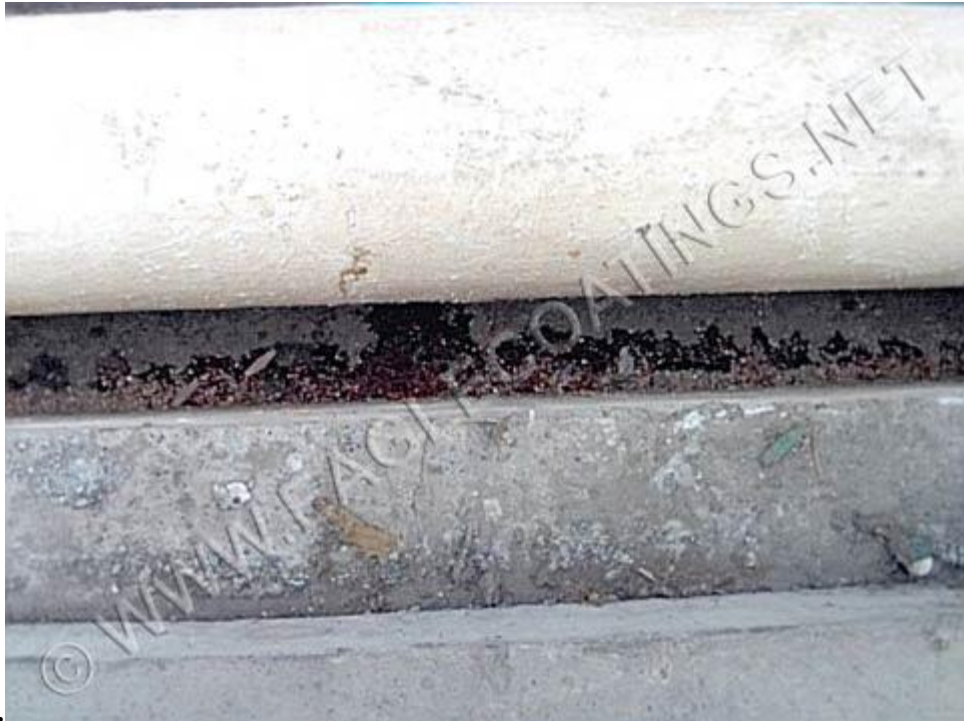
The coatings are intact, with no signs of flaking, peeling or rust bleed. The discolouration was from the insulation blanket which is deteriorating thus leaving deposits ( possible carcinogen - see the [Fiberglass Information Network](#) website ) on

the coated pipes.

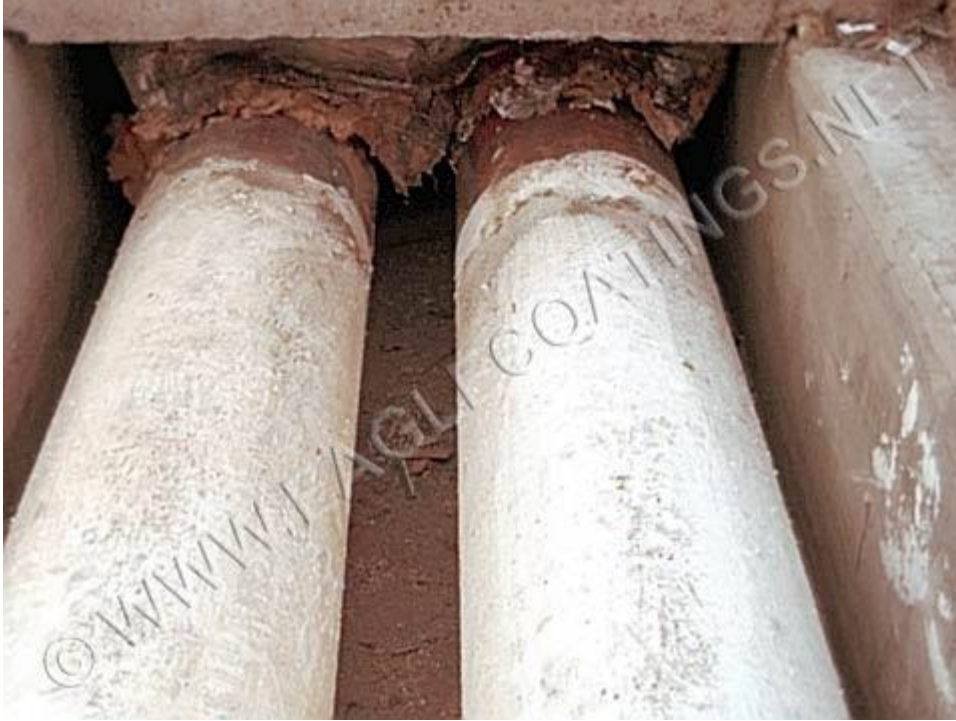
**TYPICAL CUI ( Corrosion Under Insulation**

The fiberglass insulation blanket shows signs of advanced deterioration as it has absorbed moisture like a sponge. The resulting corrosion has also reduced the structural integrity of the pipes themselves. Kurt attempted to scrape away the exposed [RUSTGRIP](#)® at the edge of the sample area with a knife and was unable to do so.

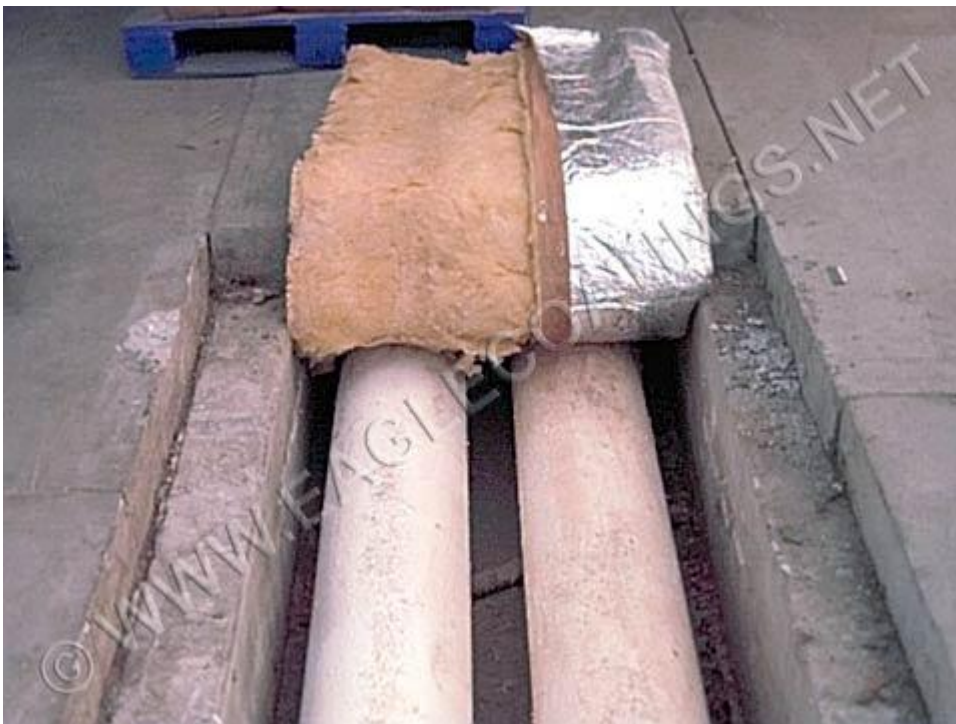
**NO CUI ( Corrosion Under Insulation**

**The light brown tinge wipes away easily with a broom. What you see are the dust deposits ( possibly carcinogenic ~ see the [Fiberglass Information Network](http://www.fiberglassinformationnetwork.com) website ) from the deteriorating fiberglass insulation which was put in place at the same time**

**we conducted this test**
