Versa Cold Cold Storage Facility

Matsqui 2002

[RUSTGRIP](#)® primer and [SUPERTHERM](#)® top coat

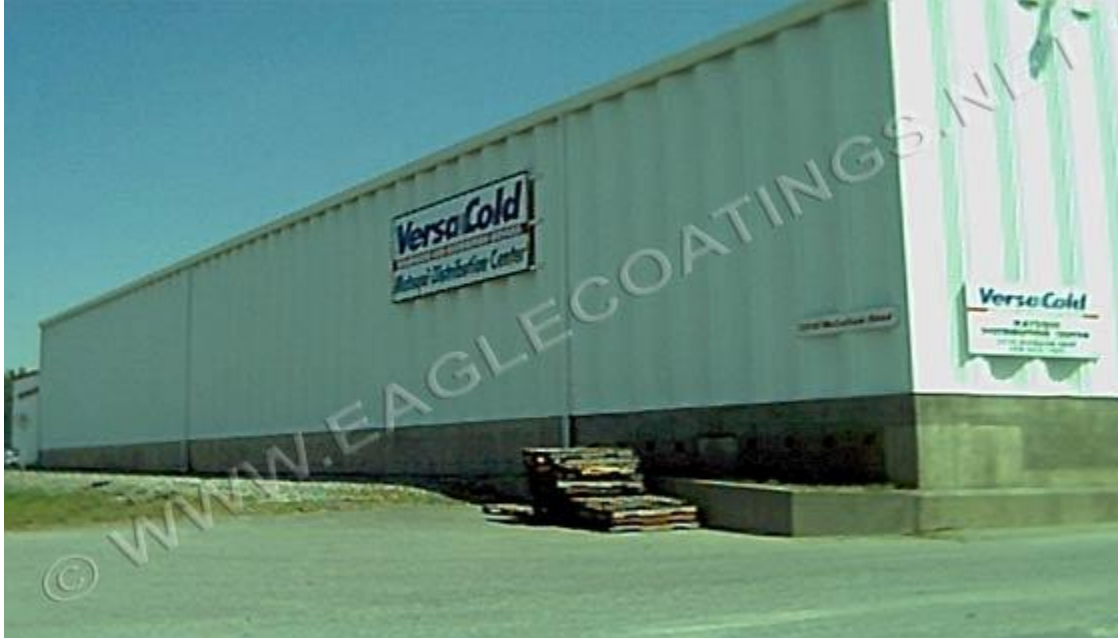
These infrared scans taken prior to the application of a primer coat of [RUSTGRIP](#)® and a combined base coat and top coat of [SUPERTHERM](#)® show black spots where the insulation has totally failed due to moisture. There is so much moisture in the insulation that it actually has a NEGATIVE R value and is now conducting heat instead of resisting heat (Water is a better conductor than resistor). This increased the problems inherent in all metal substrates being conduction, condensation and corrosion.

This caused the existing paint to crack and peel. It would have been extremely beneficial to have been given these scans prior to commencing this project. Unfortunately they were not revealed until after the project was completed.

Because of the extreme condensation on this substrate, a base coat of [EPOXOTHERM](#)® should have been applied over the [RUSTGRIP](#)® and then top coated with [SUPERTHERM](#)®. These scans also would have identified areas were a higher build of the [EPOXOTHERM](#)® / [SUPERTHERM](#)® system was required.

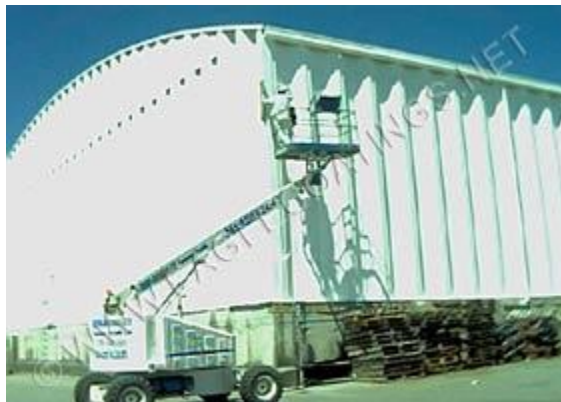
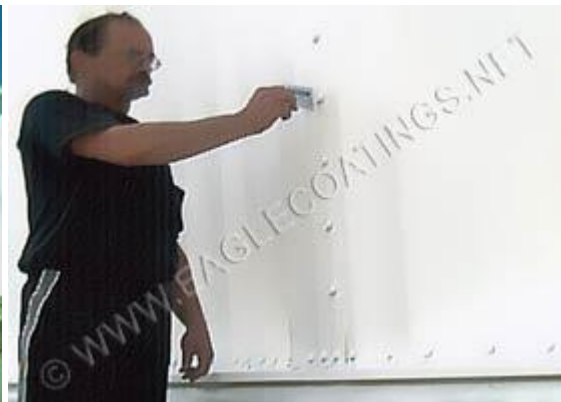
This finished system of 7 mils DFT applied in two coats, cross-hatched, provides

adequate insulation and is non - deteriorating due to being impervious to moisture for at least 10 years.

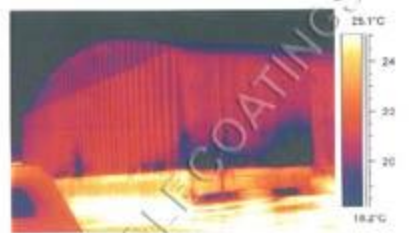
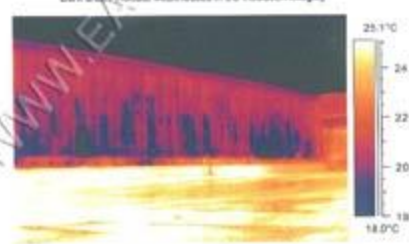
Note the TEMPERATURE SCALES on the side of each of the scans located below. The temperature range of the scan taken BEFORE the coating system was applied is from 18.2°C - 25.1°C (64.76°F - 77.18°F). The temperature range of the scan taken AFTER the coating system was applied is from 20.9°C - 35.6°C (69.62°F - 96.08°F). The adjustment was required because of the much higher ambient temperature on the day the AFTER coating scan was taken.

Building Envelope
 Dark areas indicate weaknesses in the insulation integrity

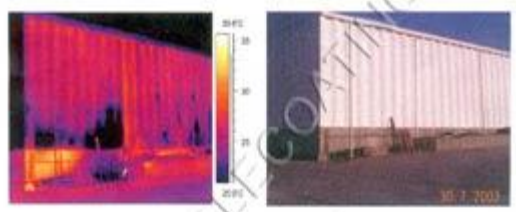
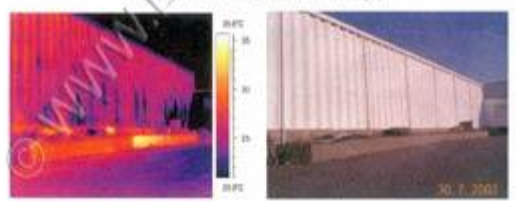
Building Envelope
 Dark areas indicate weaknesses in the insulation integrity
