Norddeutsche Affinerie Hamburg, Cooling Water Pipe

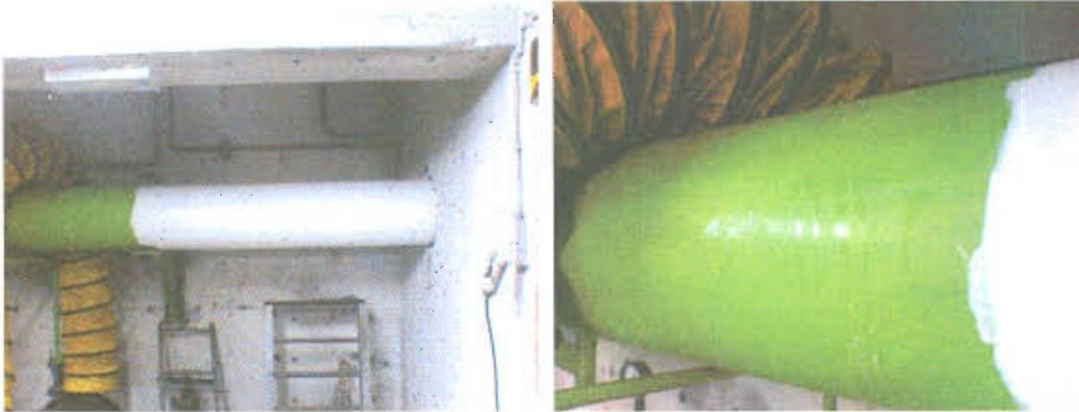
Room temperature 16°C, Temperature of pipe surface 9°C, little condensation Condensation wiped off, application of MMG coating, MMG adheres well

MMG strongly corrodes the green synthetic resin varnish

MMG plus old varnish scraped off, no problems with new MMG application Friday, 3/7/2008, 8 am

RSC 300 applied by brush and scraper, thickness approx. 3 mm

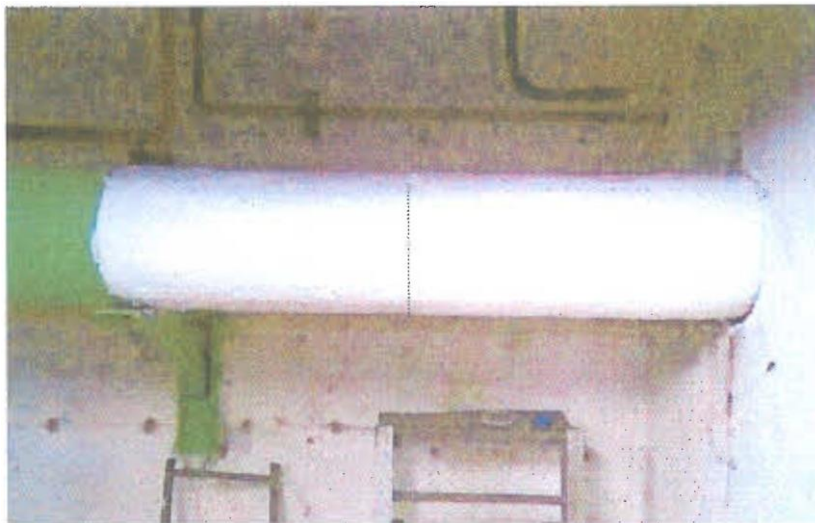
Afterwards pipe surface temperature 6,4°C with condensation,

HSC surface temp. 3 mm thick : 8,8°C without condensation

HSC surface temp. 6 mm thick : 10,3 °C without condensation
