**INSPECTION OF BELT PARKWAY BRIDGE
OVER BAY PARKWAY AND SHORE PARKWAY, BROOKLYN NEW YORK
SEPTEMBER 14, 2017**

On September 14, 2017, representatives of Superior Products International II, Inc. ("SPI") and of the New York City Department of Transportation ("NYC DOT") conducted a visual and physical inspection of the test application of Rust Grip® on certain structures of the Belt Parkway Bridge in Brooklyn, New York. The SPI representatives present were Jacob Ray, Project/Technical Specialist of SPI, and Warren Harbart of Superior Coating Solutions, the local SPI distributor in New York who organized the original test application of Rust Grip® in 2015 with the NYC DOT. The NYC DOT representative present was Danny Lima, Chief Inspector.

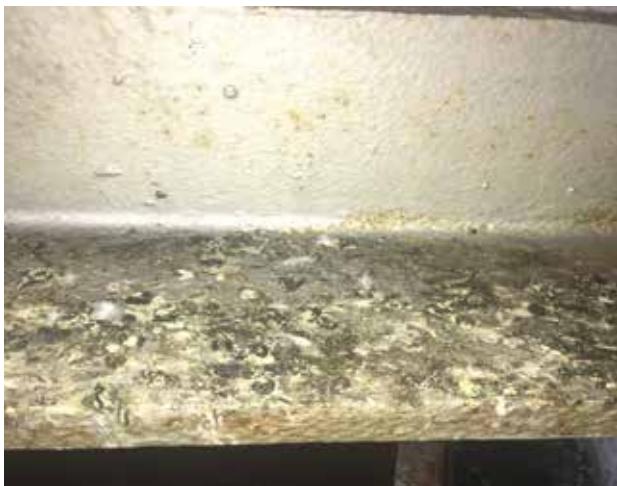
Top Side of Beam

Adjacent to the test area, the support beam has significant pack rust from heavy water leaking from the parkway above. As we have previously observed, the persistent water runoff from leakage above the top of the beam was causing significant staining and spotting on the test area, and we wanted to confirm that this staining was in fact being caused by the runoff of rusty water that had dried in the profile of the painted surfaces

The reason for the inspection by SPI and NYC DOT was a concern about a possible coating failure because of the current stained appearance of the coating film of Rust Grip® in the area of the test application. We chose this section of the beam to clean because it had the poorest appearance and because it was reachable with the lift truck that was provided by NYC DOT. The pictures below show the section of the beam before any cleaning occurred.

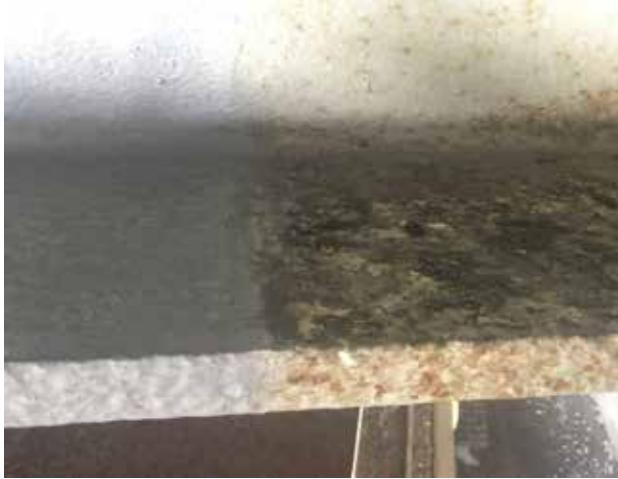
Left Side of Beam

As the rust deposits from the runoff had settled deep into the profile of the surface of the beam, we carefully removed all of the deposits without being overly aggressive and risking damage to the coating. We were successful in removing all staining and spotting in the banded area. When we finished, the surfaces were completely clean, and the appearance of Rust Grip® was similar to the day that it was originally painted on the surface. There were other areas, primarily on the inside web, where the staining was minimal (or non-existent), and Rust Grip® appeared to have been newly painted on the surface with no deterioration or loss of film integrity. Mr. Lima closely inspected the cleaned area and confirmed that there were no signs of rust bleed through or of a failure of the Rust Grip® coating film.

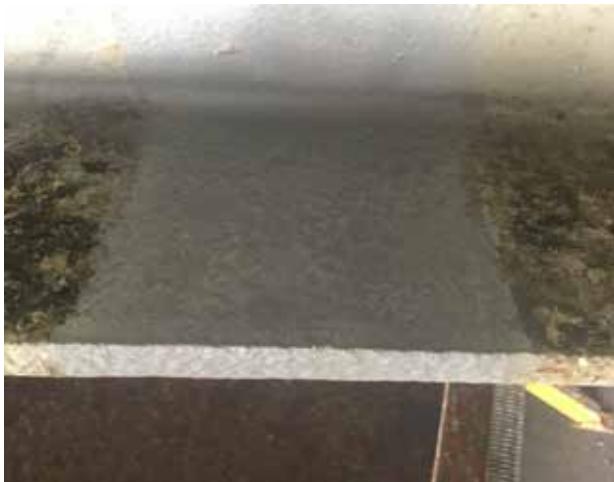
Top Side of Beam

As you can see from the pictures below, Rust Grip® has no pin holes, bleed through, or cracking and peeling of the coating film. Rust Grip® is fully intact and encapsulating the beam with no deterioration or loss of integrity of the coating film. The surface rust is the result of water run-off from corrosion that exists above the beam and that is continuously running down and coming to rest on the top of the Rust Grip® test patch.

For areas with this type of exposure, we recommend top coating Rust Grip® with Enamo Grip, a durable, completely hydrophobic and protective top coat that is suitable for full submersion in water. The next application of Rust Grip® on this type of bridge structure should be top coated with Enamo Grip to protect against the constant water saturation of the structure and to resist discoloration and peeling from the heavy and persistent water exposure. Enamo Grip can be tinted to any desired color.
