# SOUTH AUSTRALIAN WATER CORPORATION

2007

Last year I had to Demonstrate Graffiti Cleaner in a heritage area on a pipe and old stone work.

The pipe is 1 meter square riveted panels 120 meters long manufactured in Scotland 150 years ago.

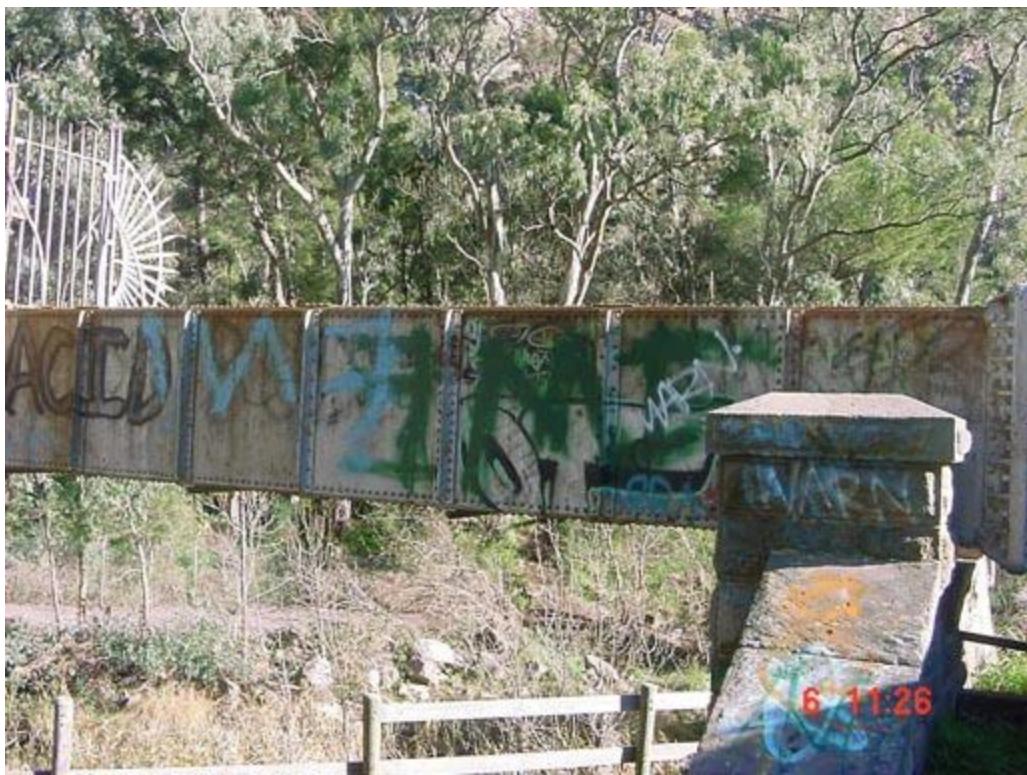
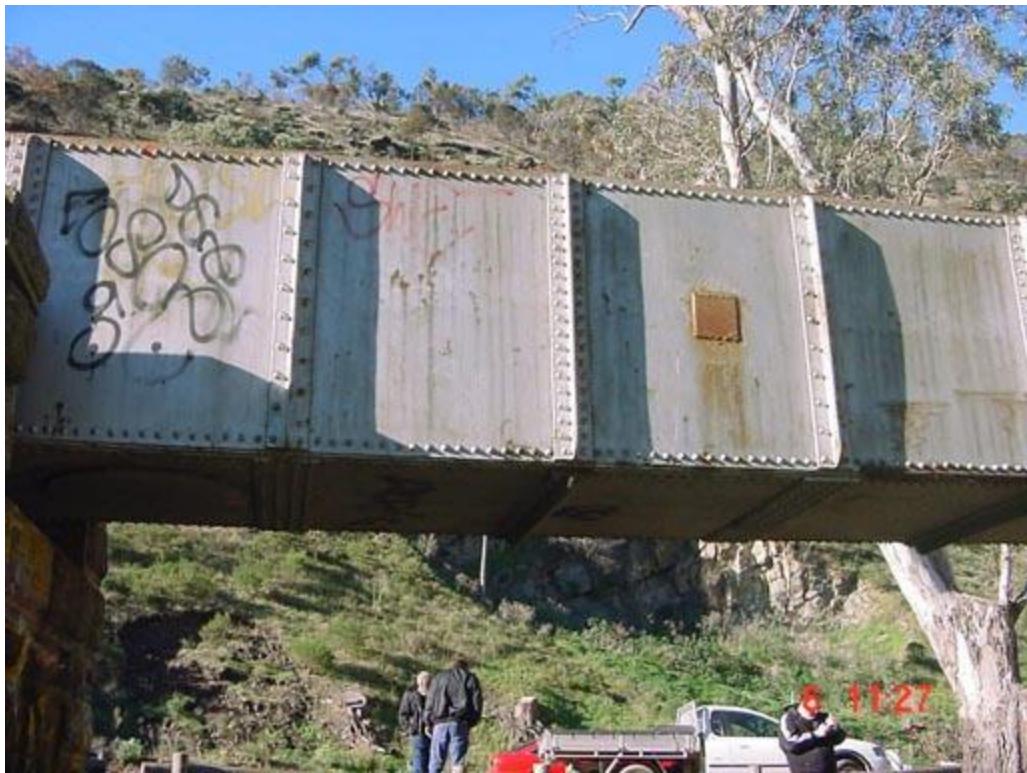
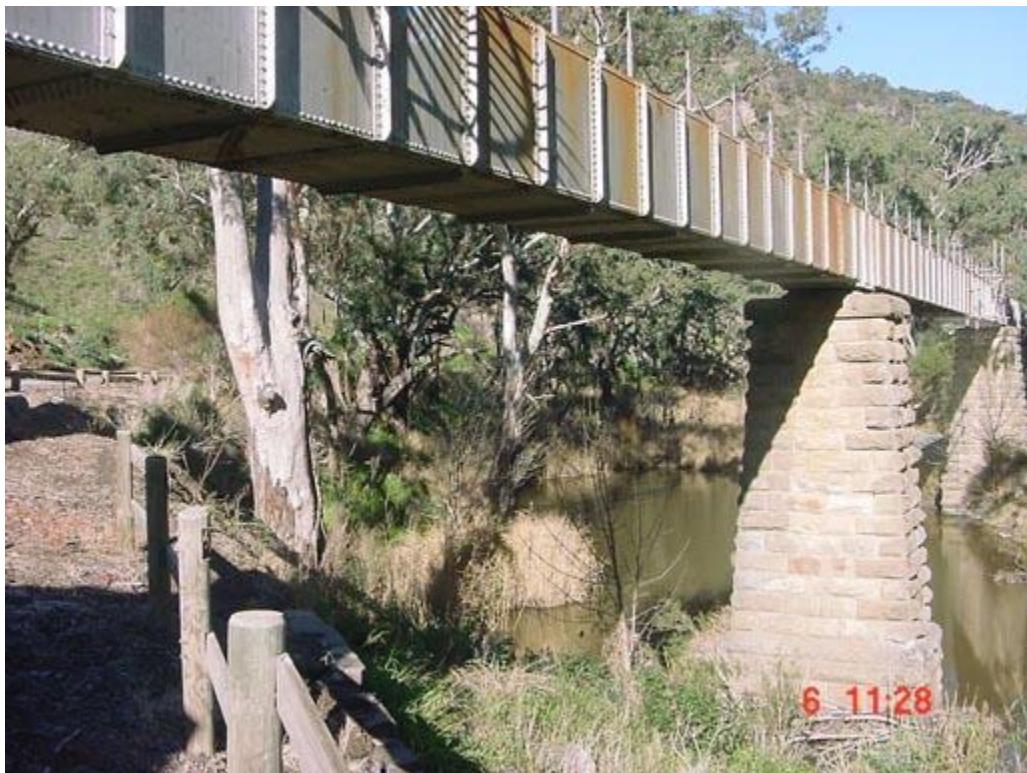
I have attached some photo's of the pipe.

The last time the pipe was painted was 45 years ago and the paint was very thick.

Due to the pipe being over water and other environmental issues the pipe could not be Grit Blasted or Pressure cleaned as these methods could not be contained. The existing paint had different layers of Lead Base Paints ( 2 mm thick ) on the sides and the top. On the underside of the pipe that was protected from the elements the paint was cracked and about 4 mm thick.

By applying Graffiti Cleaner to the side of the pipe and allowing it 5 minutes to penetrate the paint, then wiping it down with a rag the paint started to come off. By applying additional Graffiti Cleaner and wiping the area I removed all the paint down to the RED LEAD.

Work on this project could only be archived by using 2 Knuckle Booms as the cages are about 1.5 meters in area. Slight additions had to be made to one of the units so containment sheeting could enclose the area so nothing would fall into the water.

To clean the pipe only Graffiti cleaner would be used to remove the old paint.

2 coats of **RUST GRIP** ® Grip to be applied

2 coats **ENAMO GRIP** ® (S) in the colour as requested
