## HOME IN OAK BROOK

### ENAMOGRIP® JULY 2011

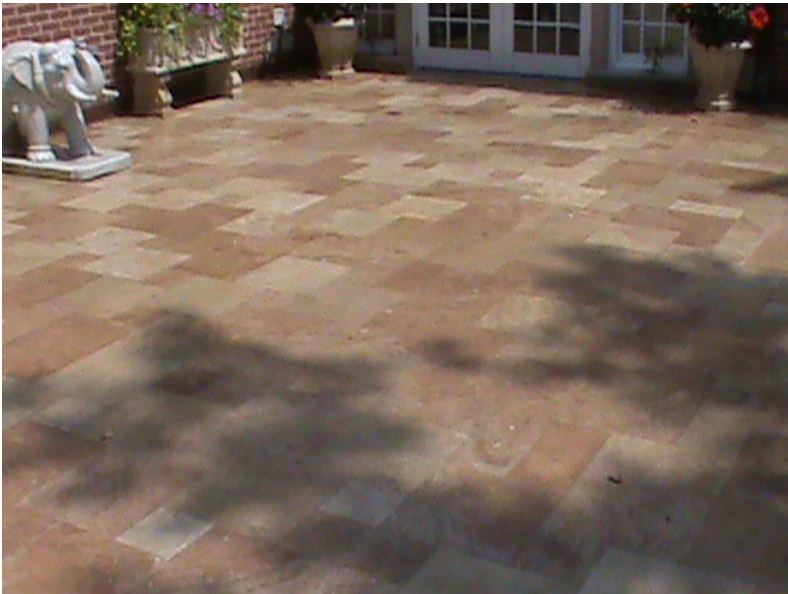
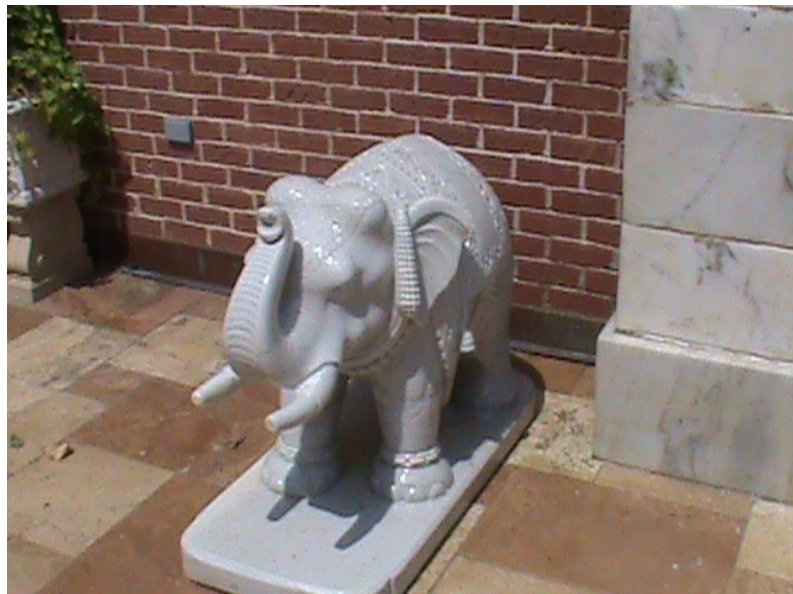
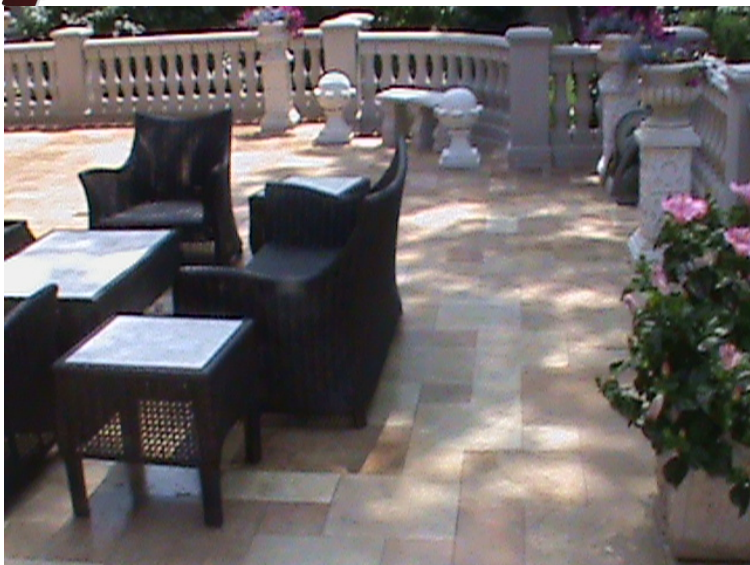
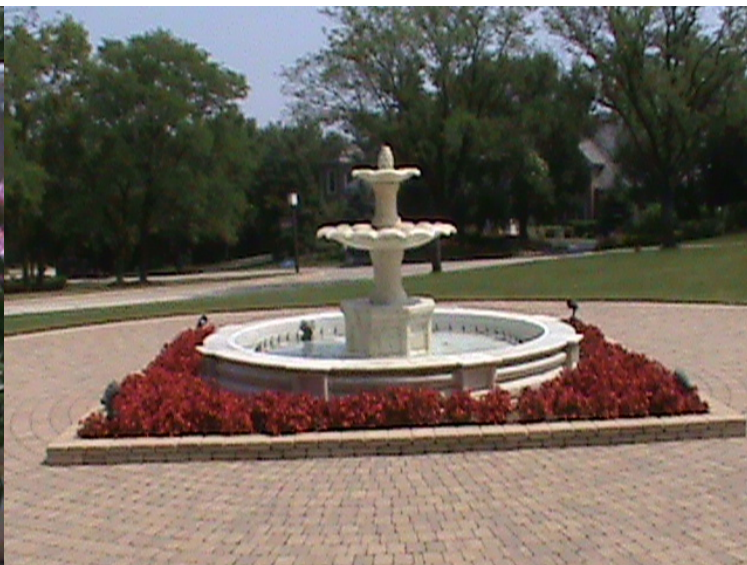
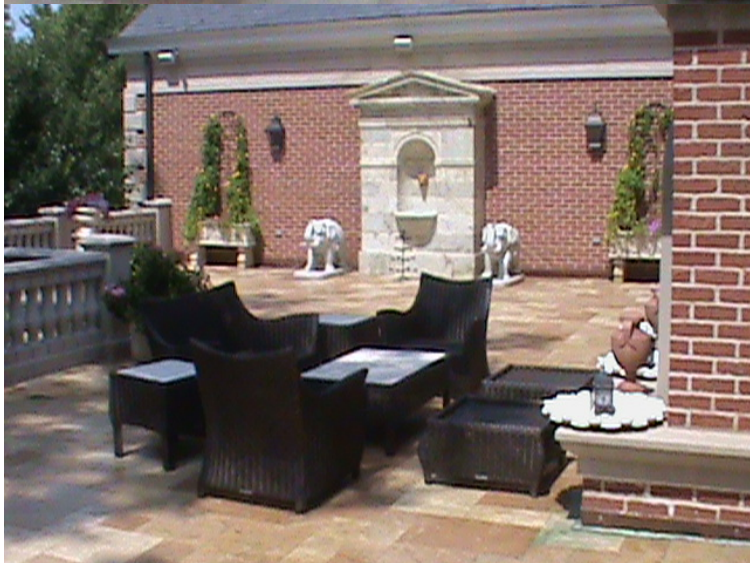
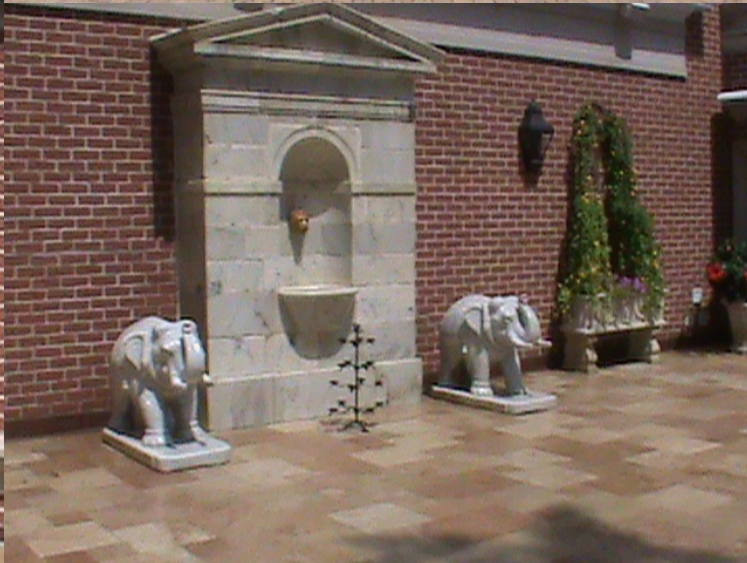
8 million dollar home in Oak Brook. Over two thousand Sq. ft. of stone and marble. They tried using a penetrating epoxy last year but it yellowed and failed over the winter. This should last them 10 years. Base coat was thinned with 25 per cent MEK which penetrated the stone surface. Finish coat was two quick applications with fine sand cast on the first coat for traction control.
