SPECIALIZED COATINGS AND PROTECTED ENVIRONMENTS

PICTURE HISTORY OF RUST GRIP IN AUSTRALIA

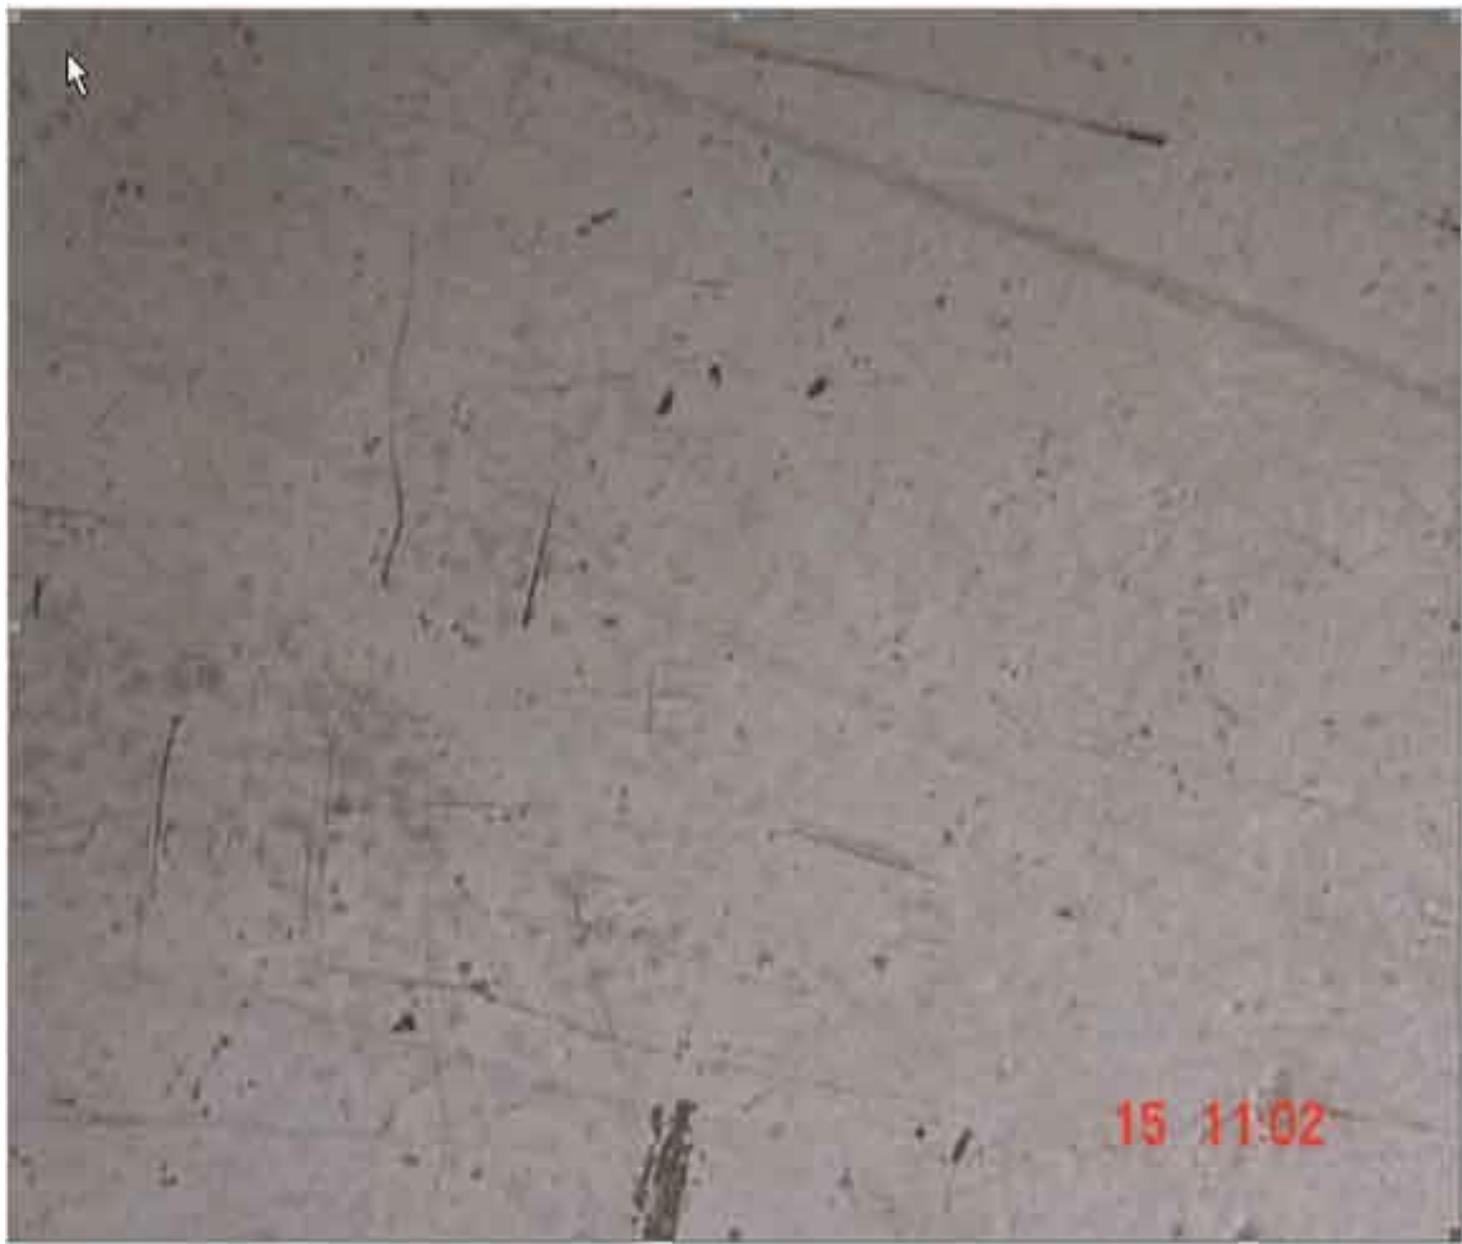
The floor had machine cutting (lathe) oil dripping on the concrete for 25 years. To get the oil out we applied 5 coats of **SP INTERLOCK / INNERSEAL** ® to leach out the oil we then applied 2 coats of **RUST GRIP (NS)** ® and 2 coats of Aqua Pox to give us 2 test areas

This test area is over 5 years old the only wear and tear has been caused by the forklifts where the forks dragged over the floor surface to scar the surface.

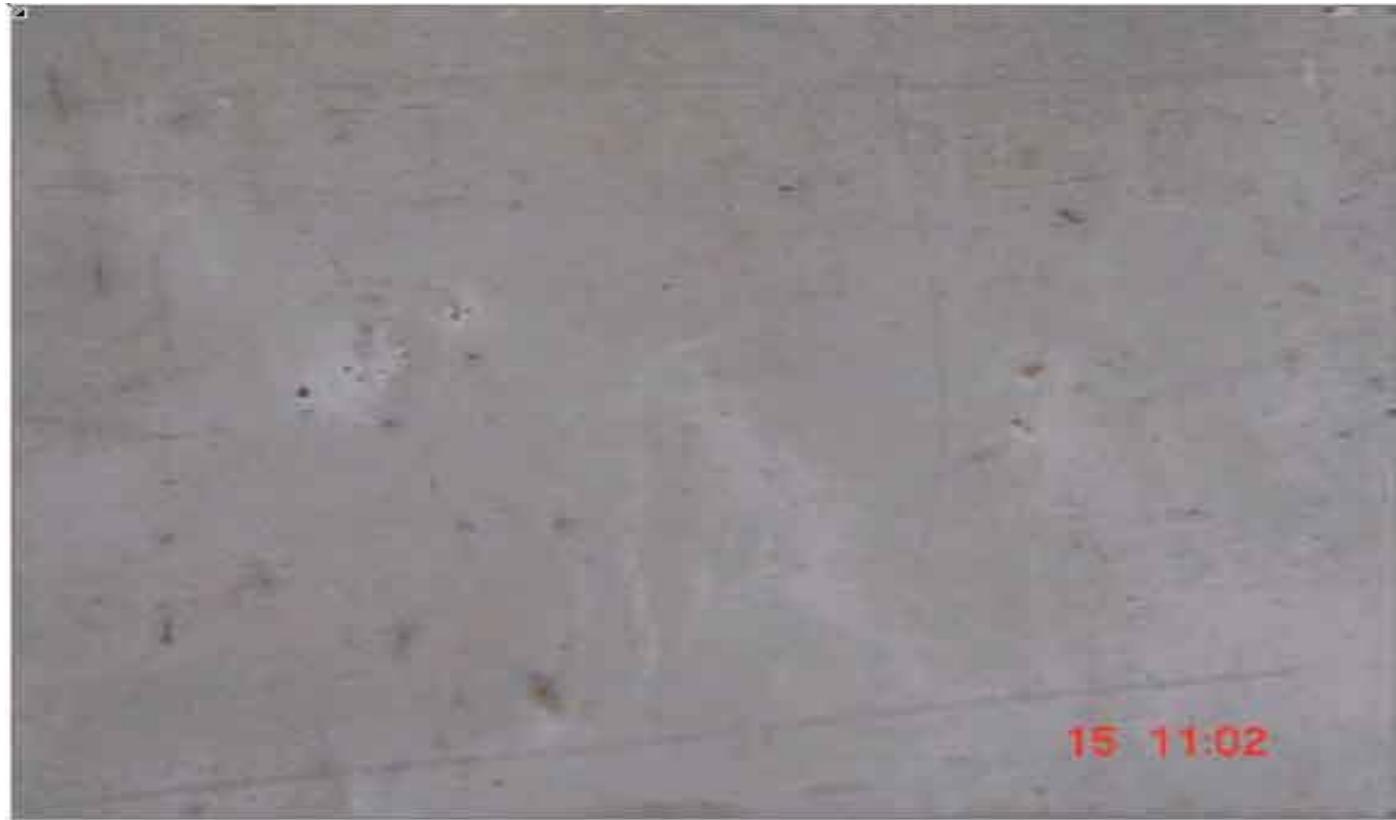
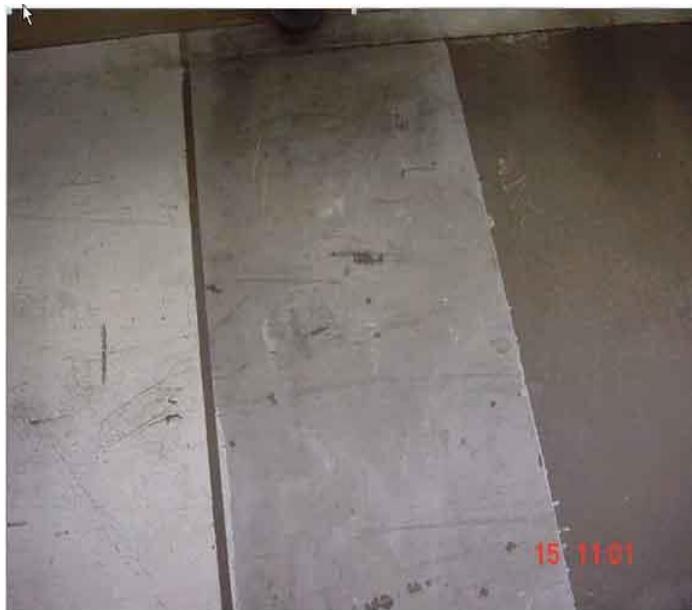
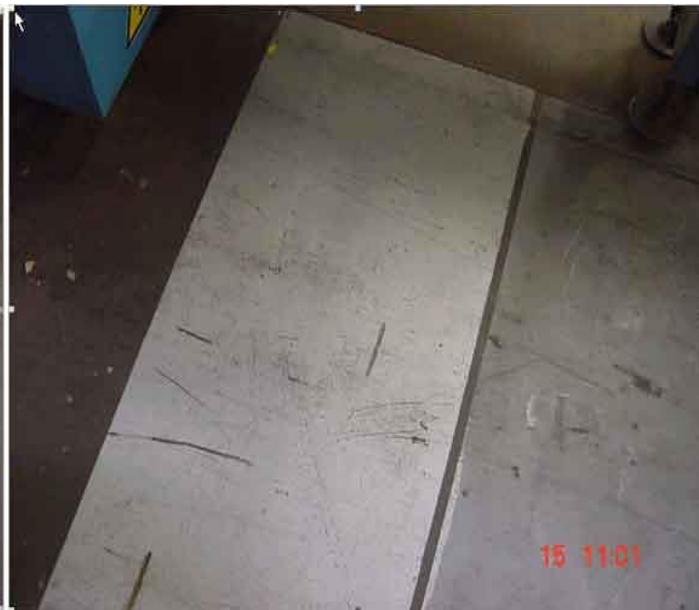
In the store area **RUST GRIP (NS)** ® Was applied over raw concrete 2 coats only and is now over 3 years old and shows no sign of wear

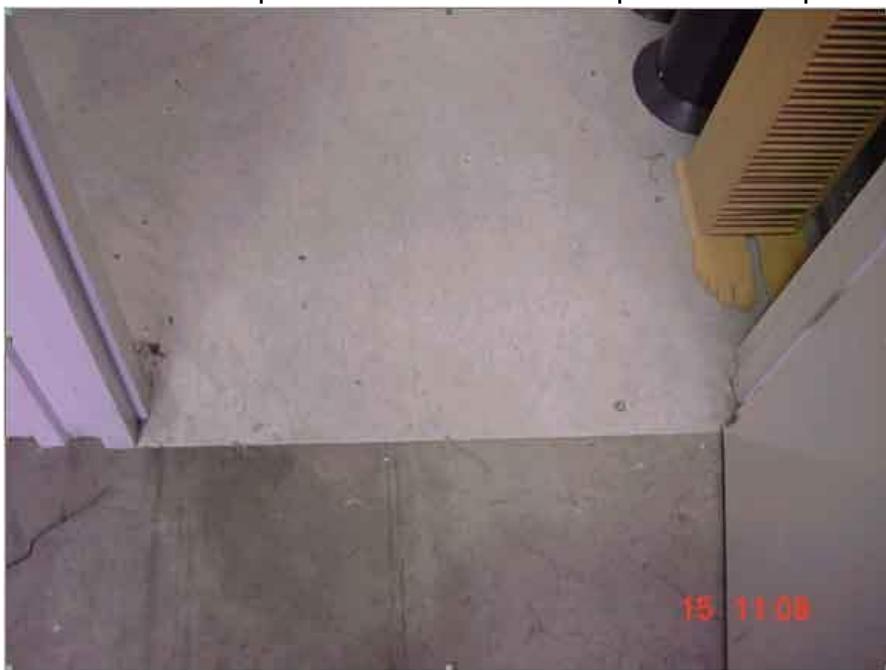
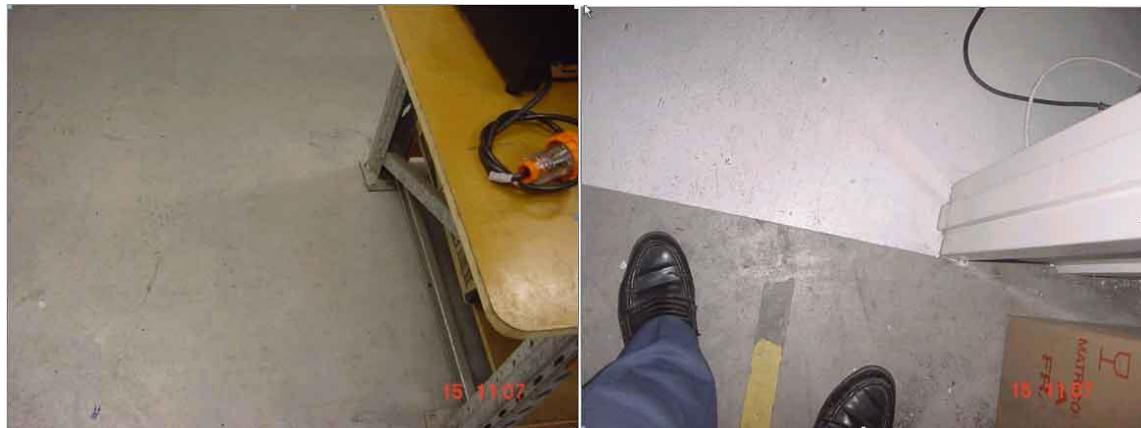
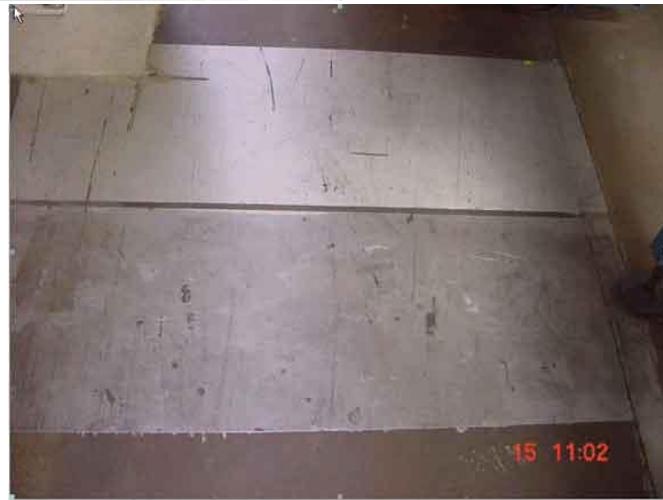
No 538 Rust Grip is on the bottom and Aqua Pox on top 539

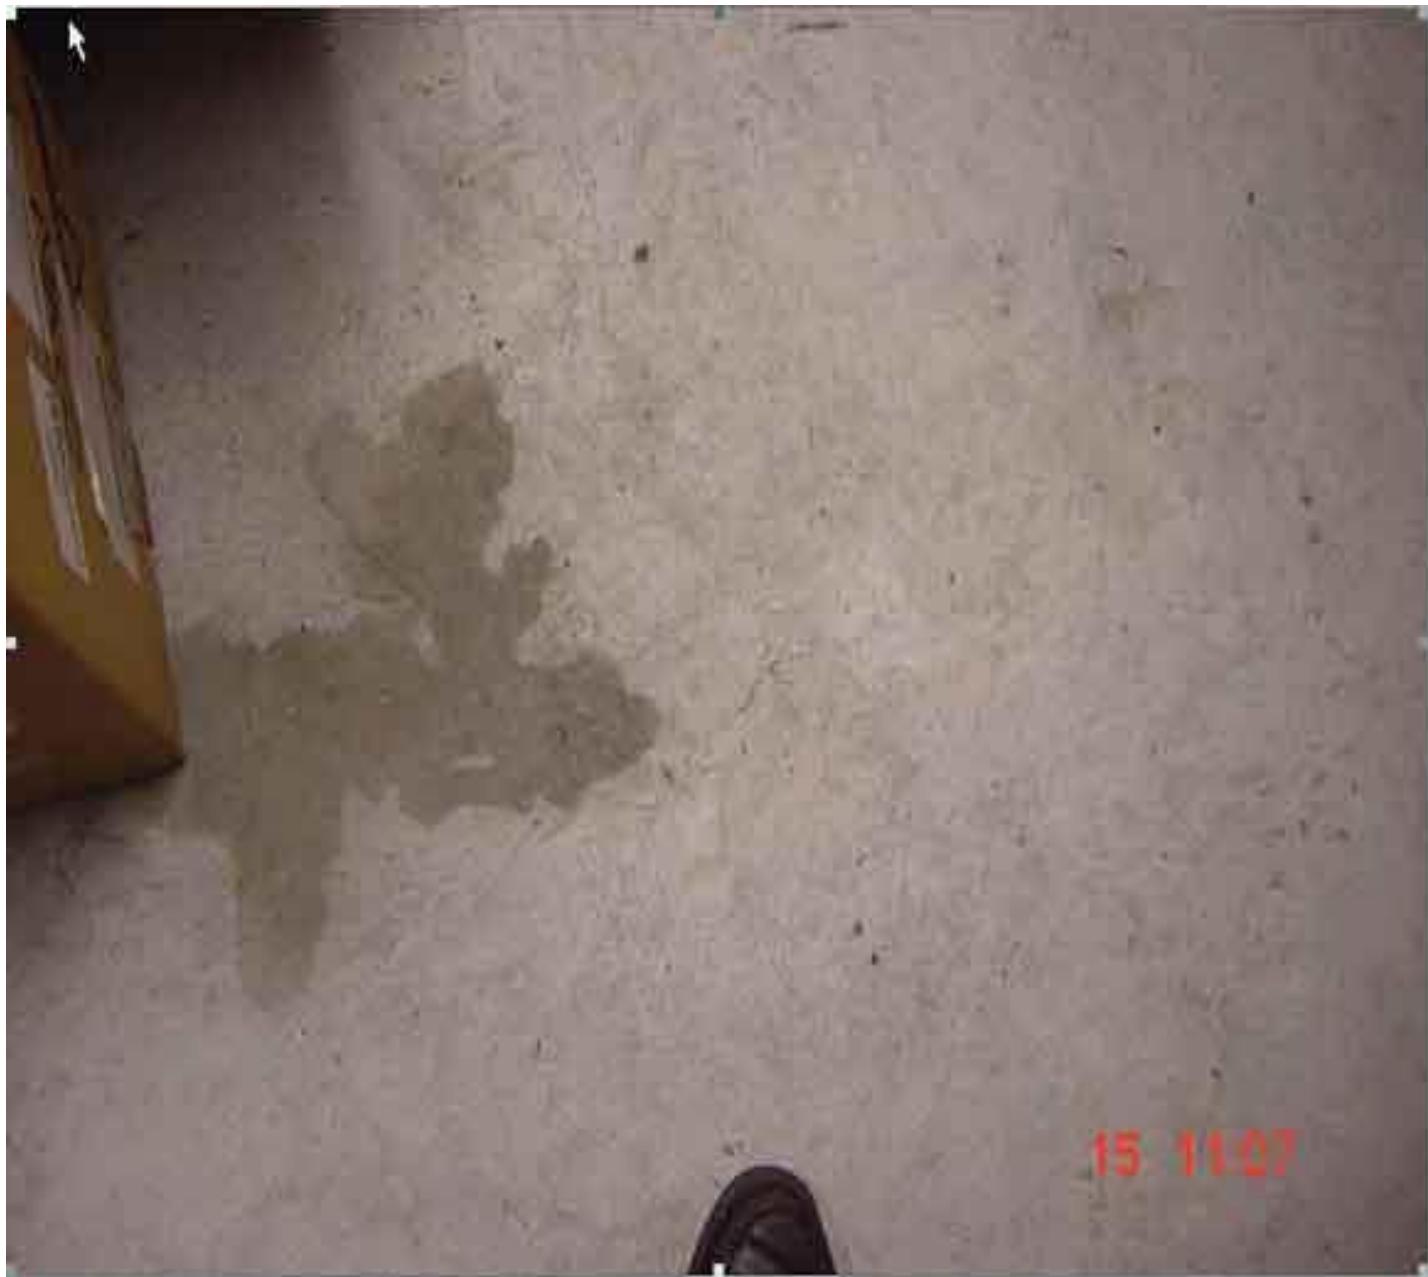
Photo No 541F you see the heavy coffee stain and outlines where the stains have been removed after clean up. The **RUST GRIP (NS) ®** is as good as new. No corrosion. The reason I said no corrosion as I have been told that coffee is highly corrosive.
