Rusting Roof

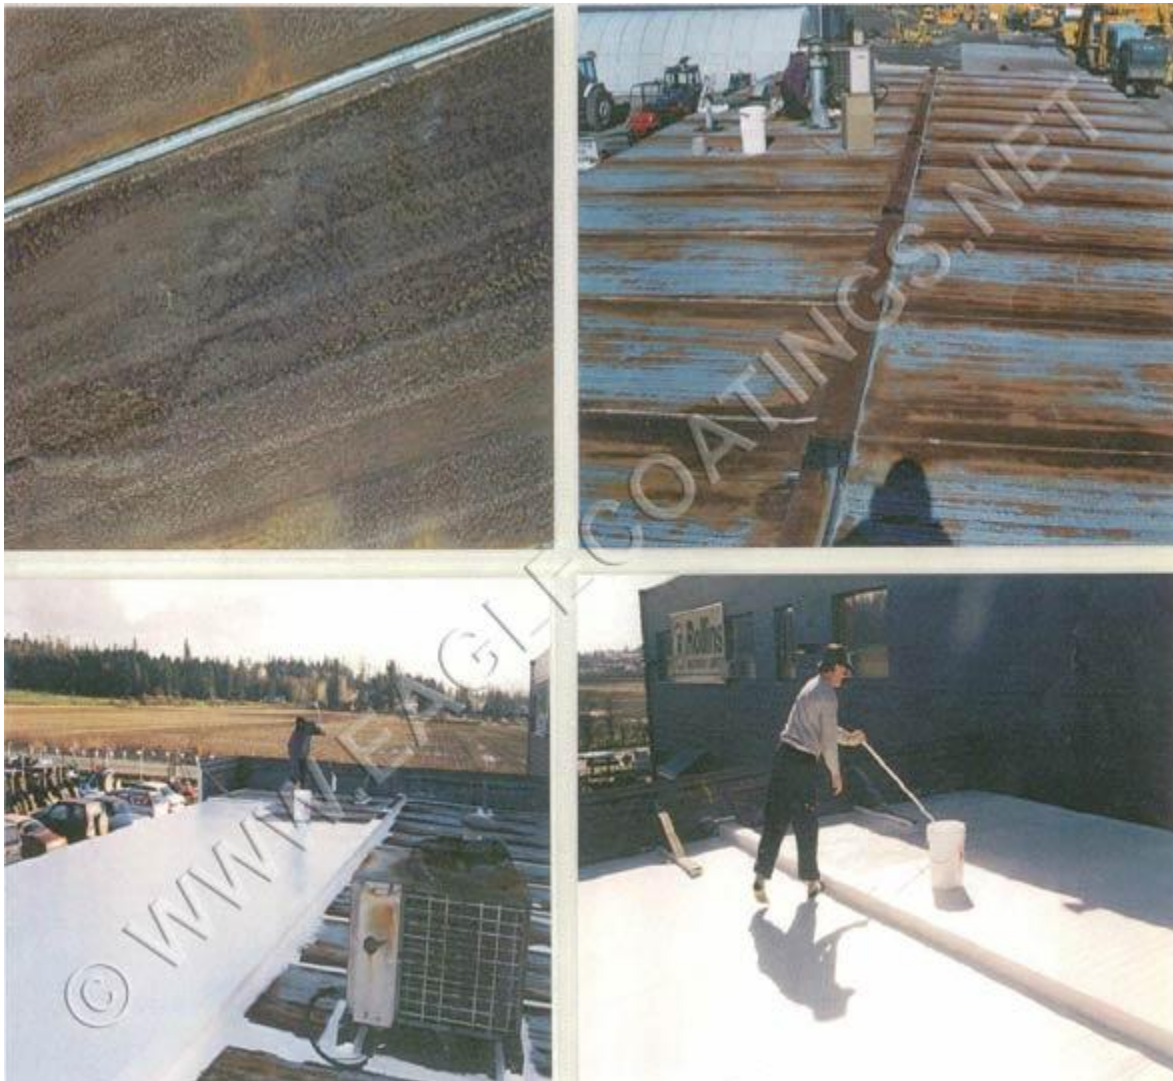
The problem in this instance was that the roof was leaking. In the first picture it can be seen where the roof had rusted right through. This area required a high build of about five coats of **SUPERTHERM**[®]. The fact that the coating also insulated was not a major consideration to this customer. When he was called as a reference however all he could talk about was that this was the coolest building in his facility. Oh and it didn't leak anymore.

The air conditioner shown in the bottom picture was running constantly when we first arrived. Before the first coat was completely applied, the air conditioner had stopped. We were so used to hearing it constantly in operation, that we were concerned we may have knocked a wire loose when we were cutting in around it. It did start a short cycle however which told us that it was fine. The reduced operation not only reduces the electrical consumption but also extends the life of the equipment
