## **SOUTH AUSTRALIAN WATER CORPORATION**

**2007**

The pipe is 1 meter square riveted panels 120 meters long manufactured in Scotland 150 years ago.

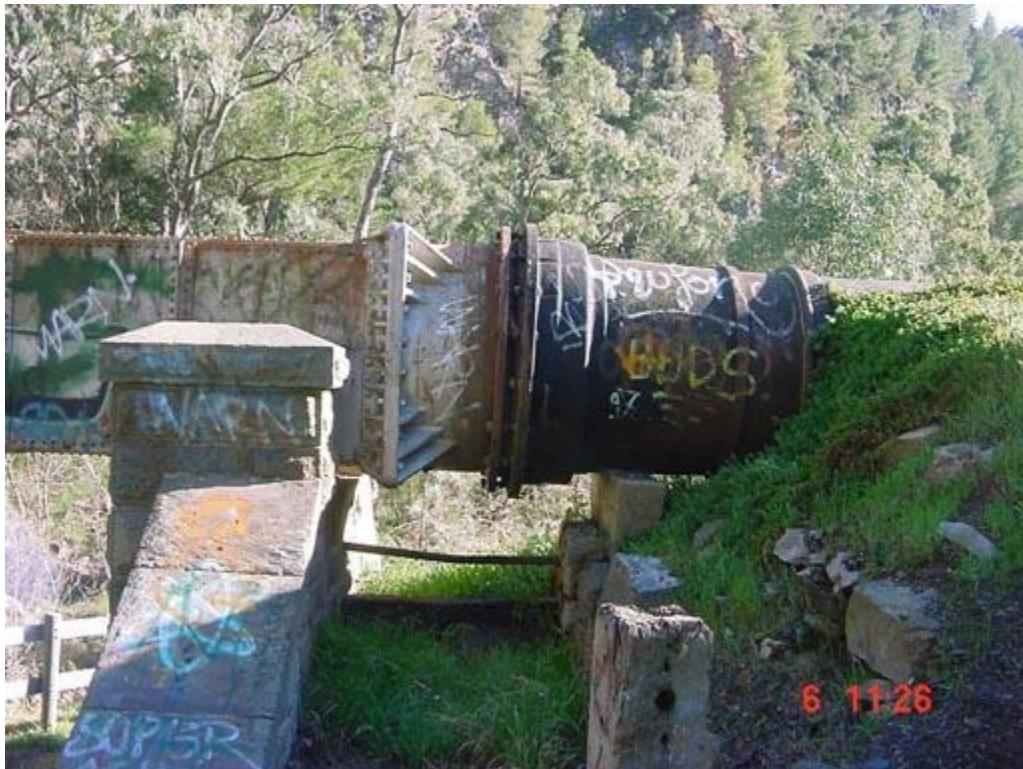
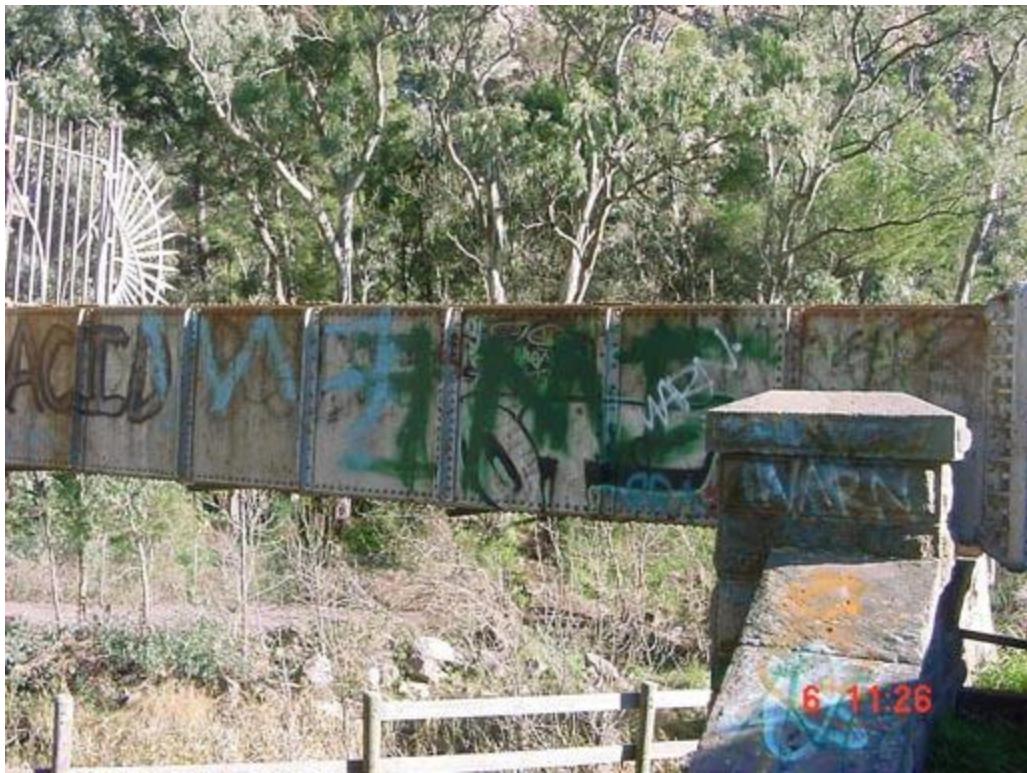
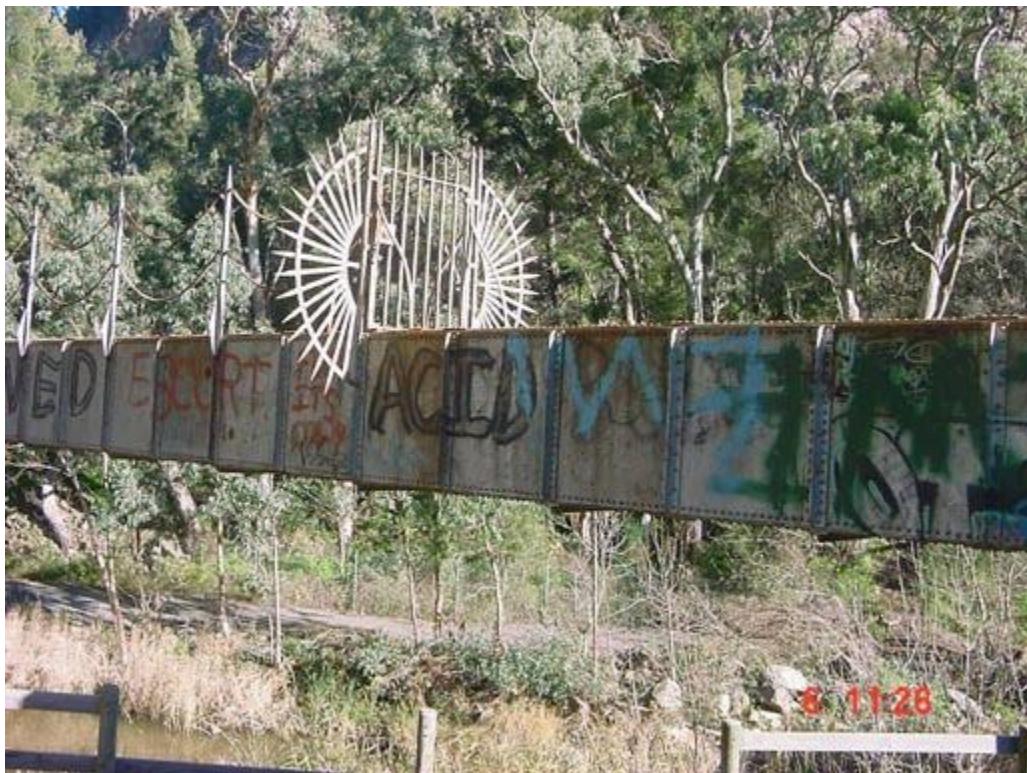
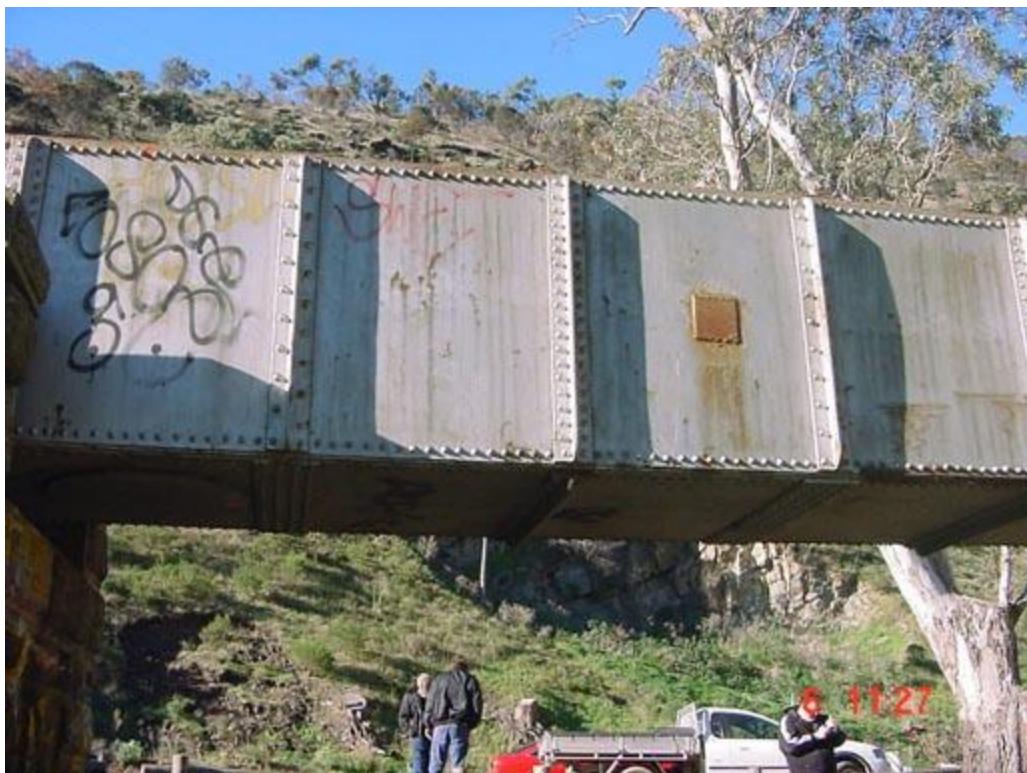
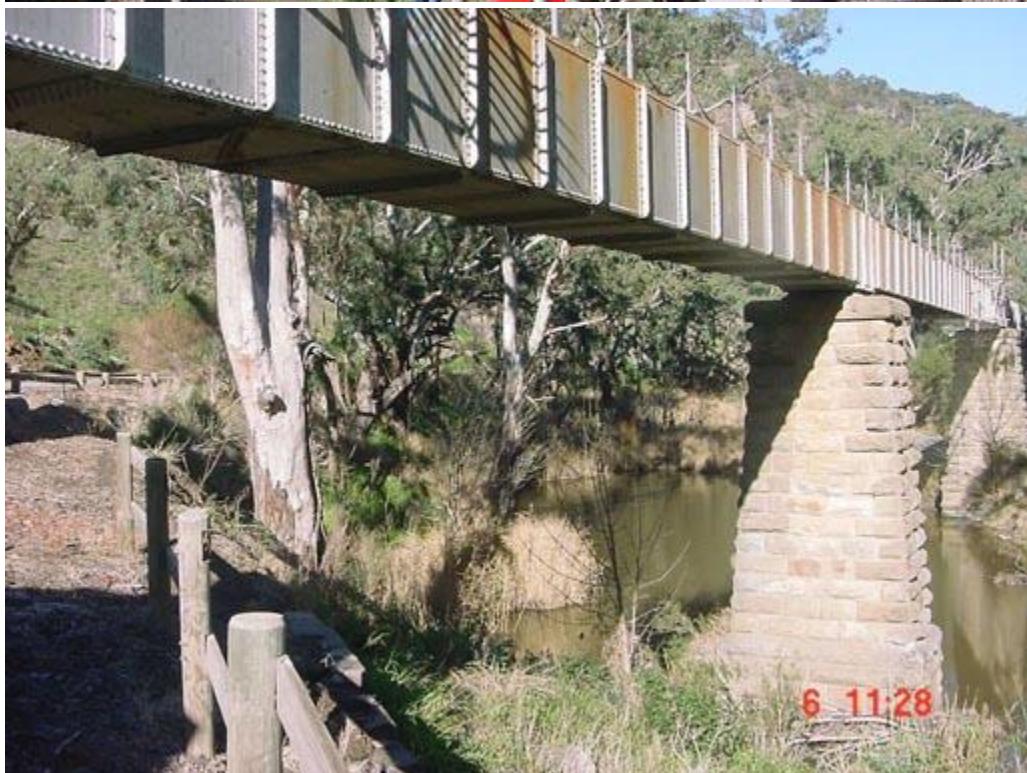
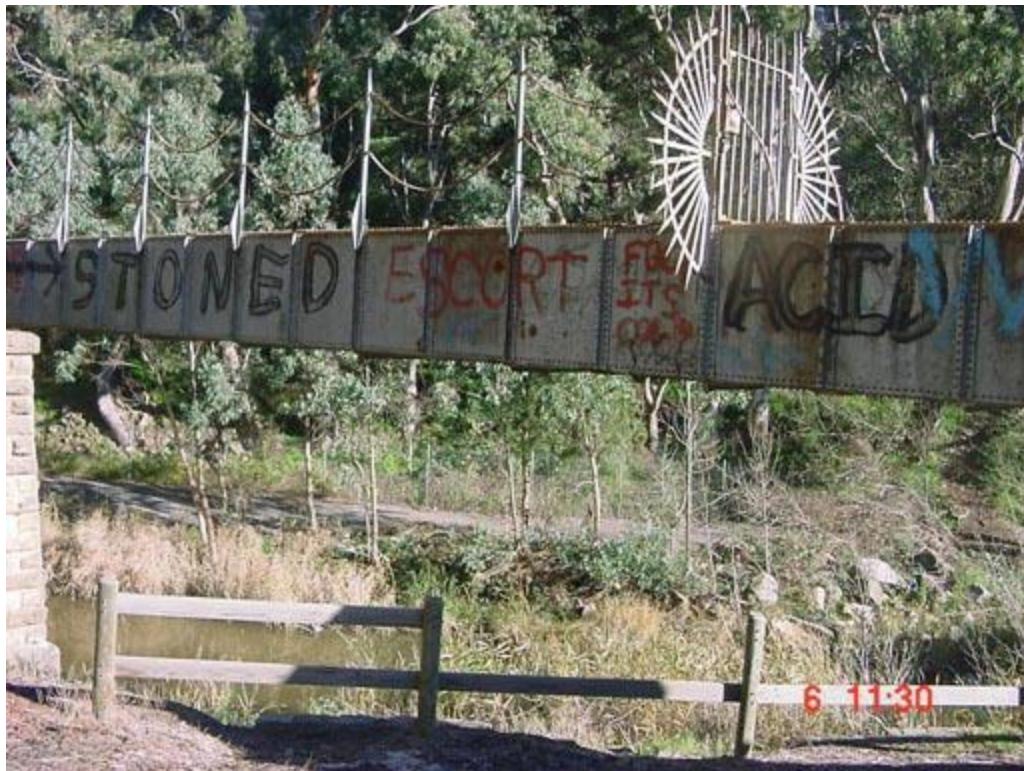
The last time the pipe was painted was 45 years ago and the paint was very thick.

Due to the pipe being over water and other environmental issues the pipe could not be Grit Blasted or Pressure cleaned as these methods could not be contained. The existing paint had different layers of Lead Base Paints ( 2 mm thick ) on the sides and the top. On the underside of the pipe that was protected from the elements the paint was cracked and about 4 mm thick.

By applying Graffiti Cleaner to the side of the pipe and allowing it 5 minutes to penetrate the paint, then wiping it down with a rag the paint started to come off. By applying additional Graffiti Cleaner and wiping the area I removed all the paint down to the RED LEAD.

Work on this project could only be archived by using 2 Knuckle Booms as the cages are about 1.5 meters in area. Slight additions had to be made to one of the units so containment sheeting could enclose the area so nothing would fall into the water.

To clean the pipe only Graffiti cleaner would be used to remove the old paint.

2 coats of **RUST GRIP** ® Grip to be applied

2 coats **ENAMO GRIP** ® (S) in the colour as requested
