Saffo Beats Schedule on Barefoot Landing Swing Bridge

BRIDGE PROJECT – BAREFOOT – NORTH CAROLINA

FINAL SUMMARY REPORT

Project Code: City of North Myrtle Beach Barefoot Bridge Reconditioning Project

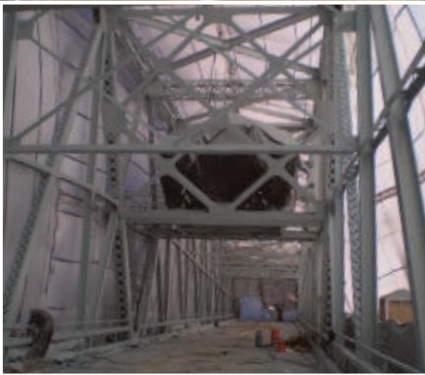
Photos courtesy of Saffo Contractors
