**Scandic Hotel
Antwerp**

SUPERTHERM® and Primer **RUSTGRIP**®

Situation at Scandic Hotel Antwerp: damaged airco ducts on top of roof, due to bird vandalism.

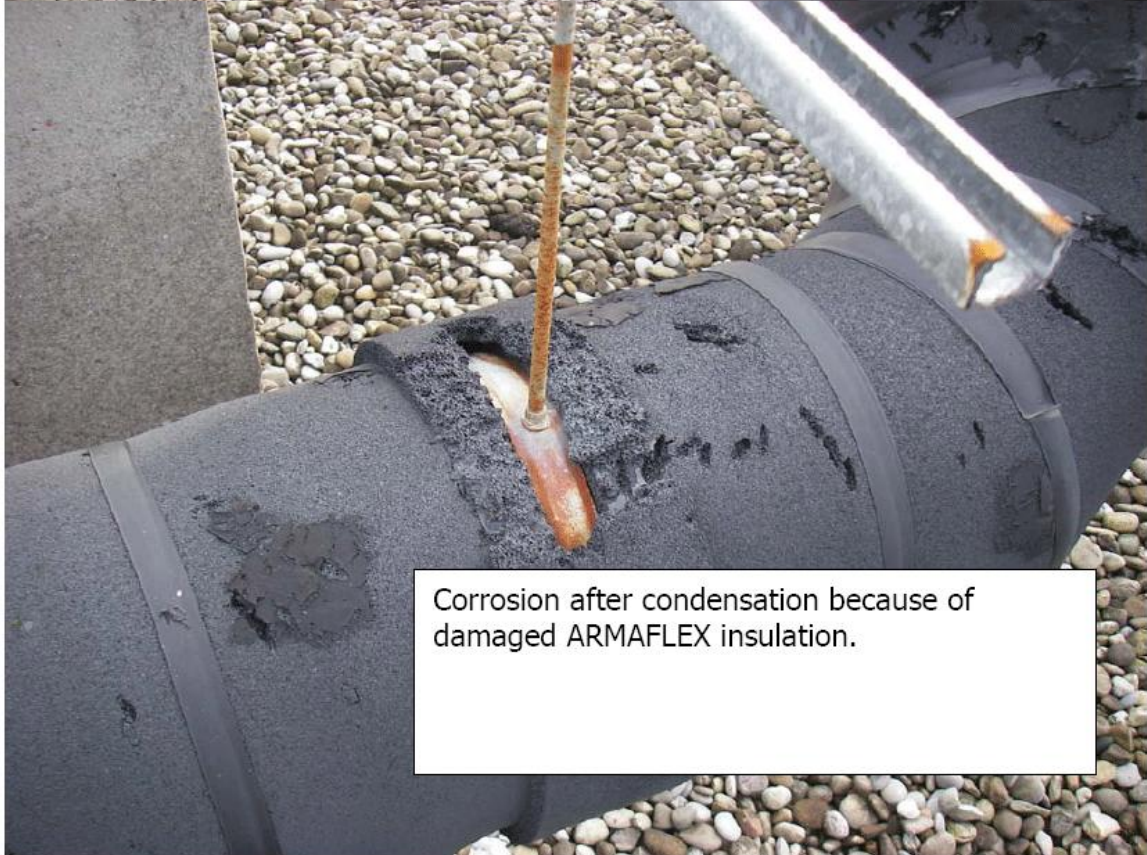
Corrosion after condensation because of damaged ARMAFLEX insulation.

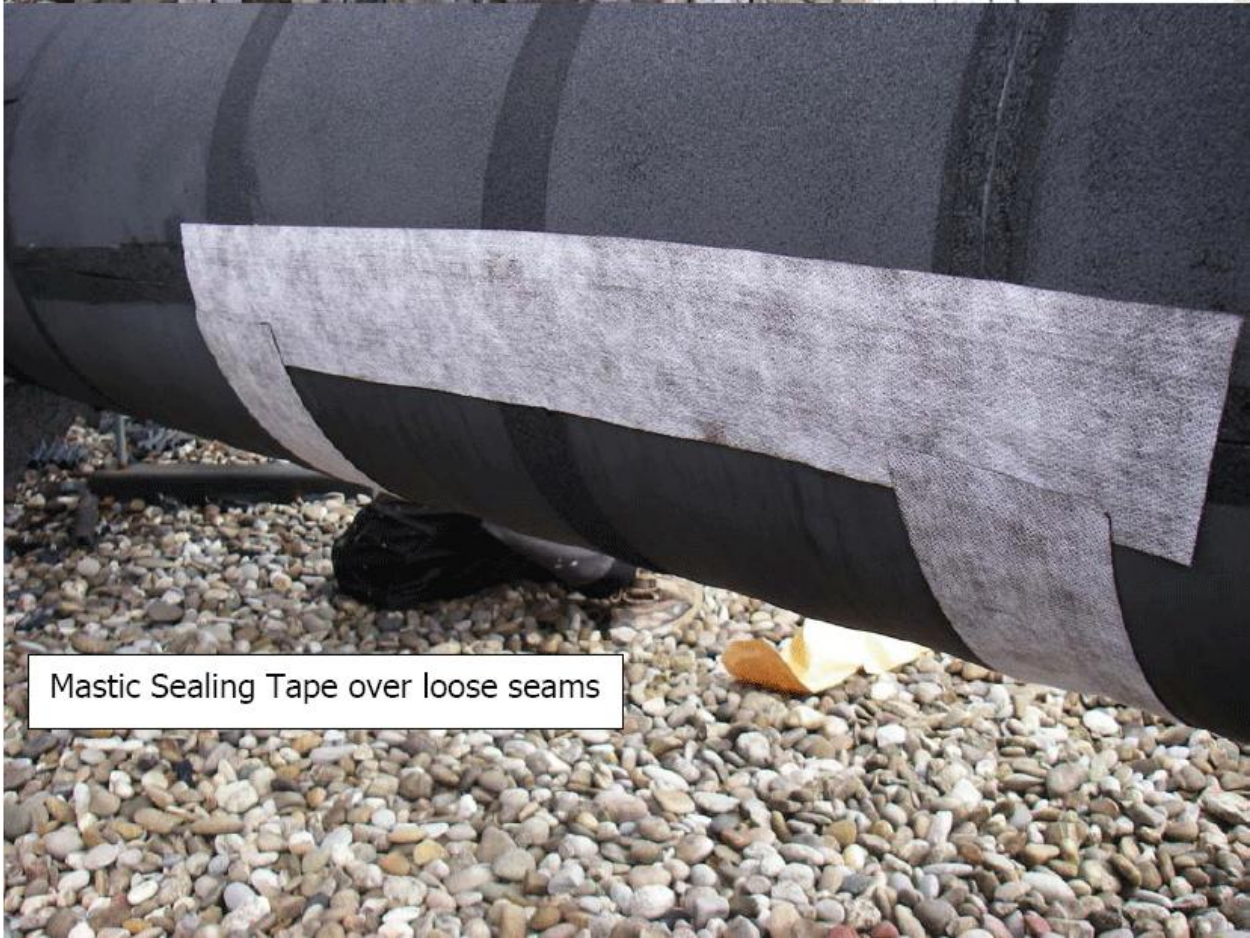
Mastic Sealing Tape over loose seams

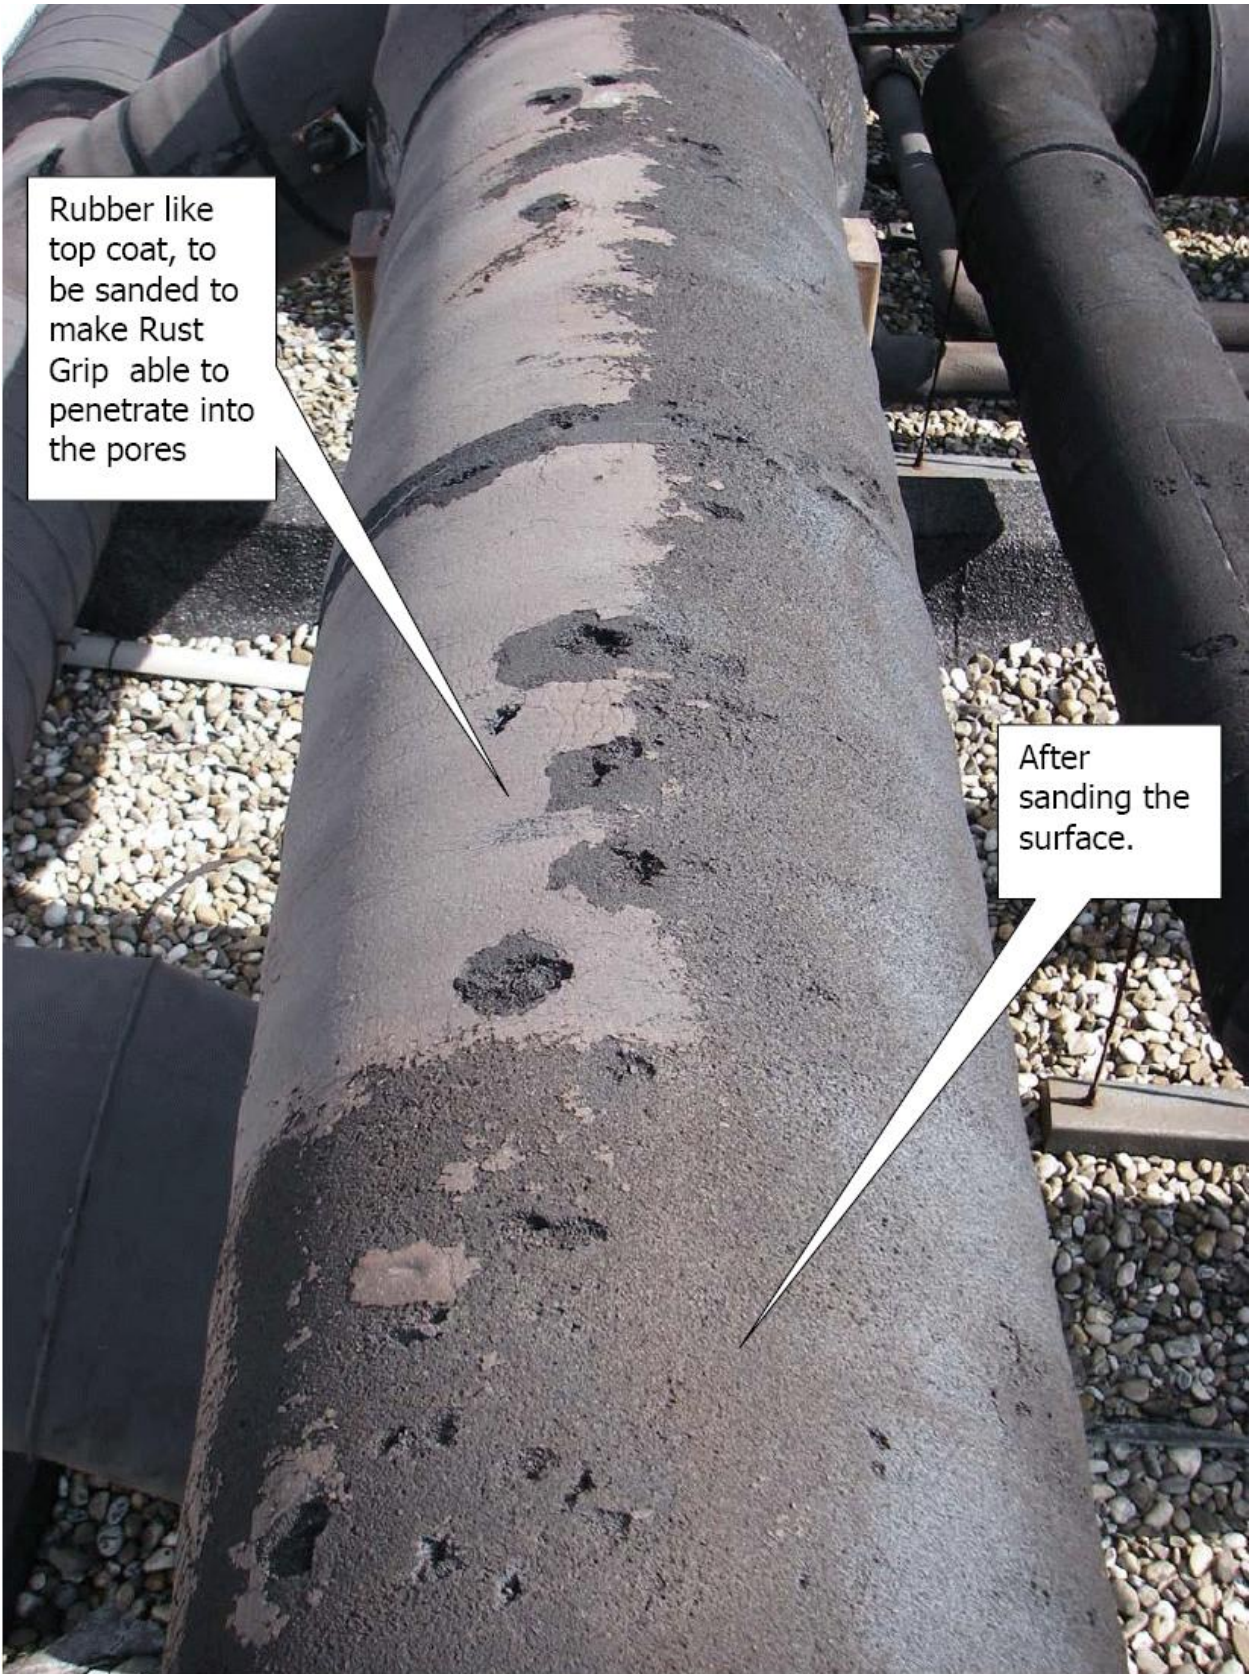
Rubber like top coat, to be sanded to make Rust Grip able to penetrate into the pores

After sanding the surface.

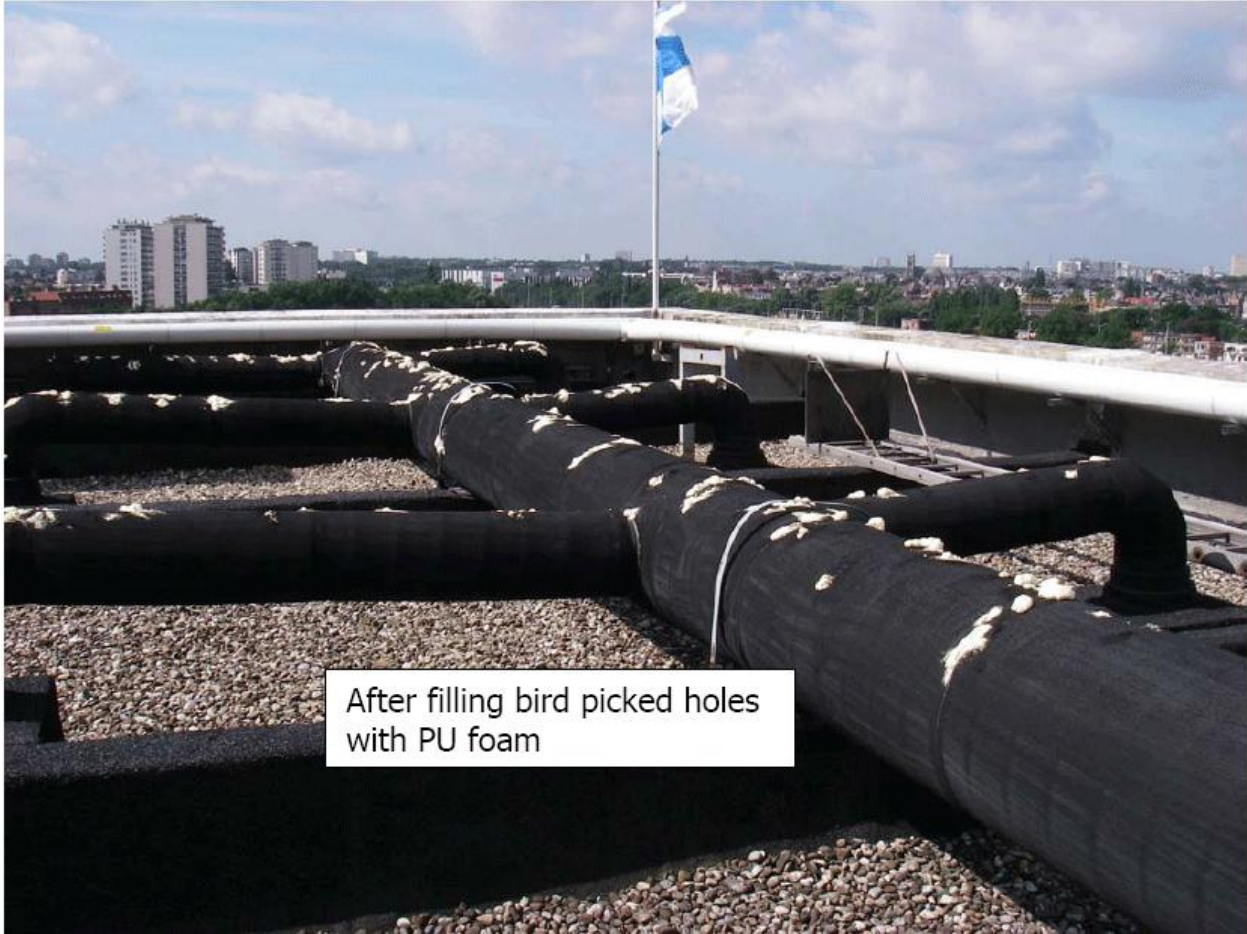
After filling bird picked holes with PU foam

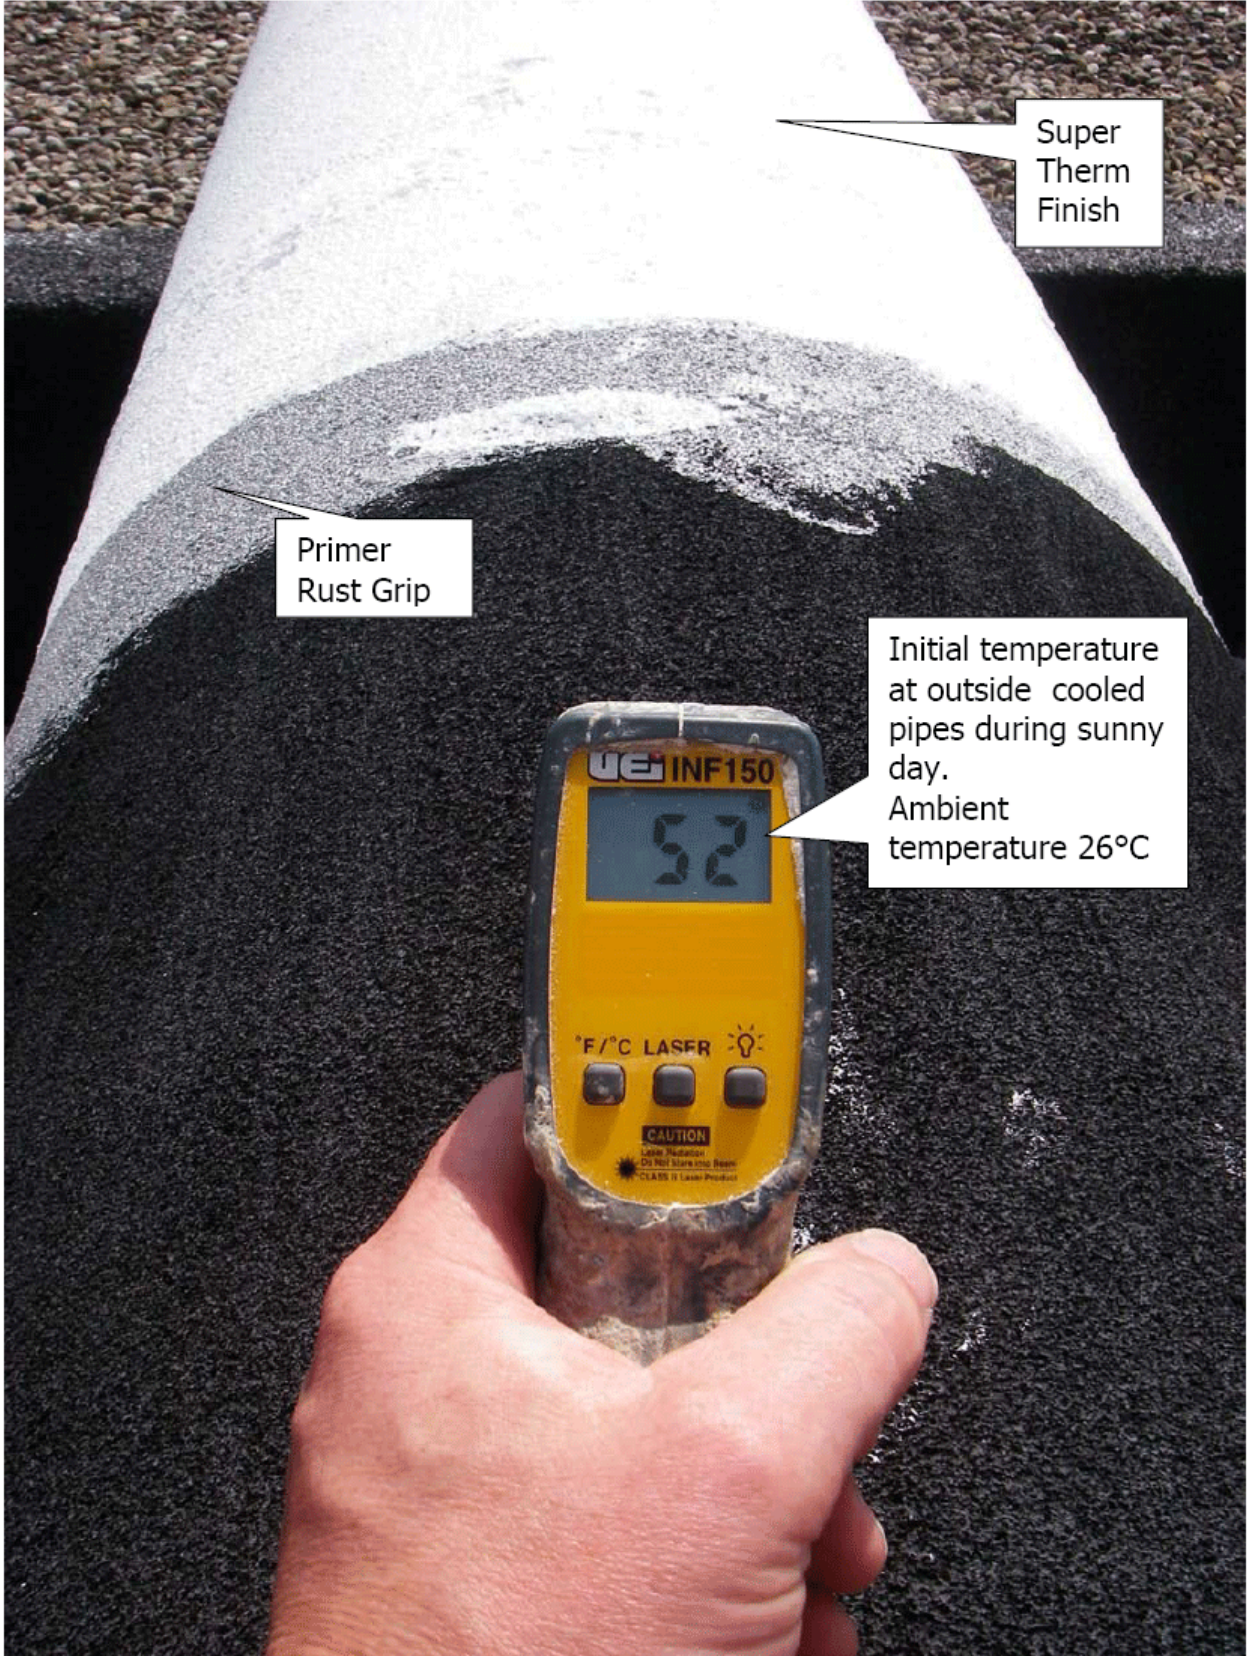
Super
Therm
Finish

Primer
Rust Grip

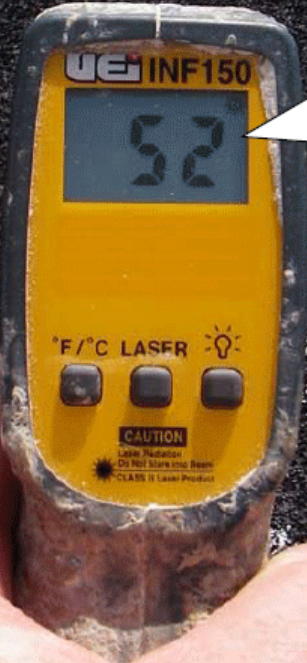
Initial temperature
at outside cooled
pipes during sunny
day.
Ambient
temperature 26°C

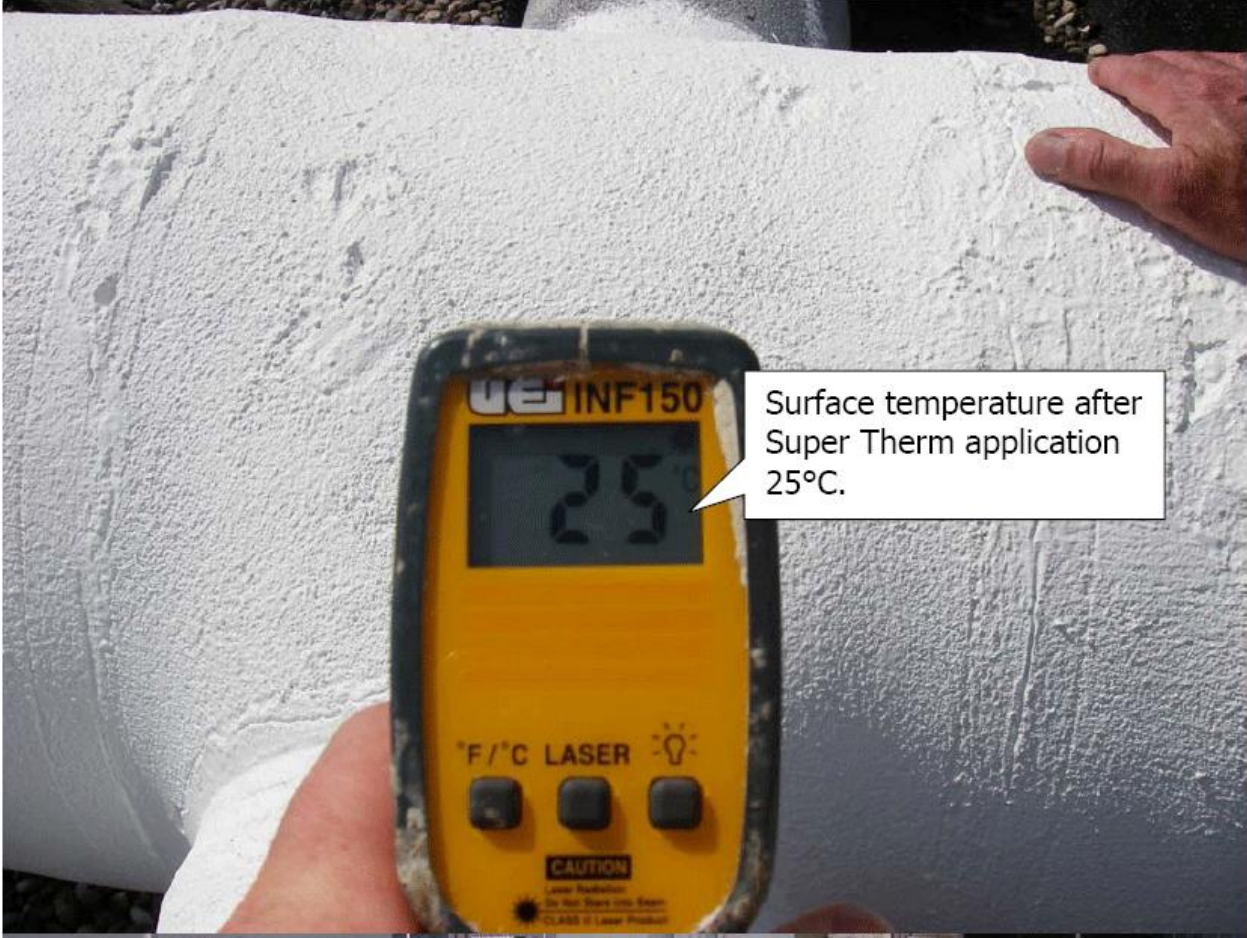
Surface temperature after
Super Therm application
25°C.
