## RAILROAD OVERPASS

Kentucky 1996 - 2004  
RUST GRIP and ENAMO GRIP

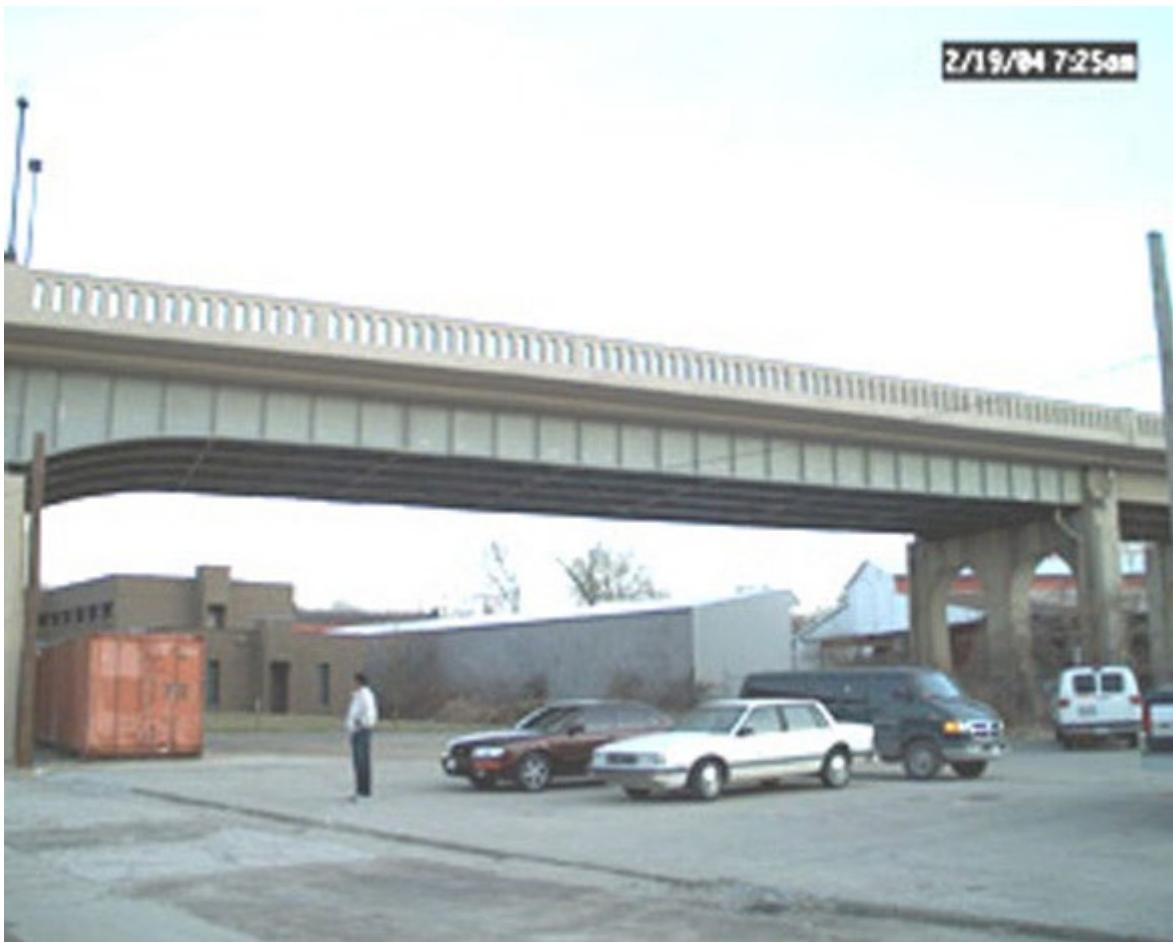
**A Railroad Overpass in Kentucky, in which trains regularly pass underneath.**

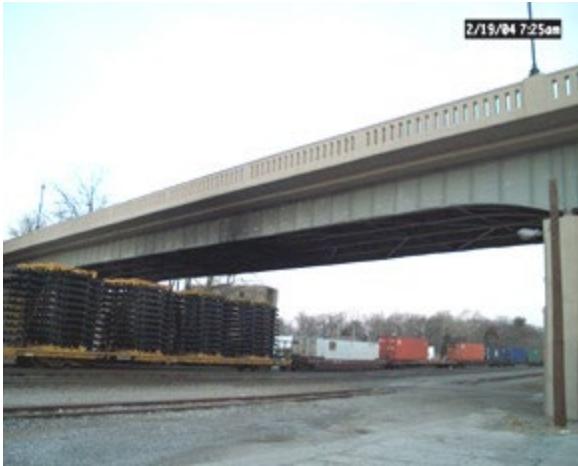
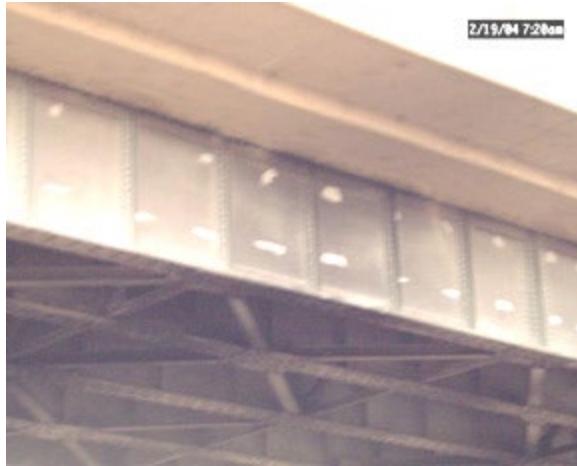
**Problem: Trains operating under the bridge leave severe diesel soot and carbon deposits behind, resulting in a corroded bridge structure.**

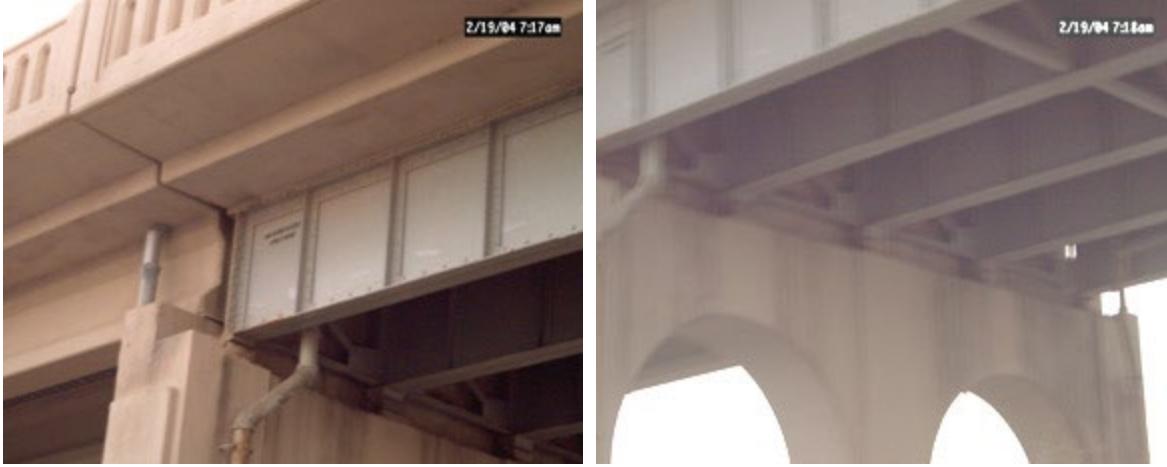
**After 8+ years of protection from RUST GRIP ® and ENAMO GRIP ®, Mr. Ted Hopwood at the University of Kentucky, which does research for the Kentucky Dept. of Transportation, reported the coating was still doing an outstanding job and looked very good.**
