# APPLICATION FOR GAZPROM AT REFINERY IN OMSK

Video application for Gazprom Refinery in Omsk

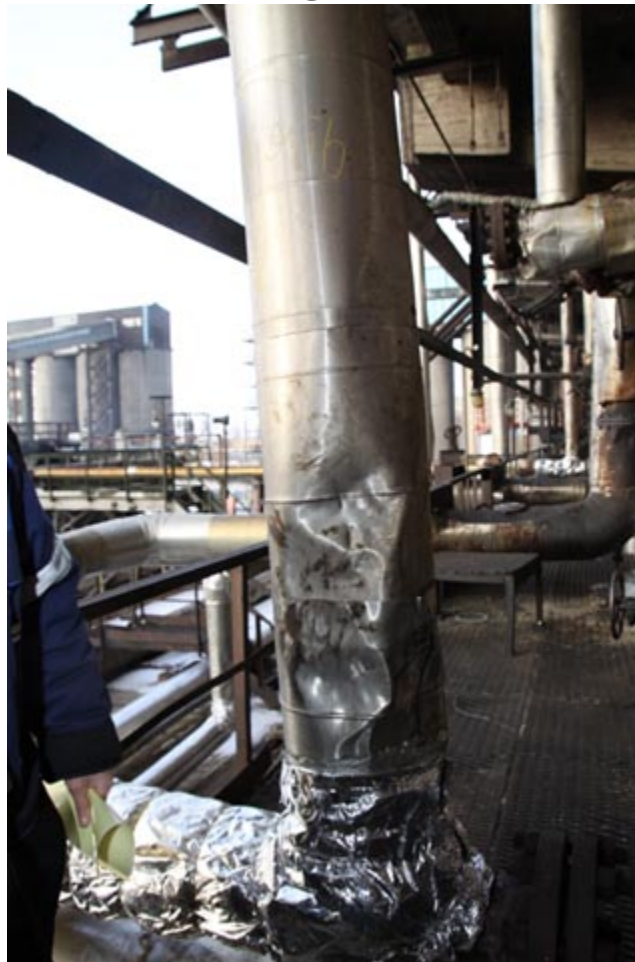
The metal jacket is worthless because it is not air nor water tight.

**470C / 878F** operating temperature

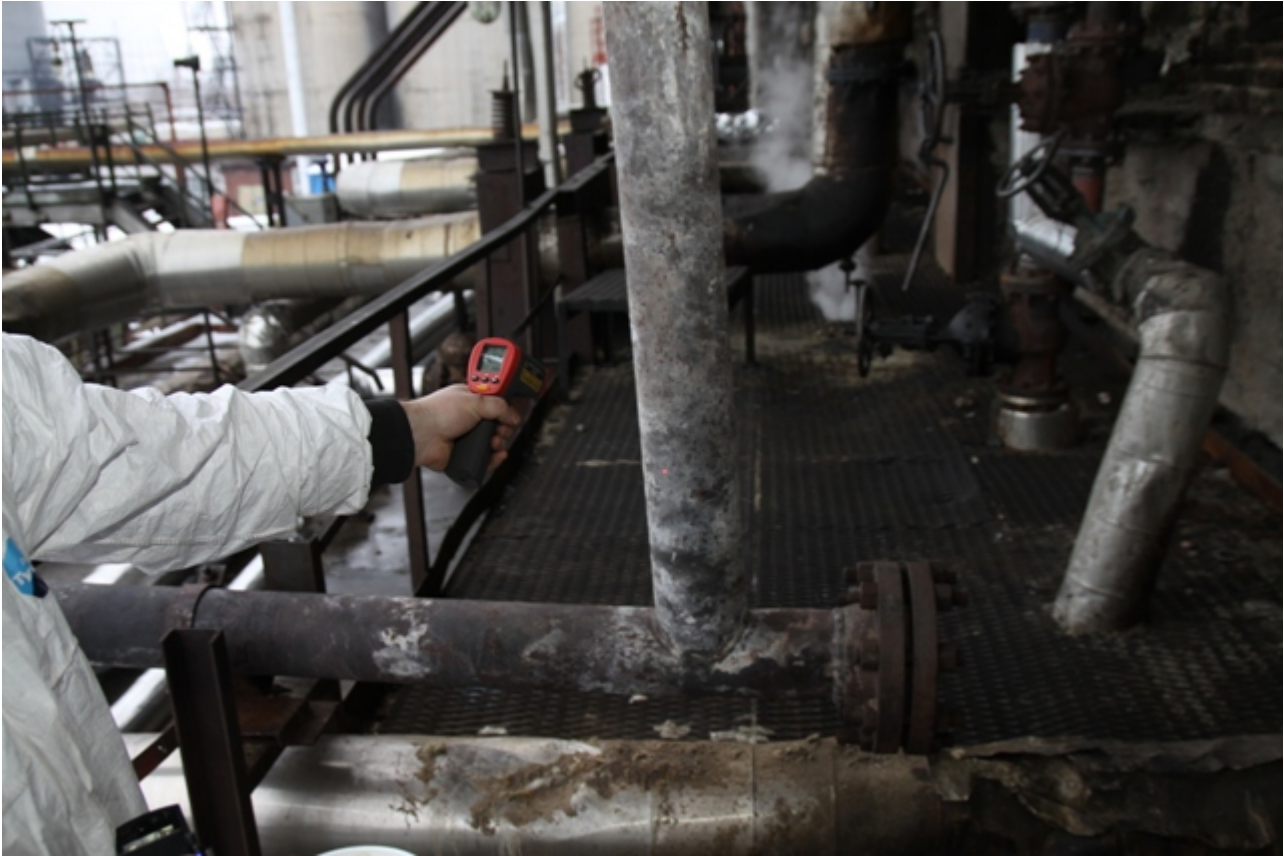
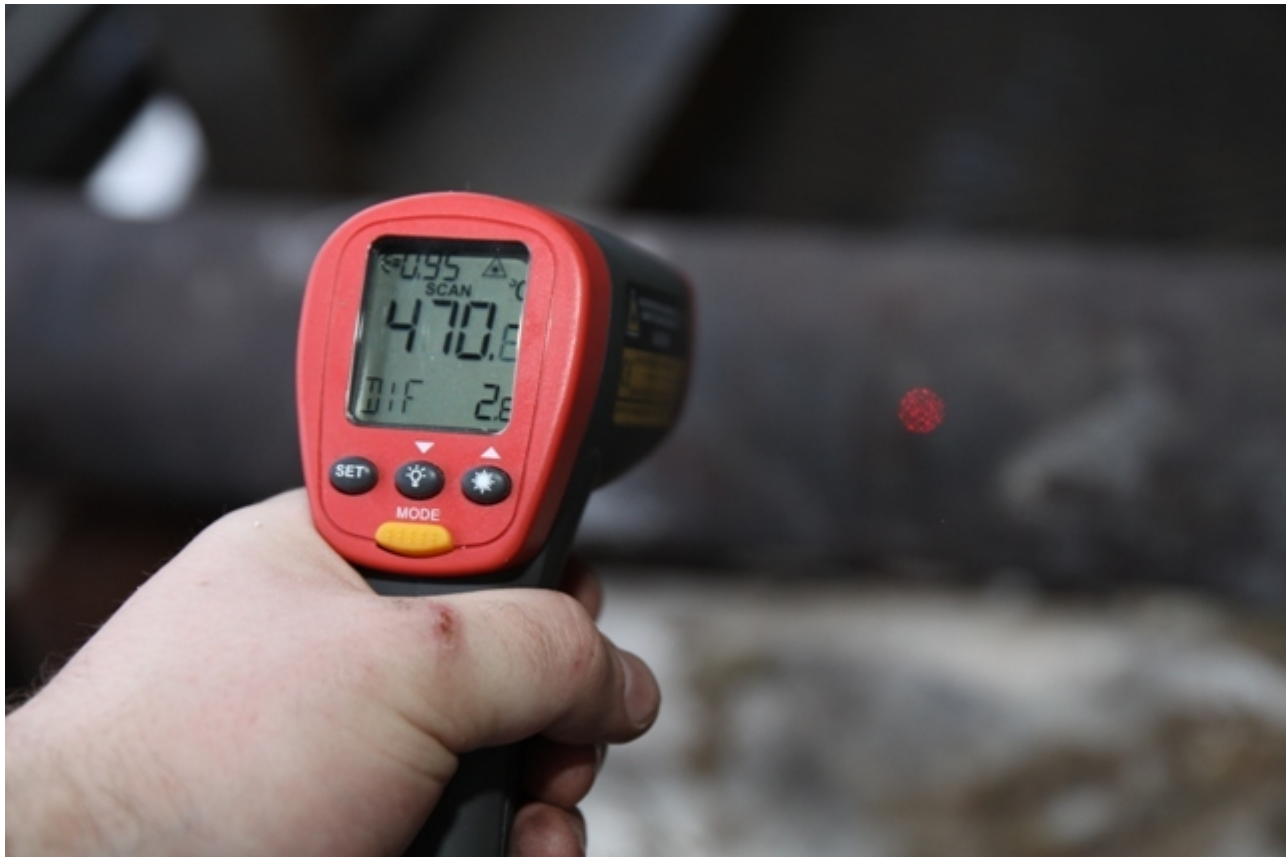
**In these pictures, some of the existing insulation wrap was cut back and how bad it looks with normal CUI (Corrosion Under Insulation).**

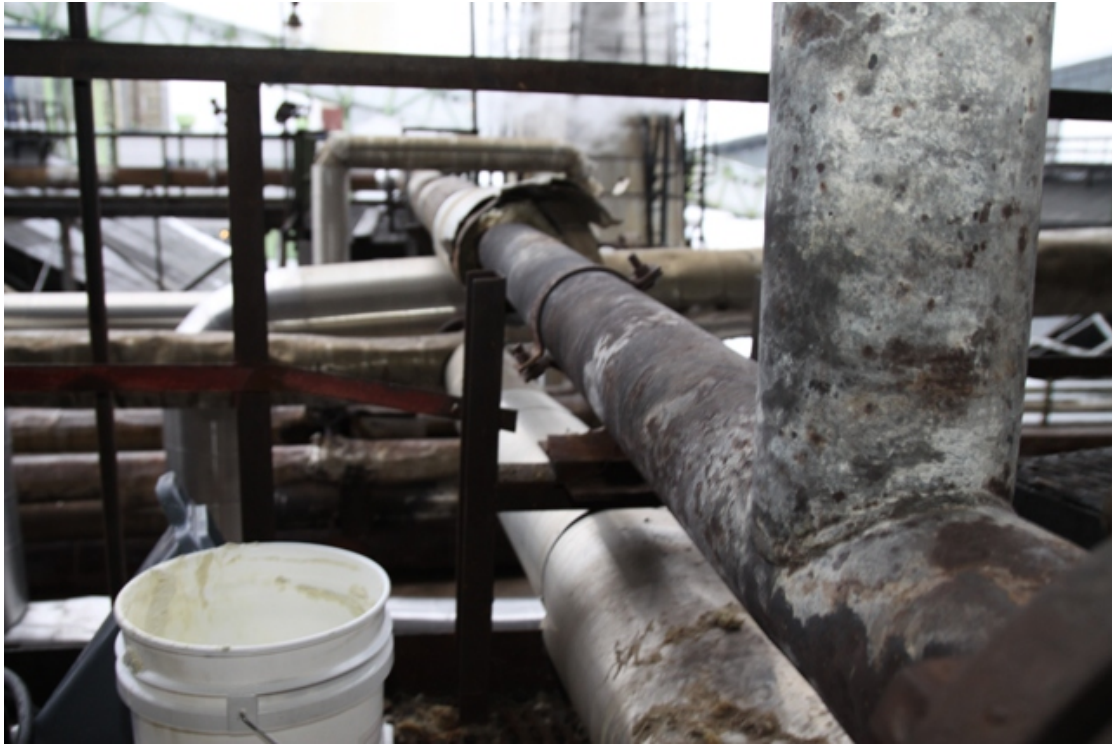
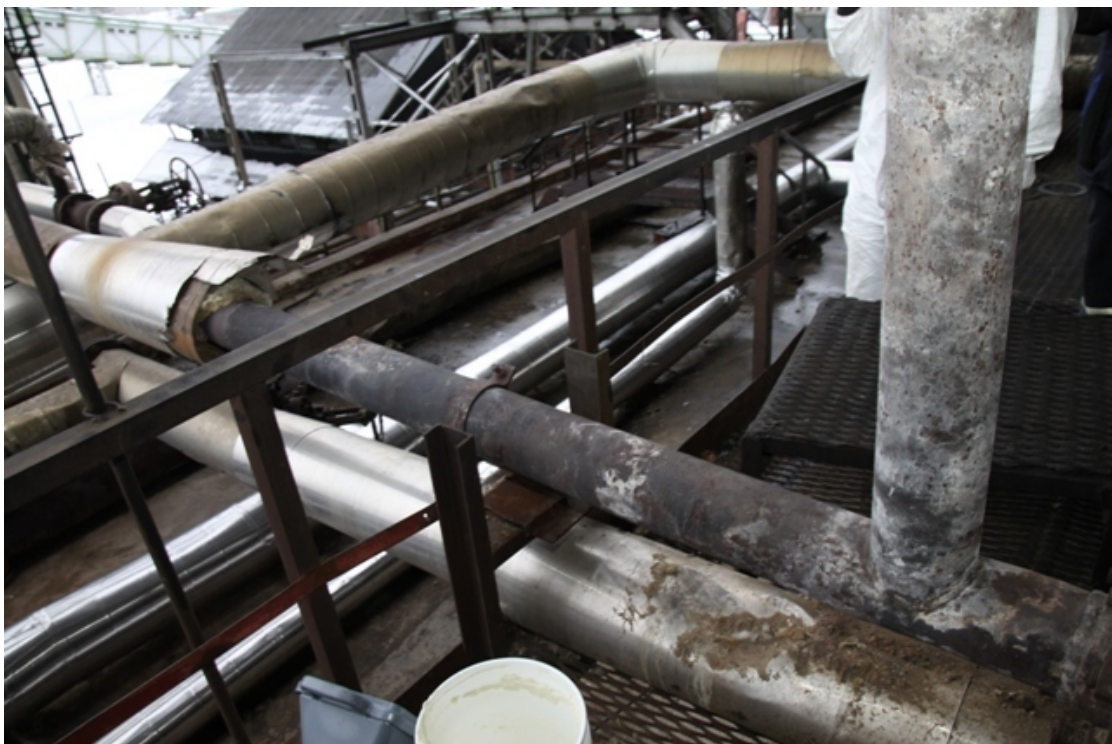
## The wrap is wet with condensation and has stopped working.

At those temperatures could only clean with wire brush.

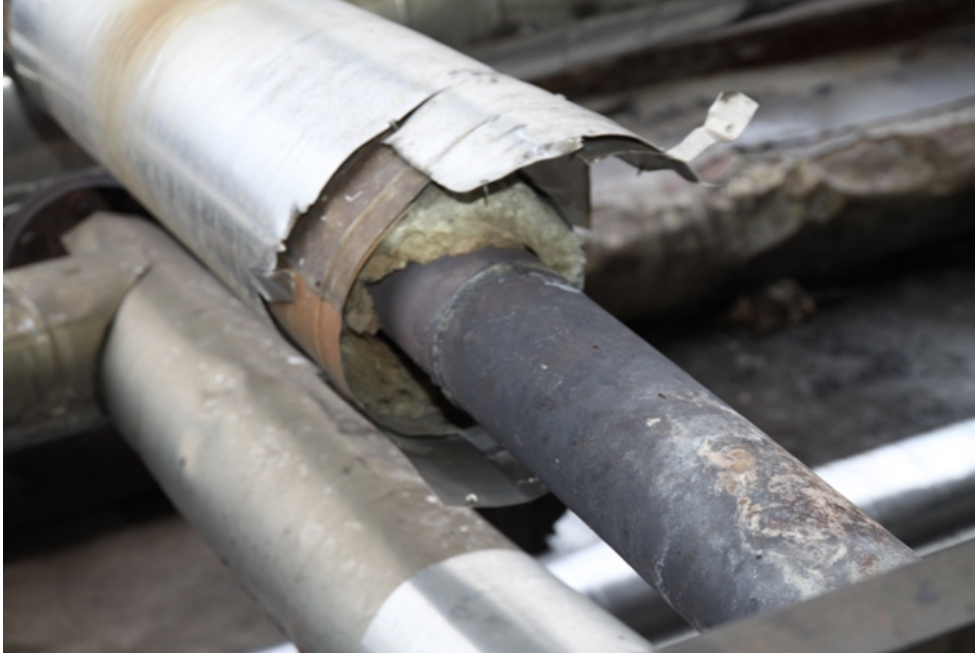
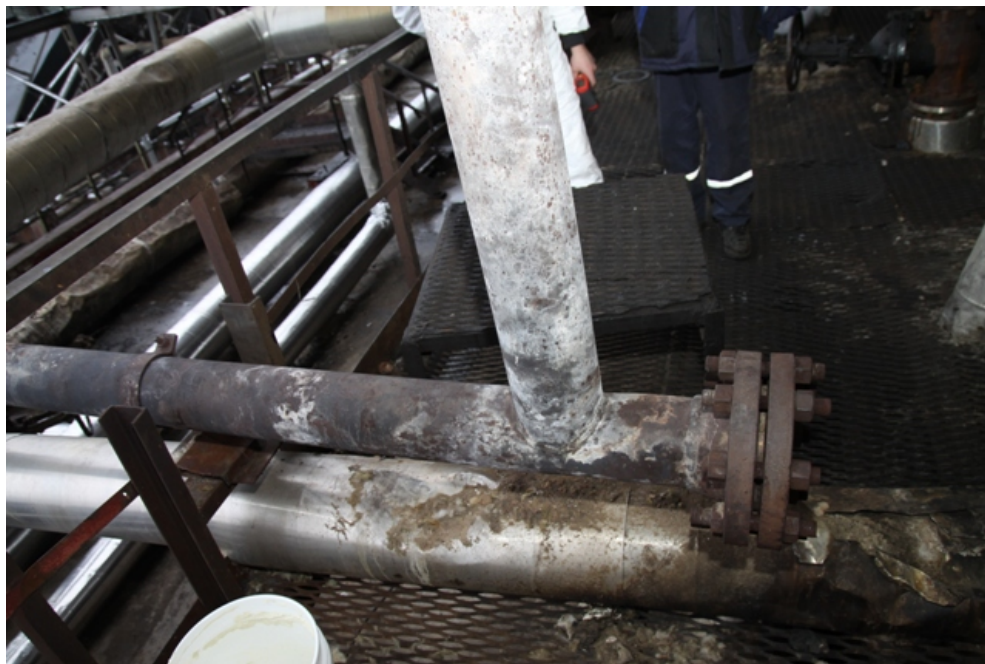
## Applying the priming coat of **HOT PIPE COATING**® at 1.25 mm / 50mils WFT

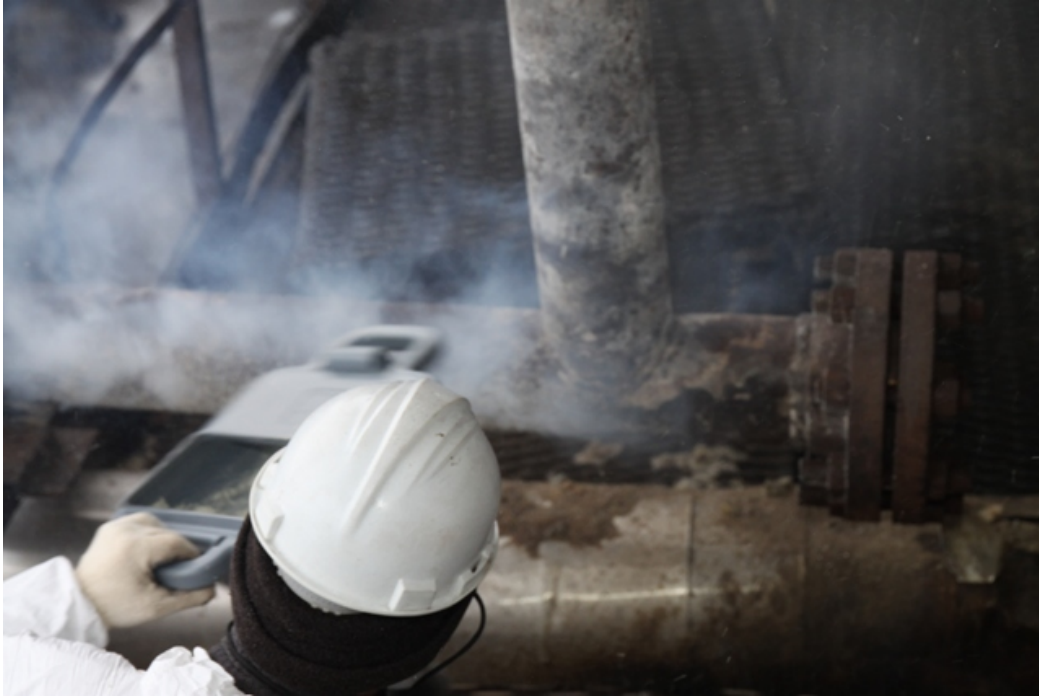
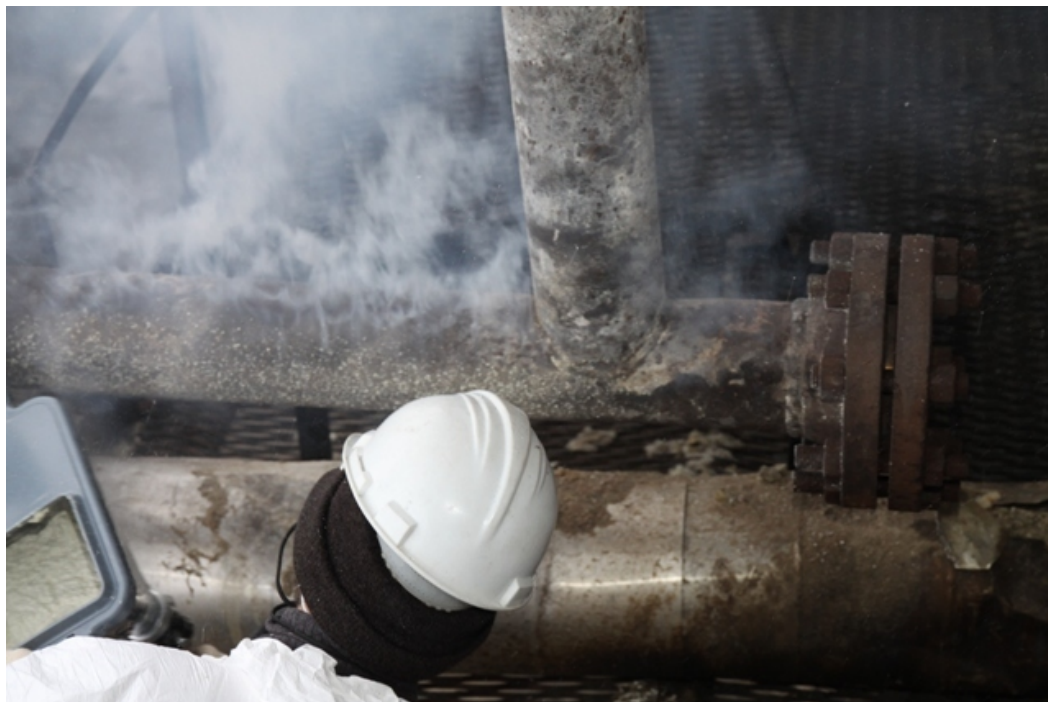
## Steaming off and charring

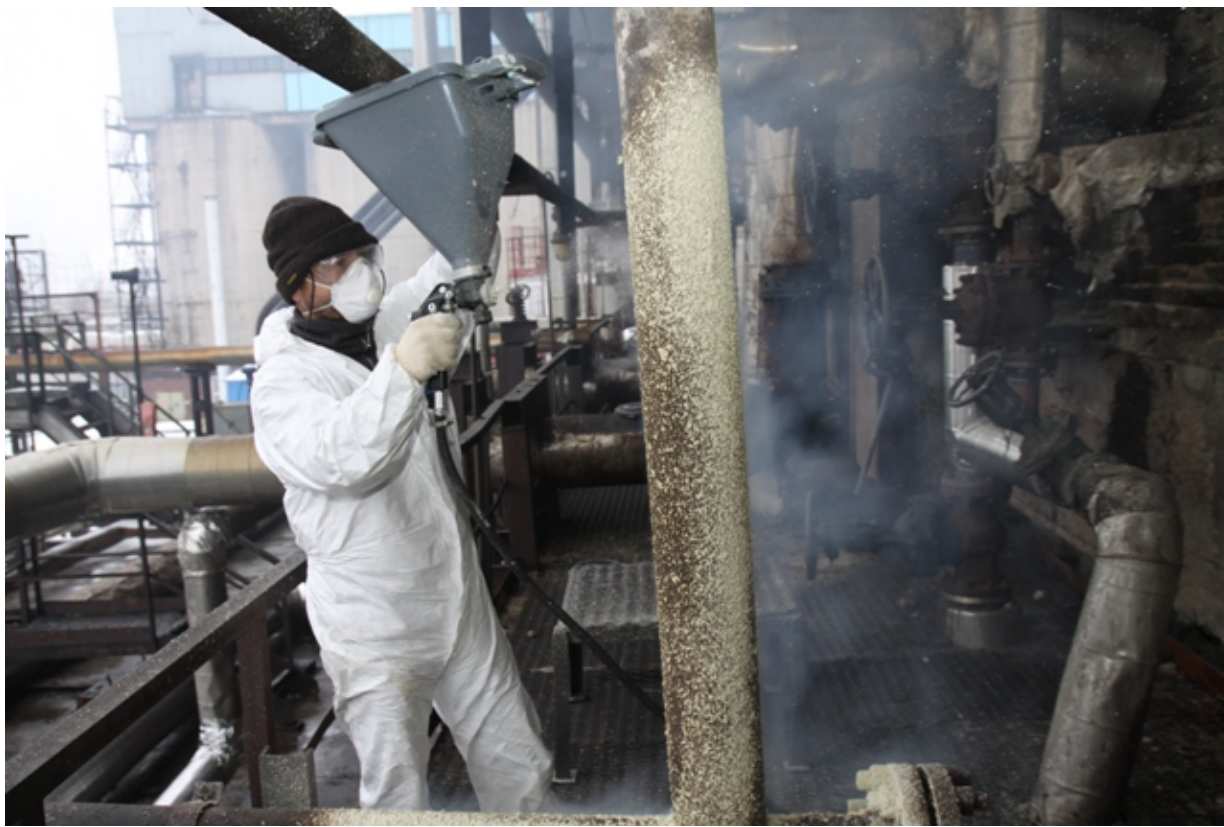
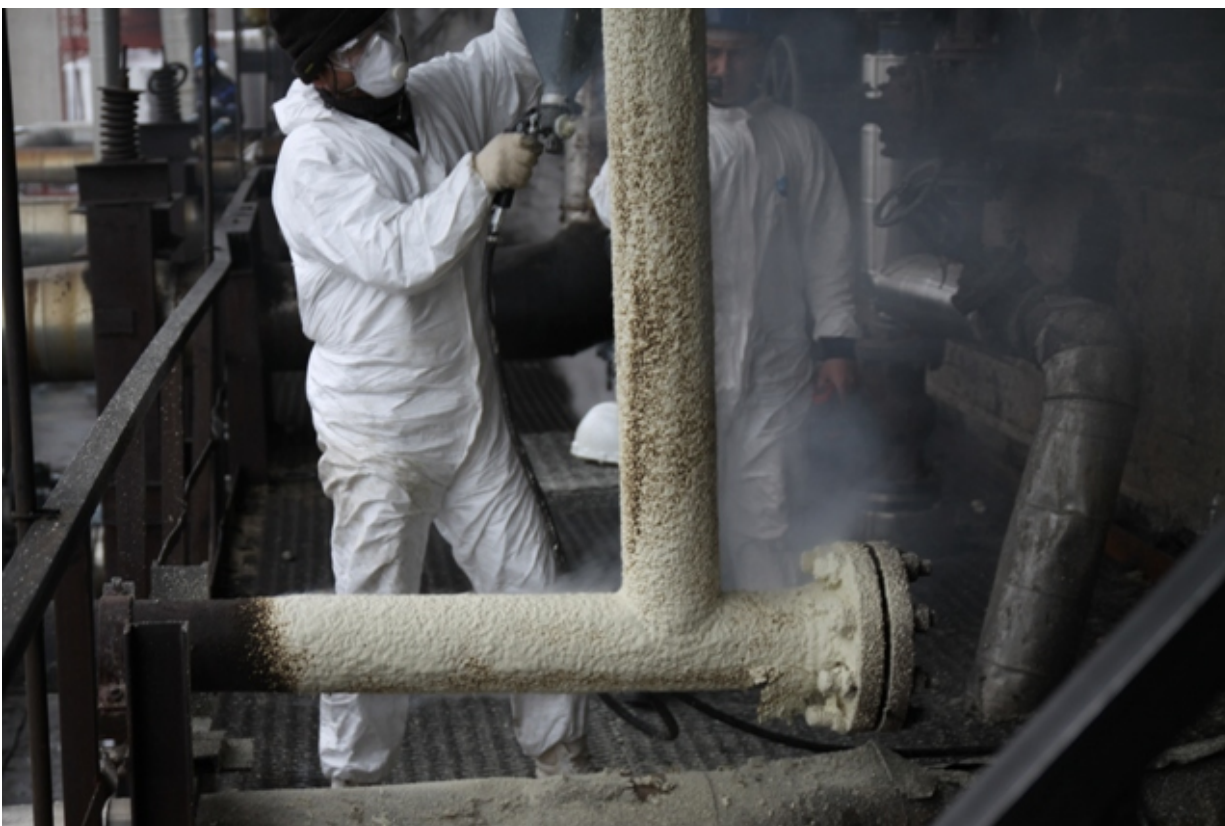
**Build Coat of 8mm / 315mils DFT. The engineers after applying the first build coat could lay their hands on the pipe.**

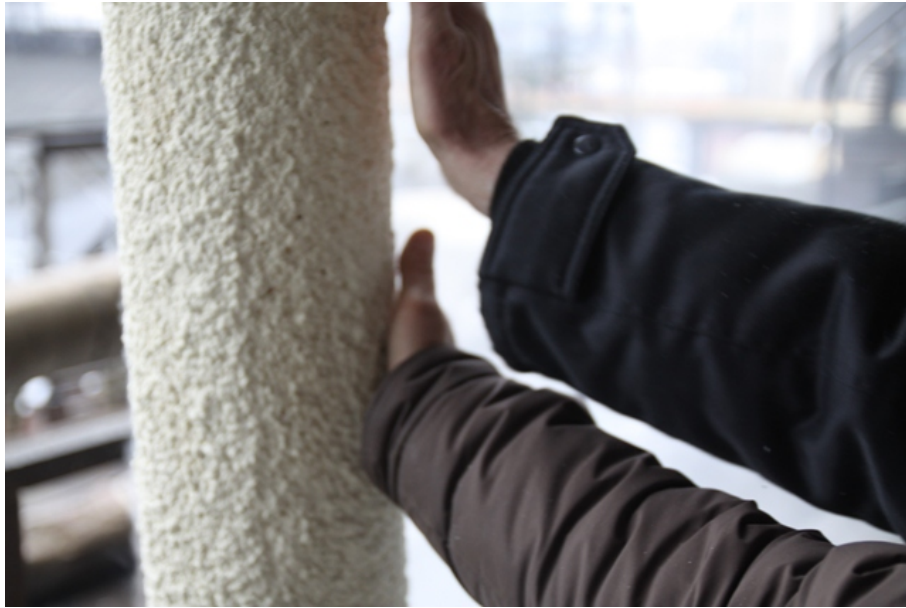
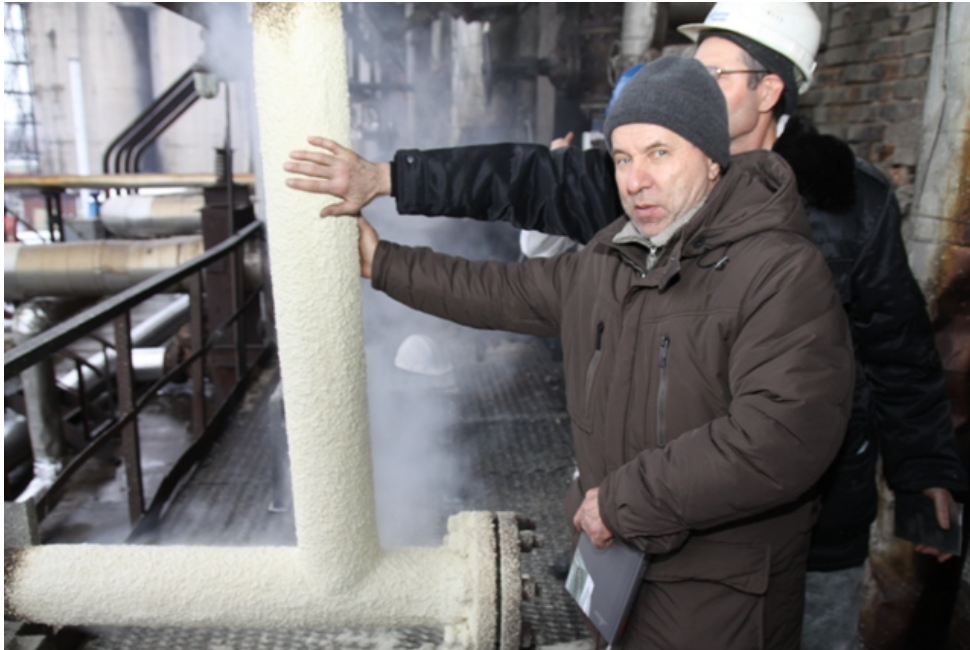
## Applying additional build coats of **HOT PIPE COATING**®

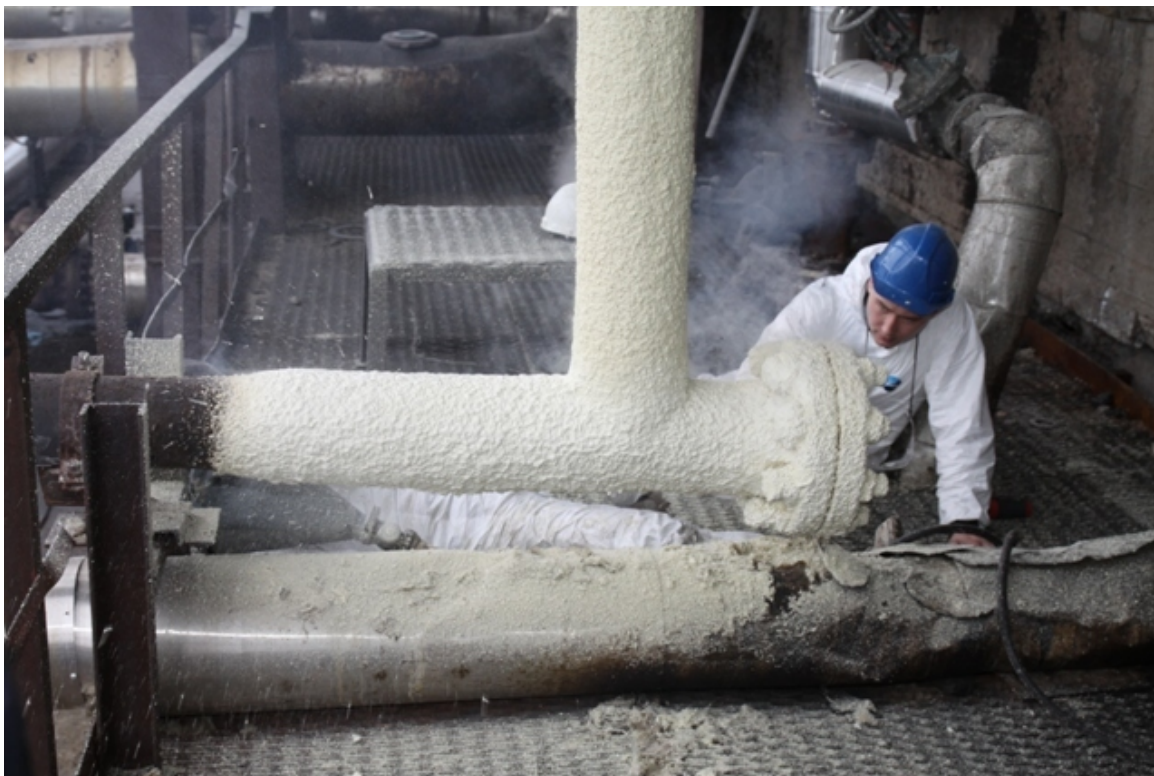
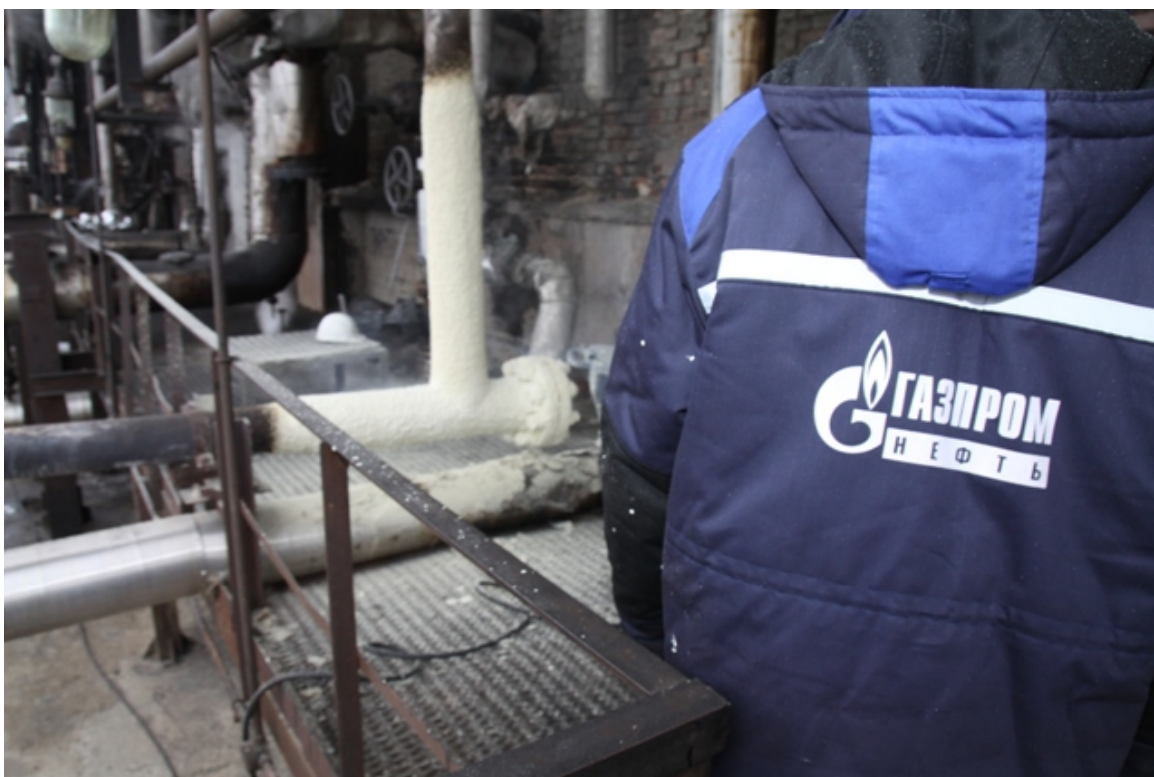
**22.43 mm / 883 mils DTF**

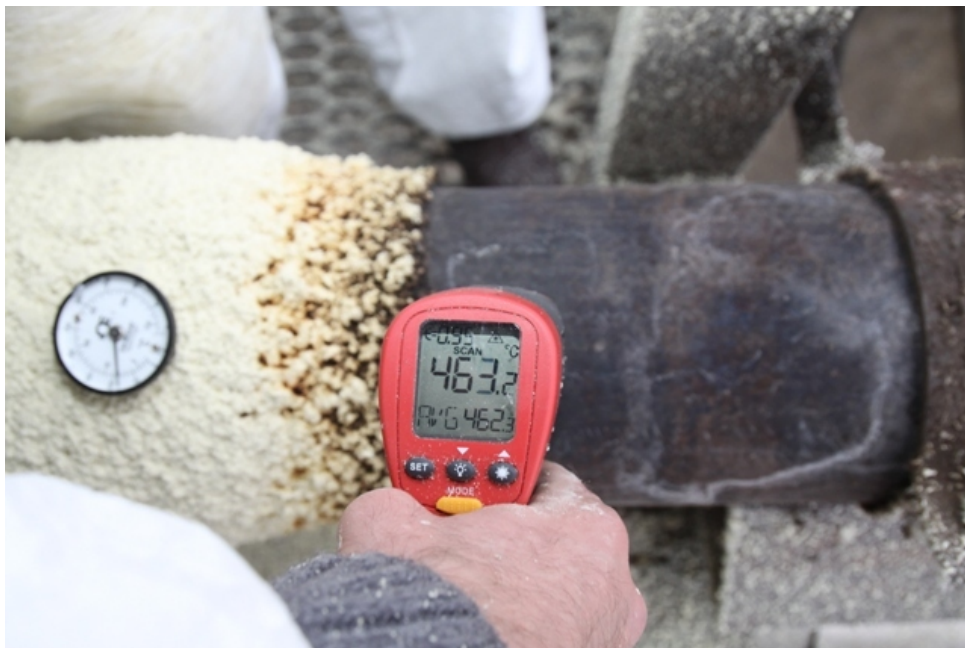
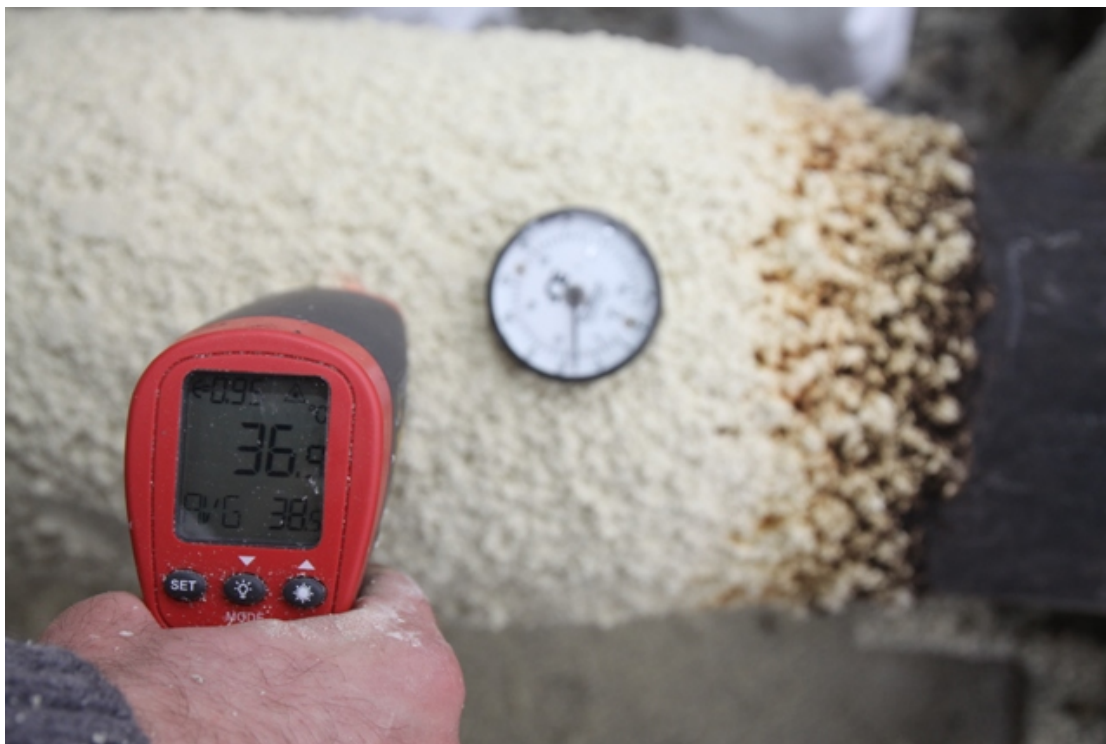
**26.32 mm / 1036 mils DTF**

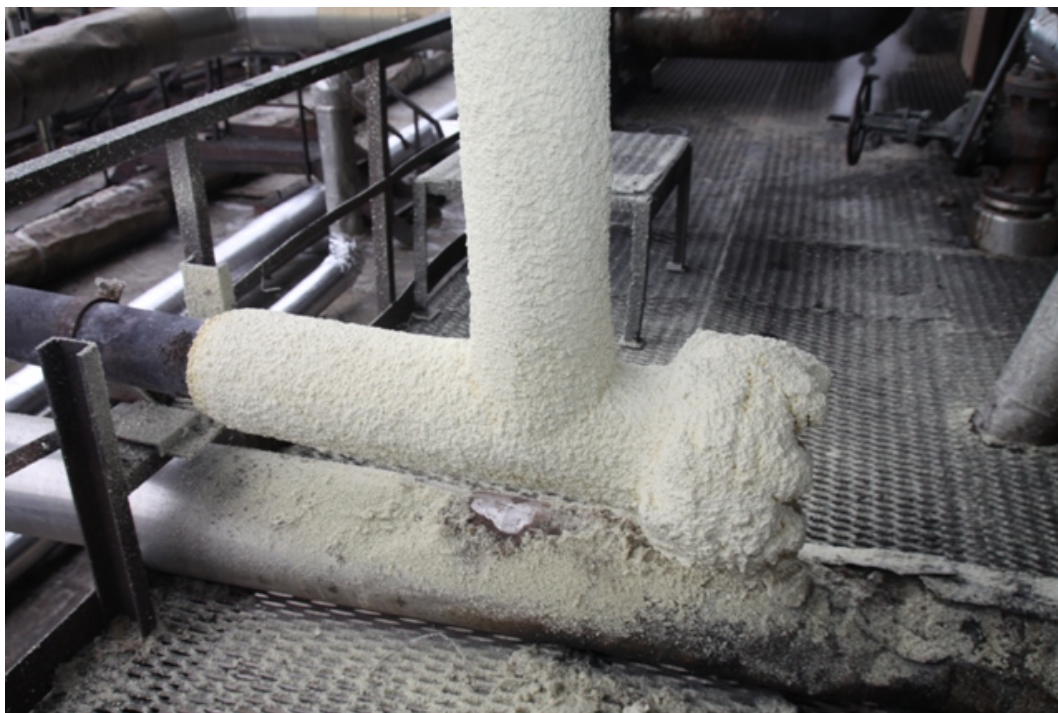
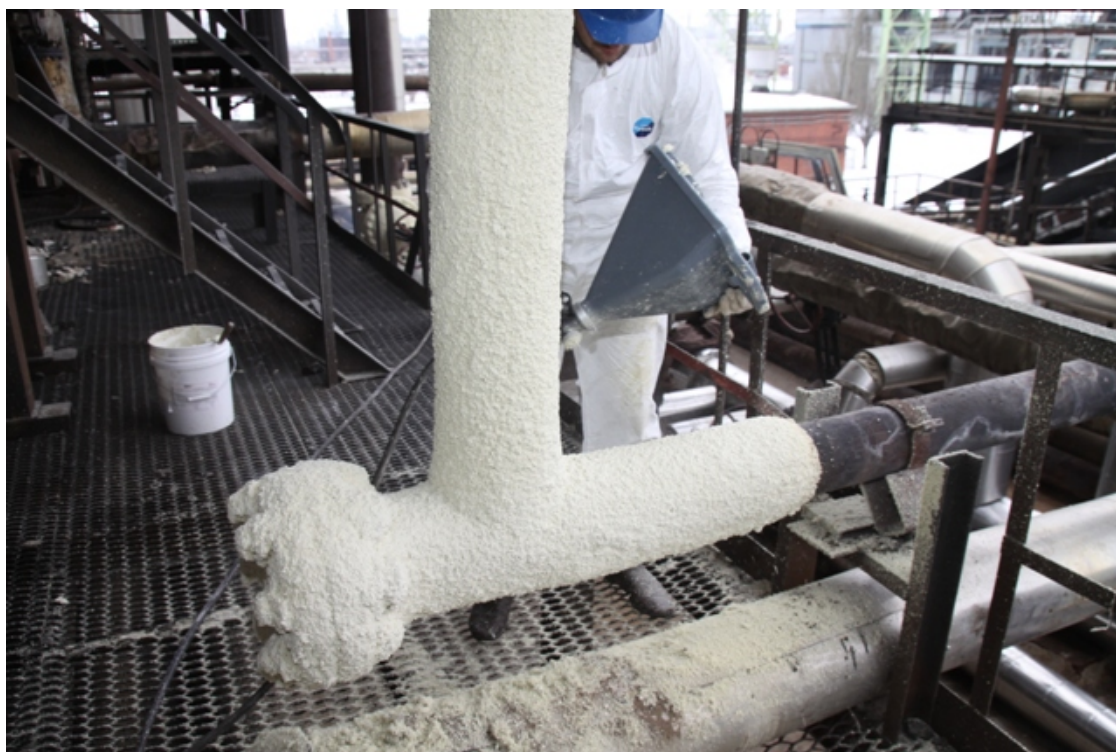
**31.74 mm / 1250 mils DTF**

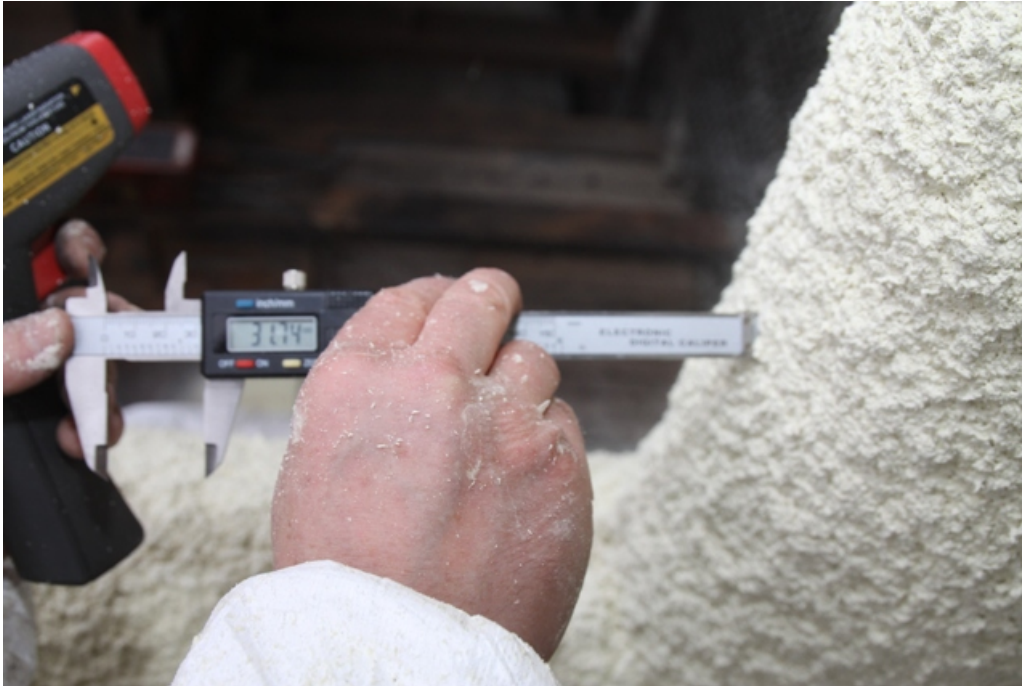
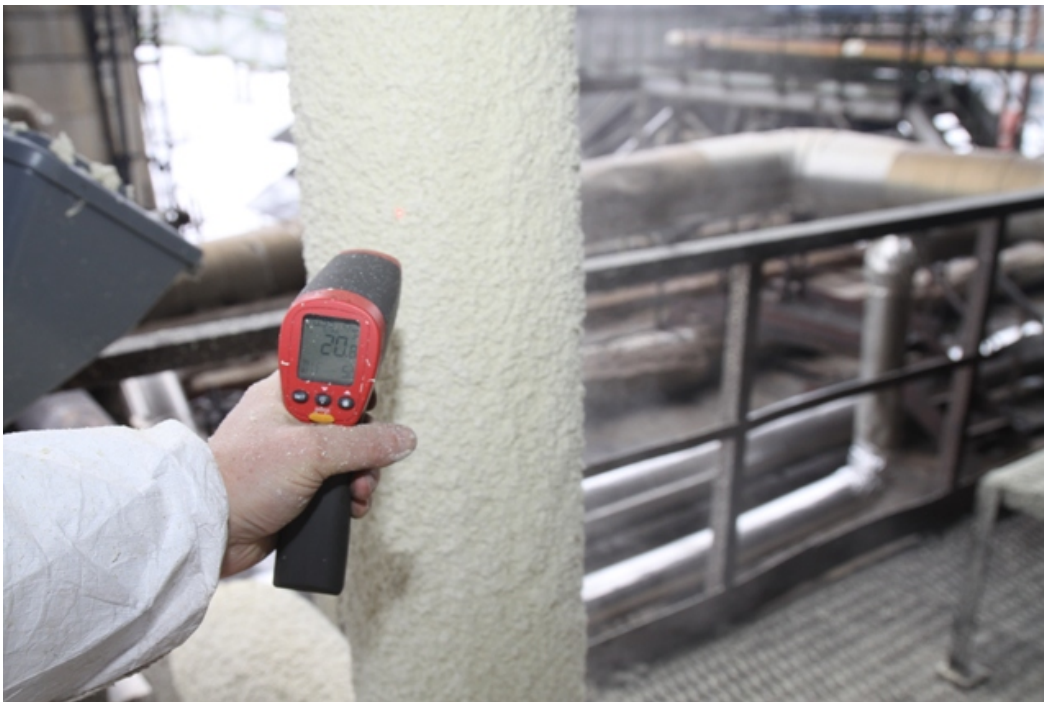
**34.49 mm / 1358 mils DTF**
