Versa Cold Cold Storage Facility

Matsqui 2002

[RUSTGRIP](#)® primer and [SUPERTHERM](#)® top coat

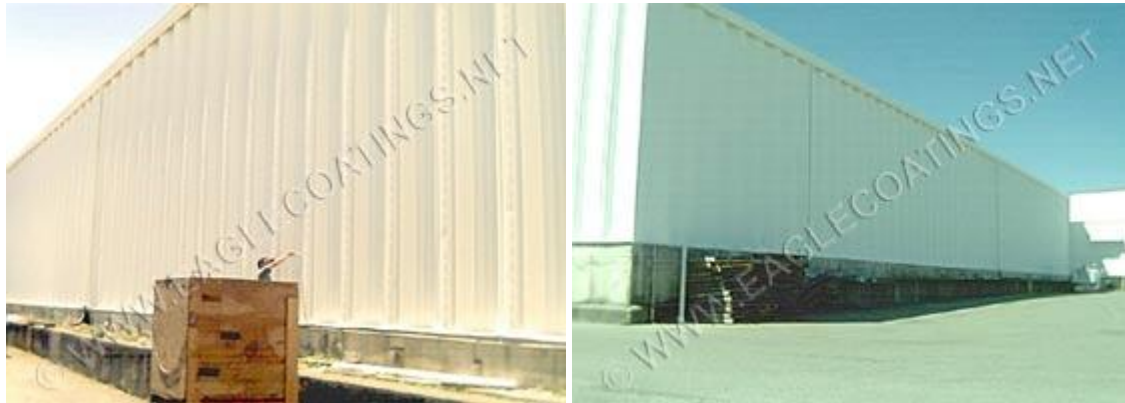
BEFORE 05/17/2002 Interior-20°C Exterior 23°C AFTER 05/30/2003 Interior-20°C Exterior 31°C

Note the TEMPERATURE SCALES on the side of each of the scans located below. The temperature range of the scan taken BEFORE the coating system was applied is from 18.2°C - 25.1°C (64.76°F - 77.18°F). The temperature range of the scan taken AFTER the coating system was applied is from 20.9°C - 35.6°C (69.62°F - 96.08°F). The adjustment was required because of the much higher ambient temperature on the day the AFTER coating scan was taken.
