## O'TOOLES KITCHEN LIBERTYVILLE, IL

May 2015

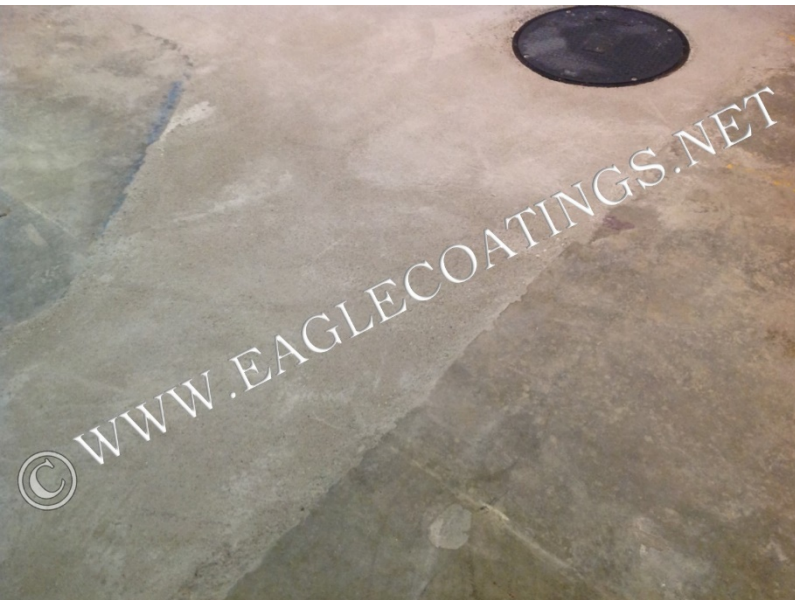
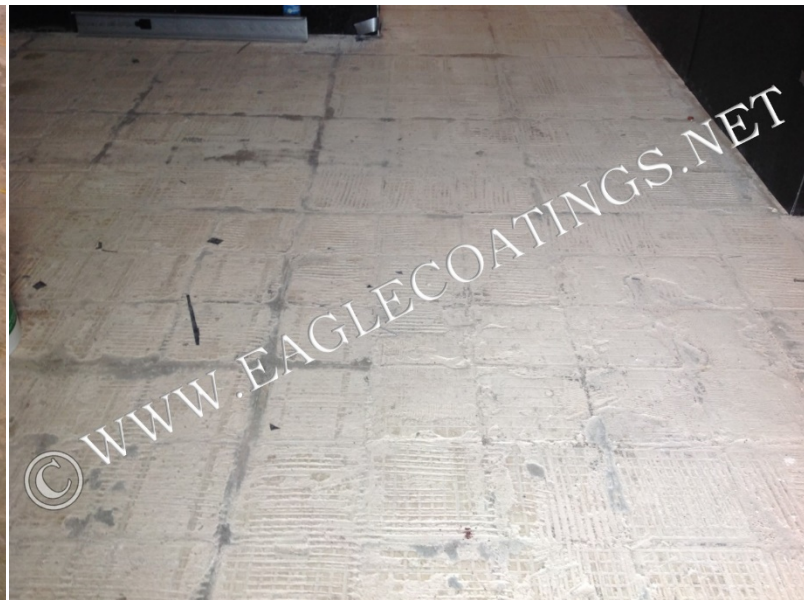
The project consisted of two applications. The Kitchen area was sealed with **ENAMO GRIP 5000**® tinted to a pale gray. The existing surface was the mortar that remained after the removal of quarry tiles.

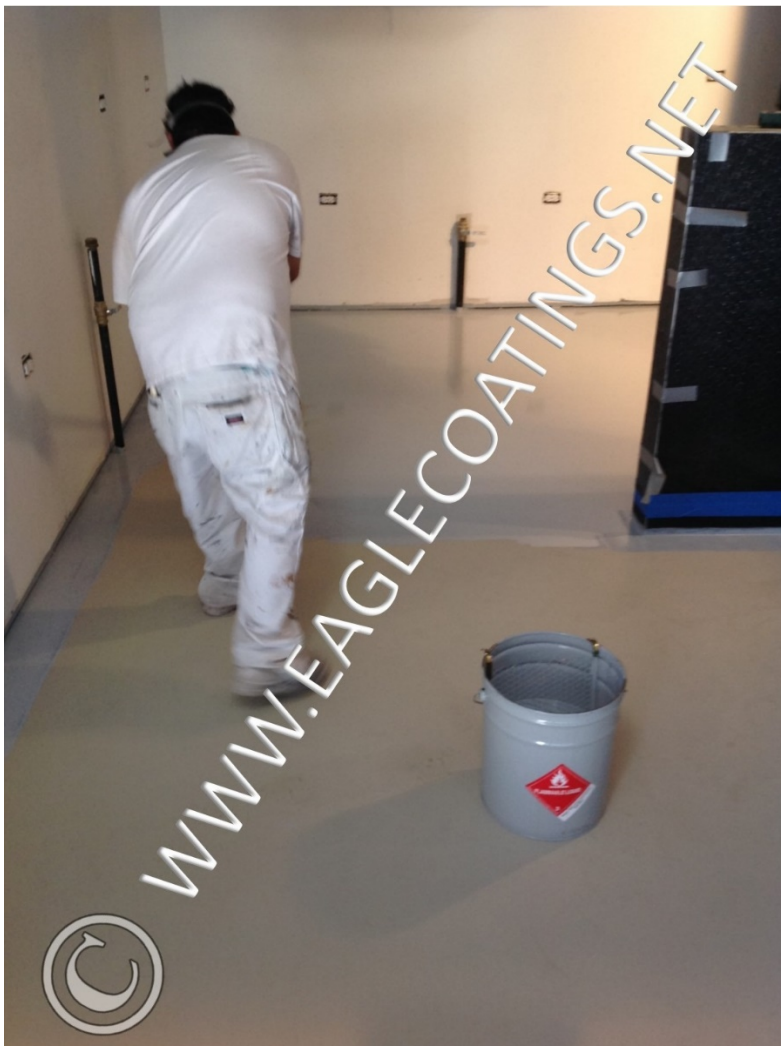
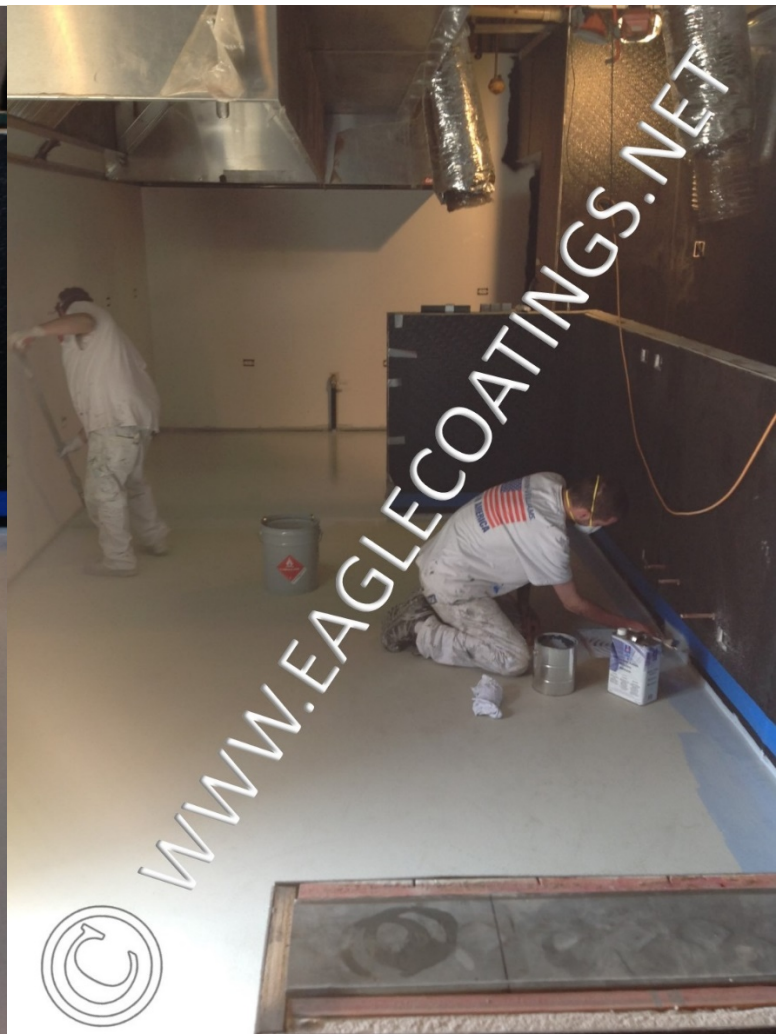
The surface was treated with a floor topping system, TRU® Self-Leveling, provided by Alliance Specialty.

The finished surface was much different than typical concrete products. It was far more dense and has the ability to be polished. We applied the primer coat of **ENAMO GRIP 5000®** thinned with 20% MEK. The application temperature was in the high 70's. Our application thickness for the primer coat was @ 8mils WFT.

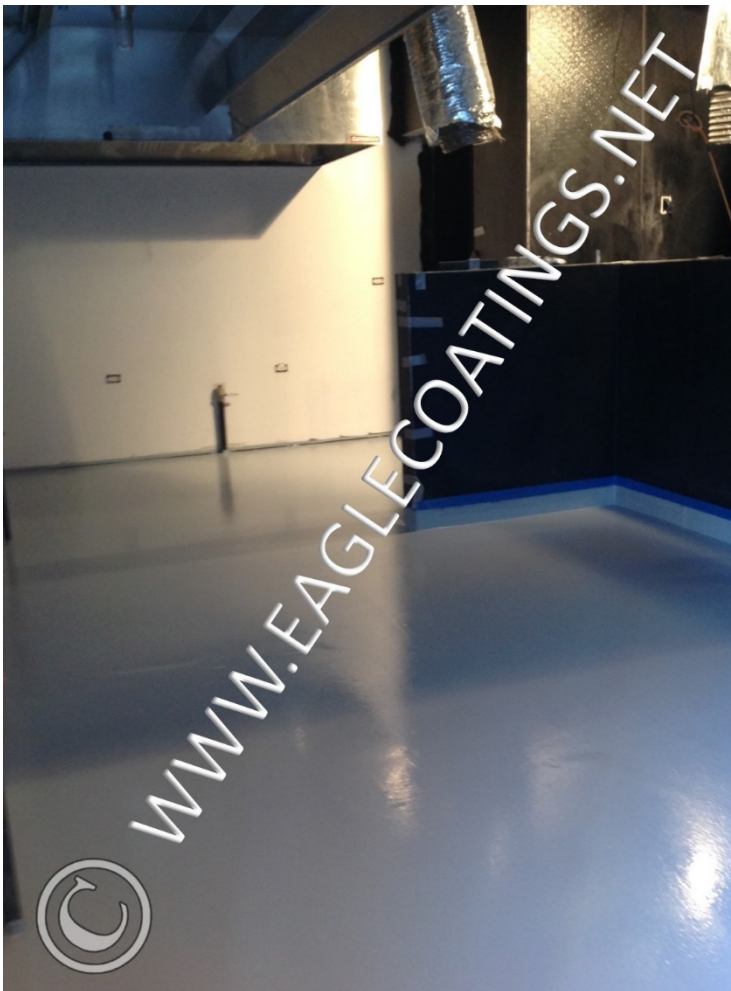
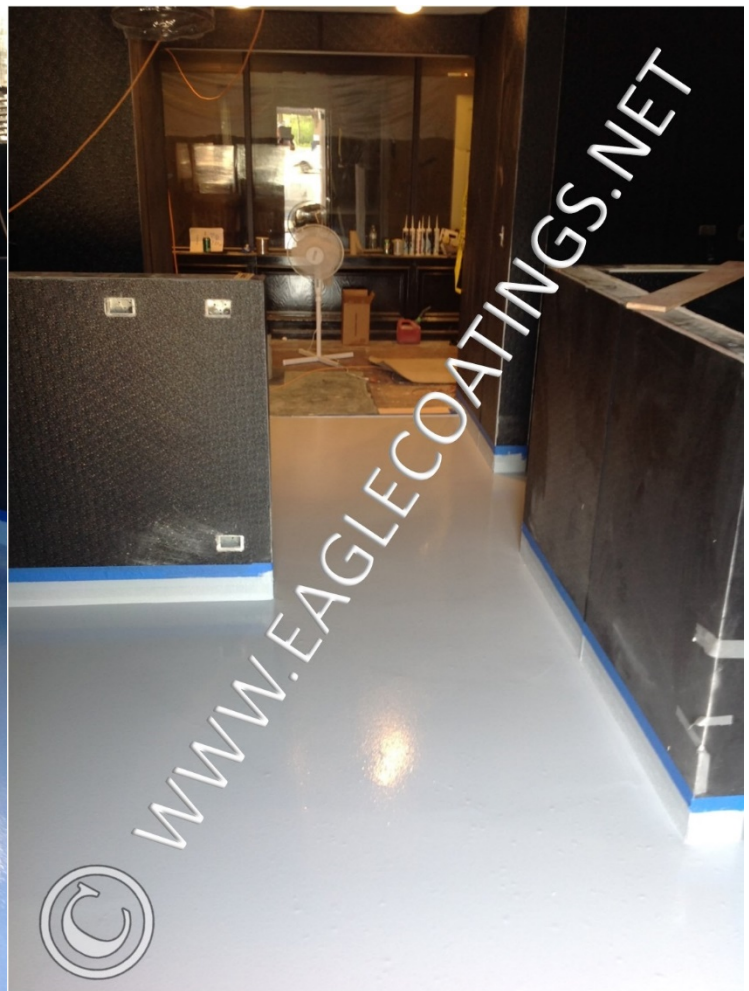
In my previous experience with **ENAMO GRIP 5000**® and concrete floors, the initial primer coat would instantly soak into the porous surface of the concrete and would be ready to apply the second coat in less than an hour. This is not the case with a dense self-leveling hydraulic topping. We waited for over two hours and the surface was not yet entirely tack free. However, the MEK did penetrate into the surface with the **ENAMO GRIP 5000**® and we were able to successfully apply the finish coat. The finish coat included “Sharkgrip” and was applied again @ 8 mils WFT.

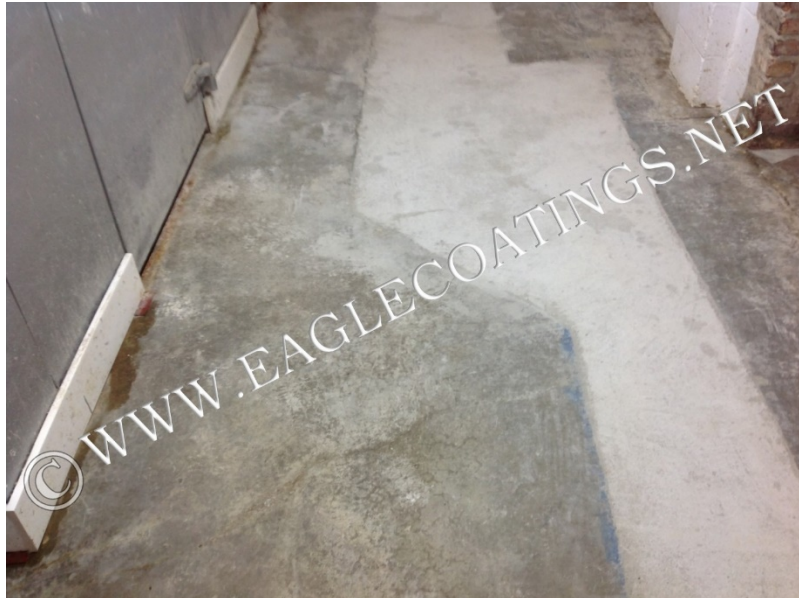
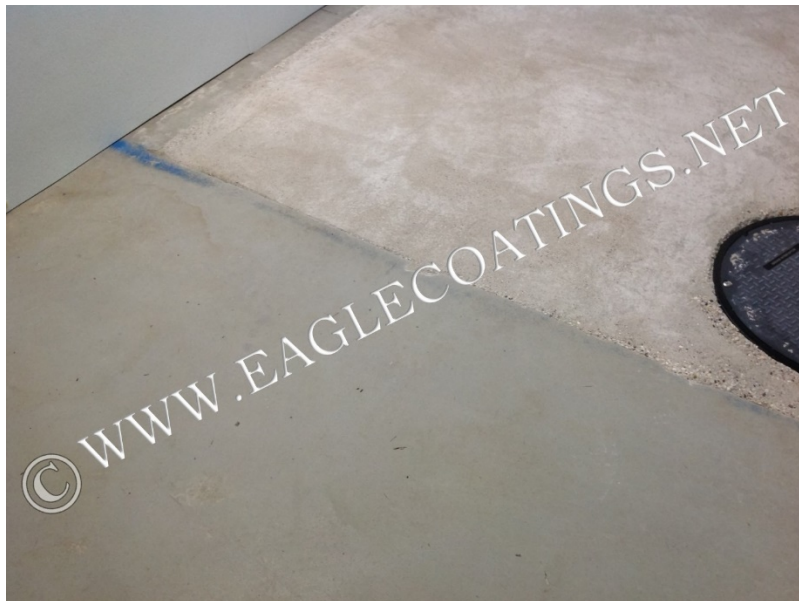
The second application was the sealing of the basement floor with **RUST GRIP**®. Three weeks prior to the application, there was significant trenching done in the floor to install new drain lines and grease traps.

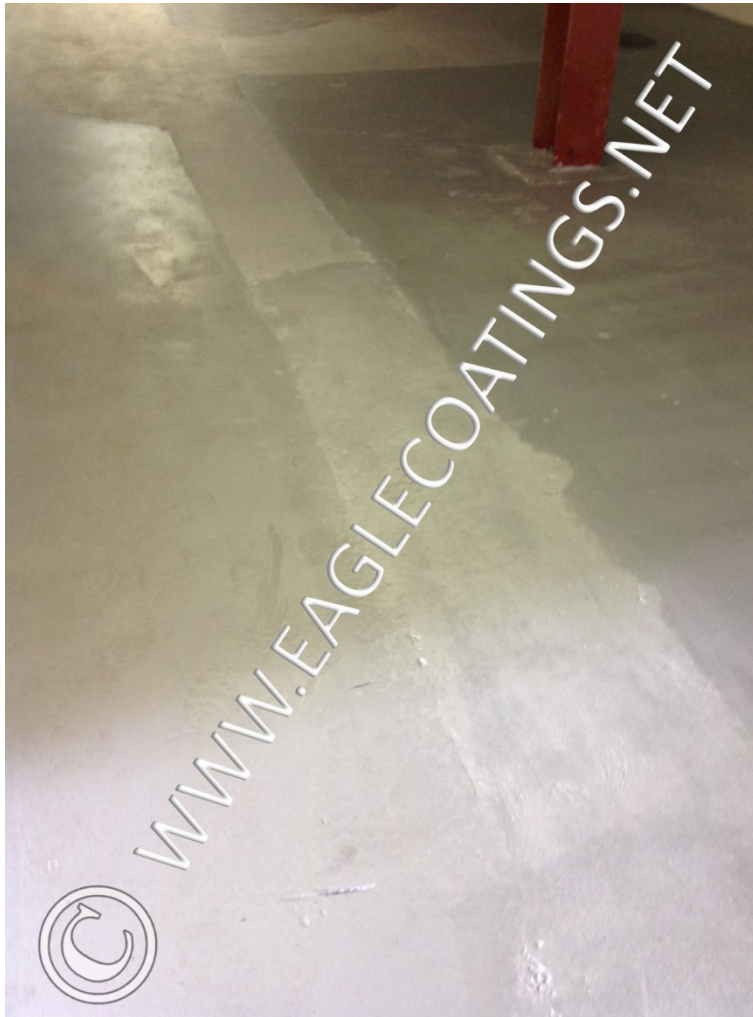
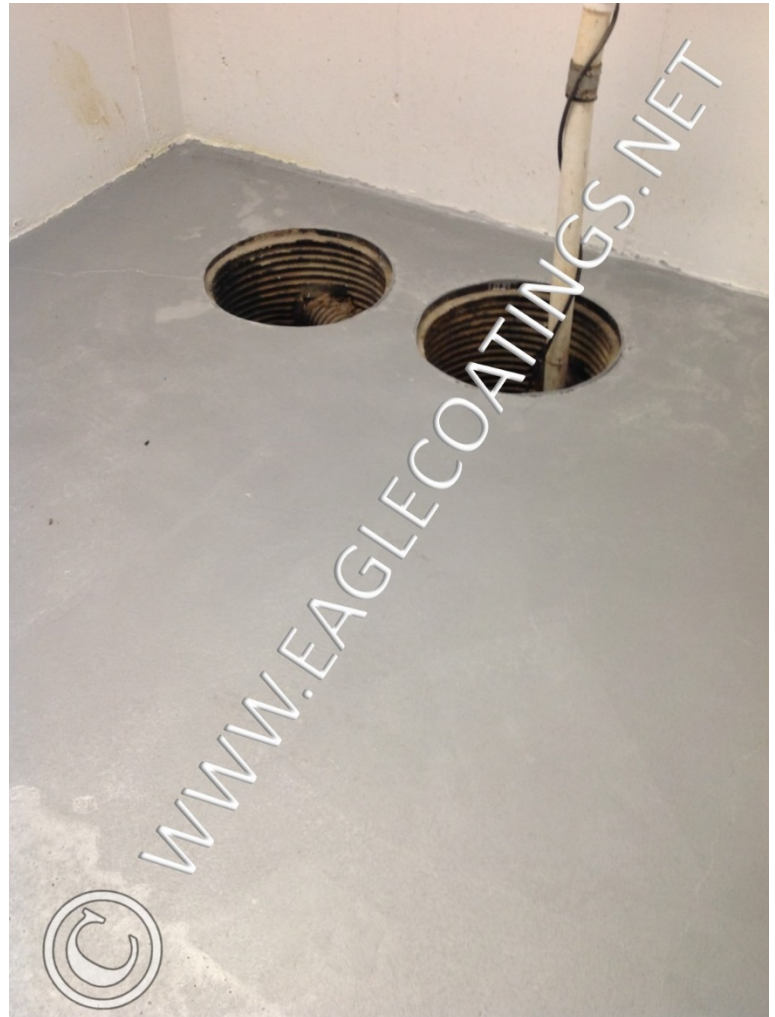
The concrete in the trenches was a low compressive strength mix with pea fill aggregate. This material still displayed a high moisture content of over 20% compared to the existing floor which was 11%. This prevented the use of any leveling application as per Mike with Alliance Specialty. To resolve the situation, Alliance Specialty ground the floor surfaces to provide a flat floor surface between the trenches and the existing floor. We had previously acid washed and power washed the entire floor using acetone as a rinse to accelerate moisture evaporation. The **RUST GRIP**® was applied with “Sharkgrip” in one coat with a minimum thickness of 10 mils WFT. My examination of the surface two days later showed that the **RUST GRIP**® had properly bonded with all the concrete surfaces including the material in the trenches. This occurred because the material was a low compressive strength mix with pea fill aggregate. This created a very porous texture which allowed for a higher than average moisture reading while also providing a very rough and porous surface for the **RUST GRIP**® to bond to.
