HOT SURFACE COATING™

CUSTOMER: GDF SUEZ
PRODUCTS: RUST GRIP ; HOT SURFACE COATING ; ENDUROOF ; ENDURO TOP-E
MARKET: ENERGY & MINING
COUNTRY: FRANCE (COURTESY OF SUPERIOR PRODUCTS NETHERLANDS)
DATE: AUGUST 2012

PROJECT DESCRIPTION

Application of protective and insulative coating on MDEA gas absorber vessel 1151-B on platform K12-BP, GDF Suez. Vessel was heavily corroded due to a very common problem in traditional insulation materials and systems, namely corrosion under insulation (CUI). Besides this, traditional insulation materials tend to absorb moisture and lose their insulation value gradually.

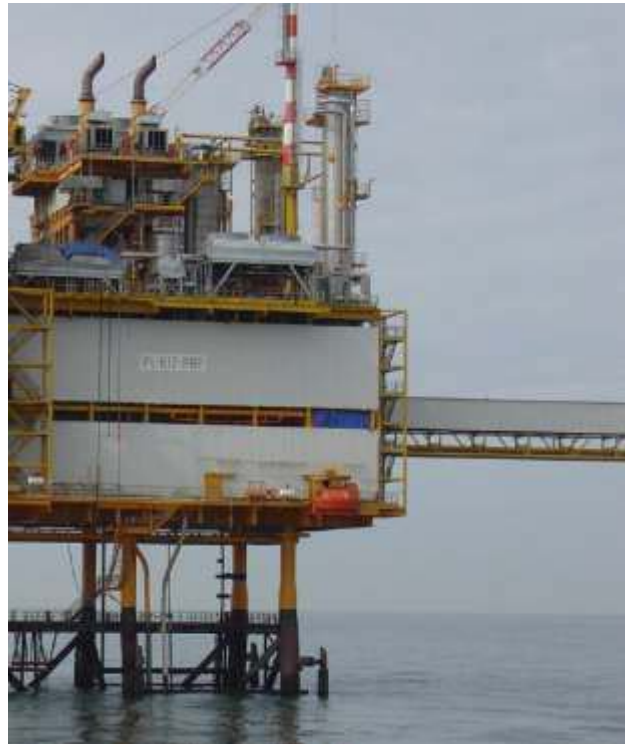
Project Site – prior to application

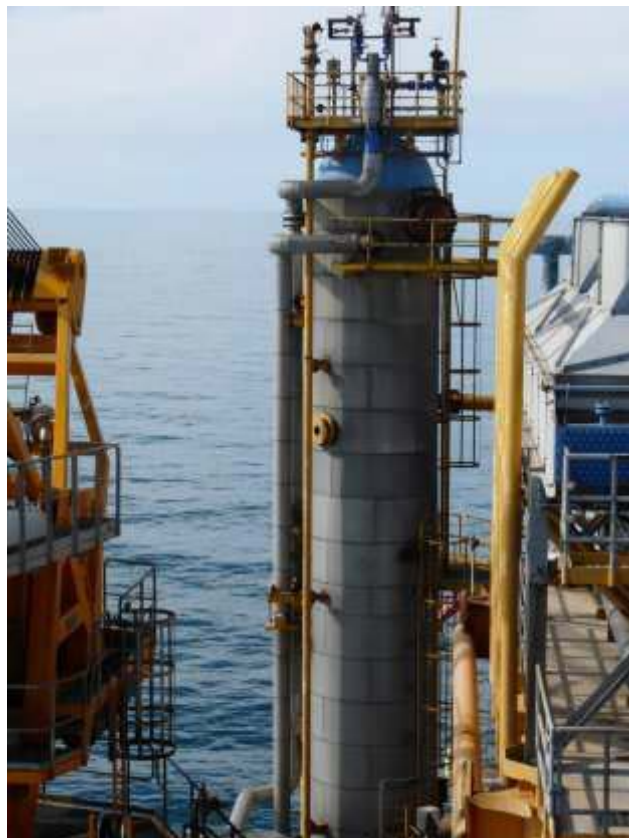
1151-B MDEA gas absorber (upper right tower)

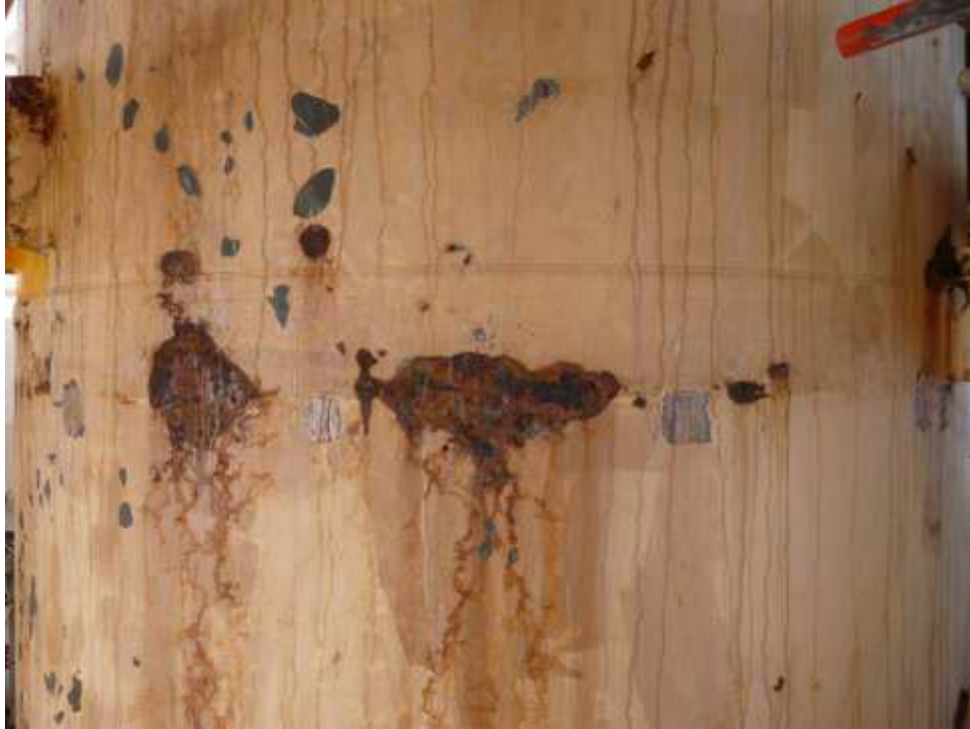
Vessel after removing the insulation material

The vessel was completely covered from top to bottom with scaffolding and a tent. After removing the old insulation material the complete vessel was power washed with water to remove all dirt, loose particles and any existing chlorides.

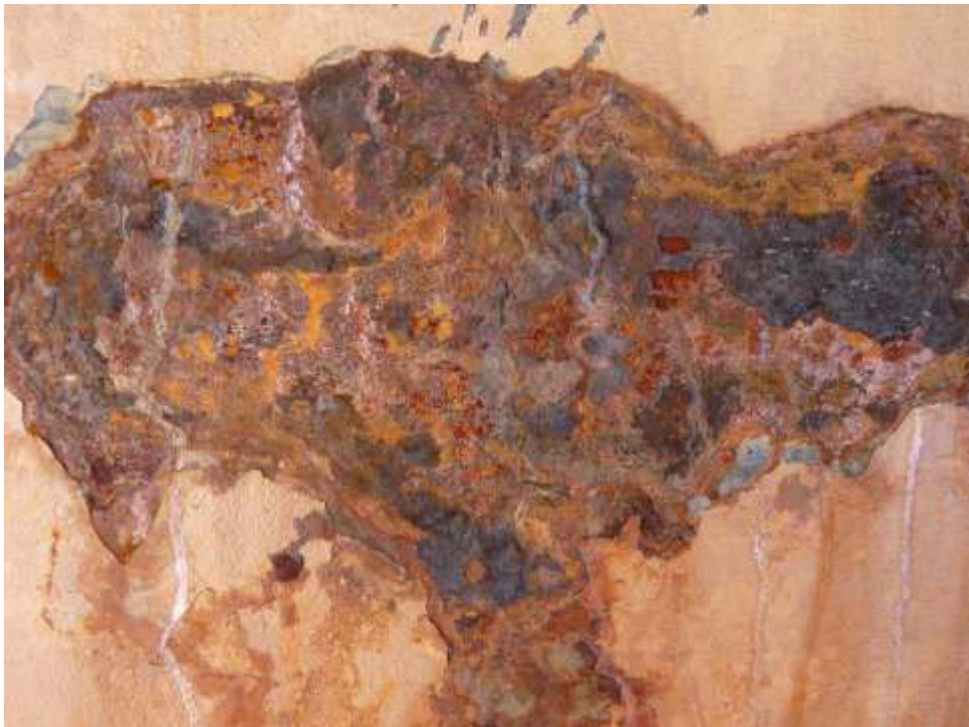
Corrosion under insulation (CUI) – Close up

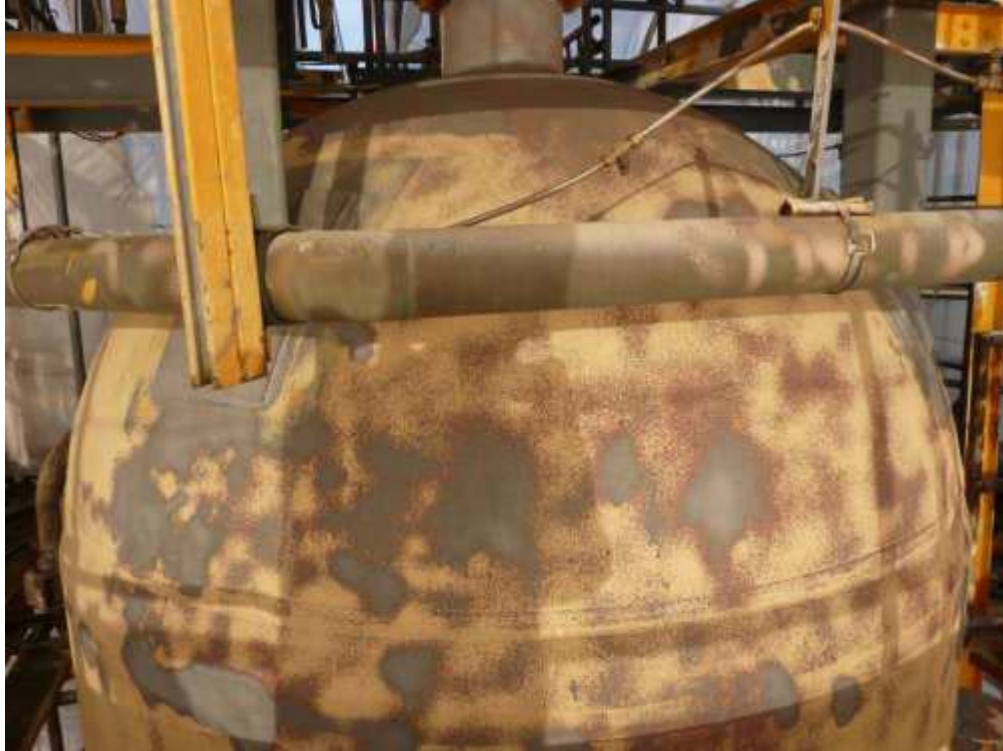
Sweep blasted surface before application

After a shut down for welding, the system was fully operational again for the rest of the application. The complete vessel was blasted to SA1 on the lightly affected area's with still good adhesion of the old coating system and up to SA3 on the heavily corroded areas.

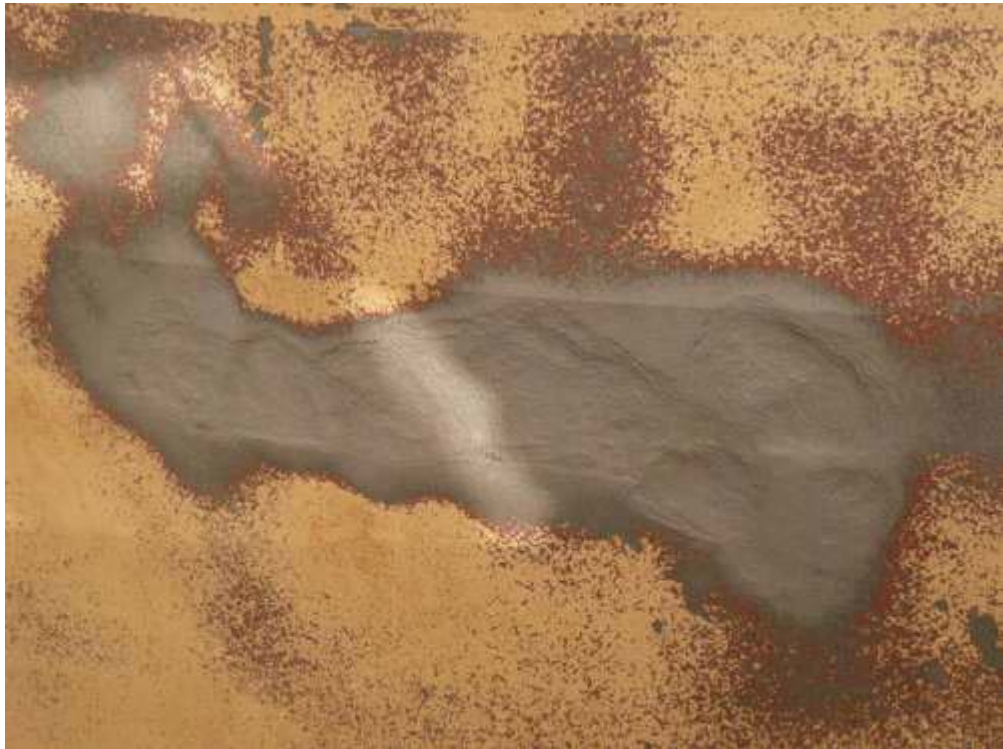
Blasting until bare metal on heavily corroded areas

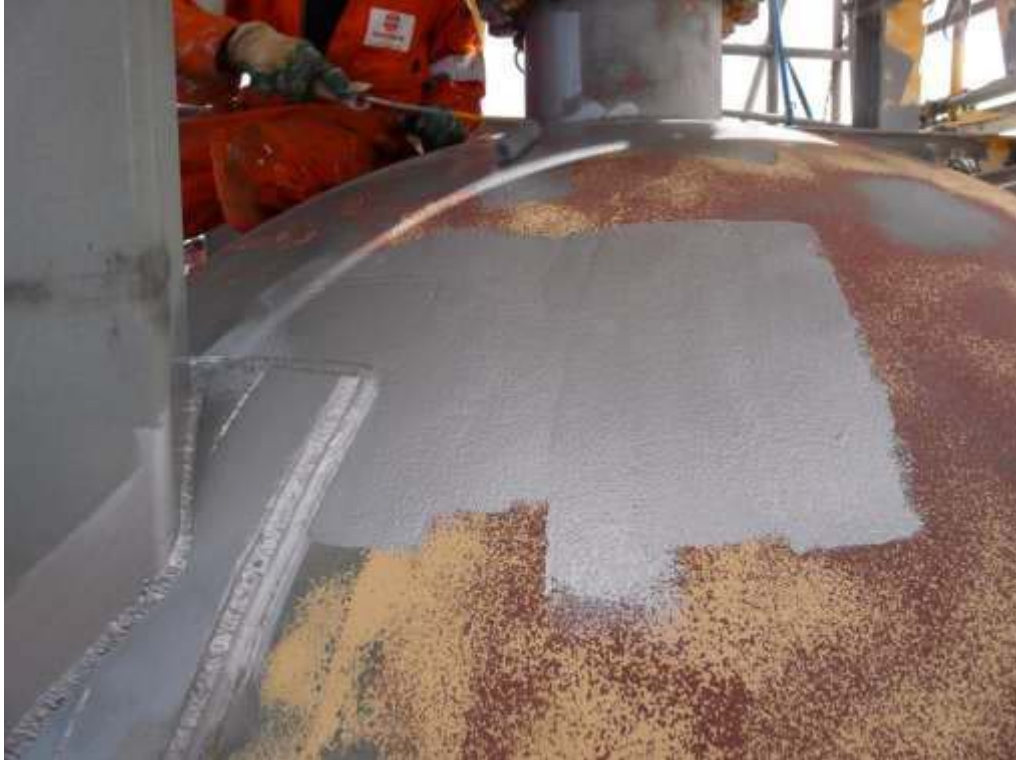
RUST GRIP being applied around details with brush and roller with 5-10 cm overlap

In the first step, RUST GRIP was applied in 2 coats with a total DFT of around 150-200 micron DFT. This is a bit more than the specifications, possible because of the higher temperature of the surface. Usage per square meter is about 0.25 – 0.35 litre (depending on surface and details).

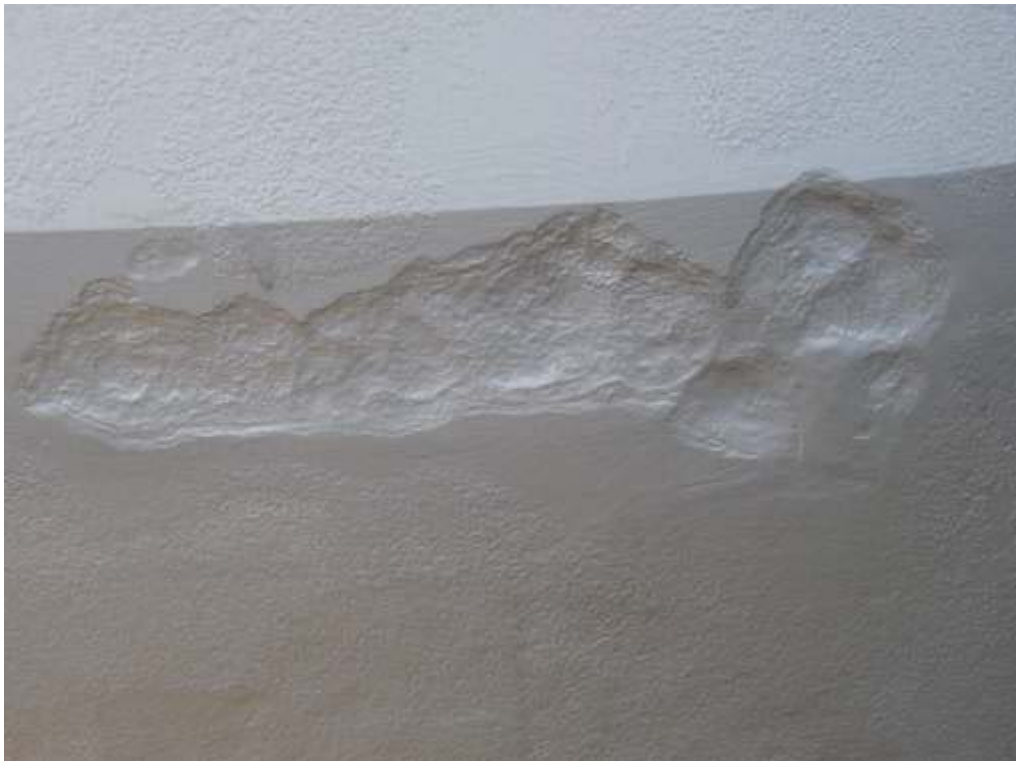
RUST GRIP applied on heavily affected areas

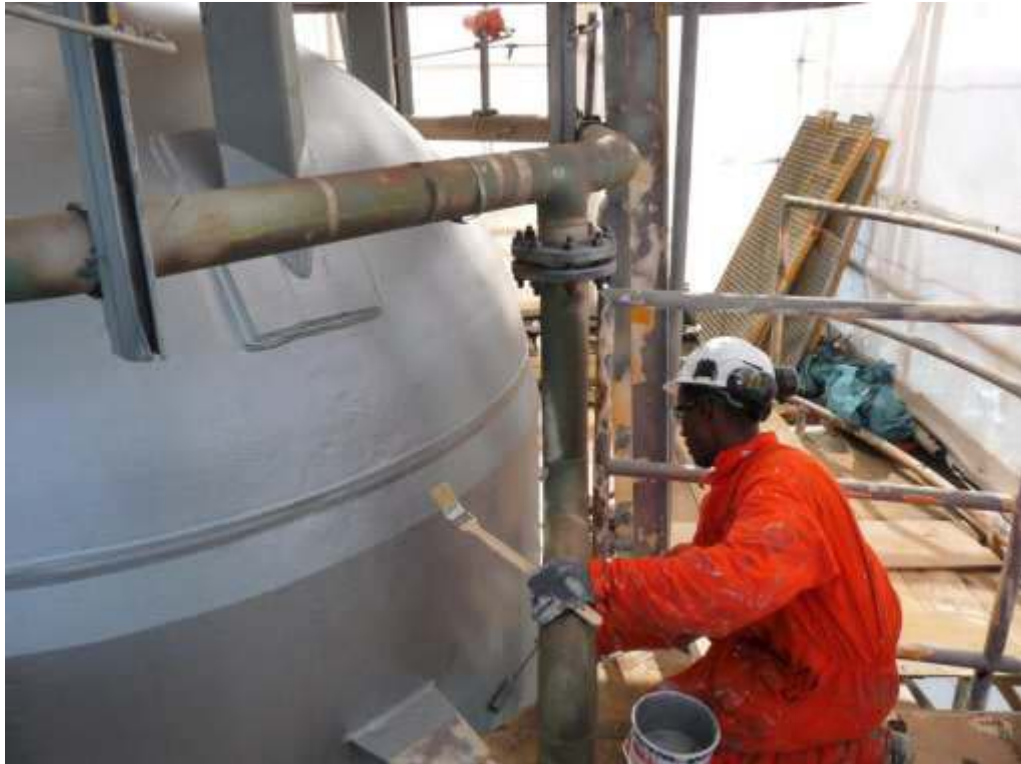
Application of RUST GRIP by roller and brush

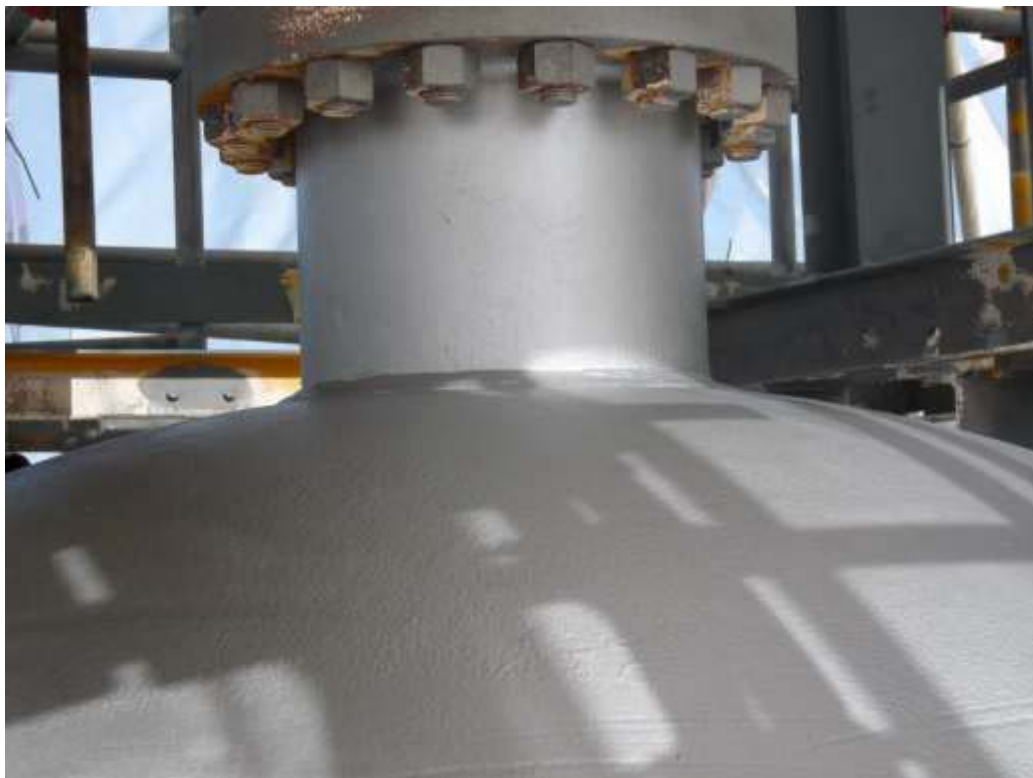
Top completed with RUST GRIP

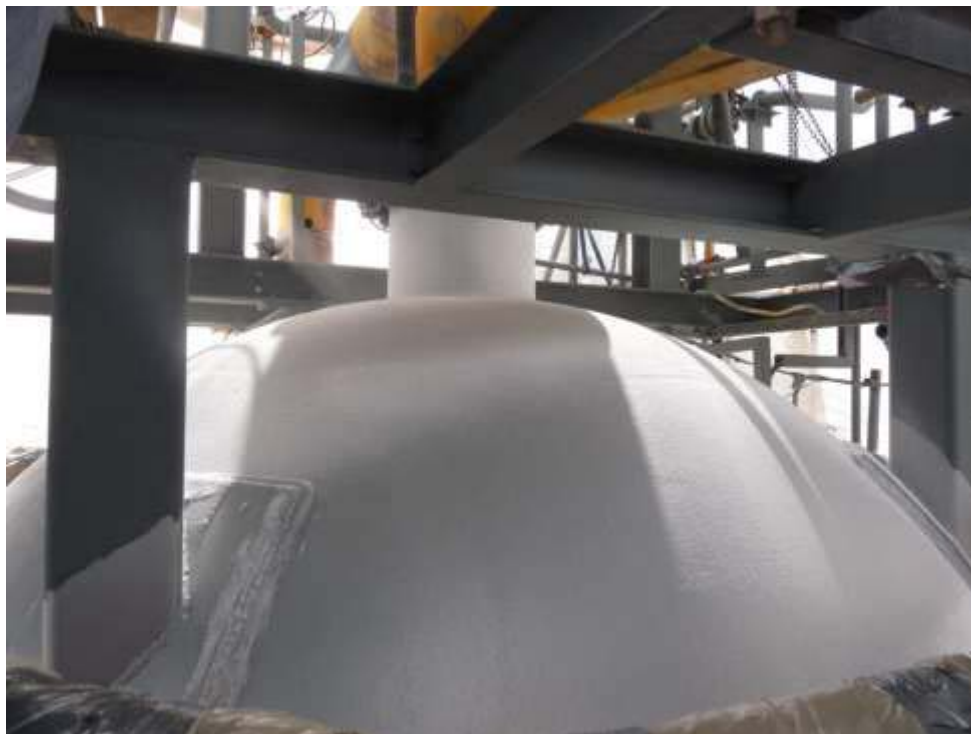
First layer of HOT SURFACE COATING at 1,5 mm

Next step was that 10 mm of HOT SURFACE COATING was applied on the surface to reduce the surface temperature with 35% and save on energy for heating the MDEA gas absorber. HOT SURFACE COATING was applied with a 57 liter Graco pressure vessel with a RTX Texture spray gun. It was built up in roughly 4 layers: first layer with a 3 mm nozzle between 1,5-2 mm, additional layers with a 4 mm nozzle around 3 mm until 10 mm was reached

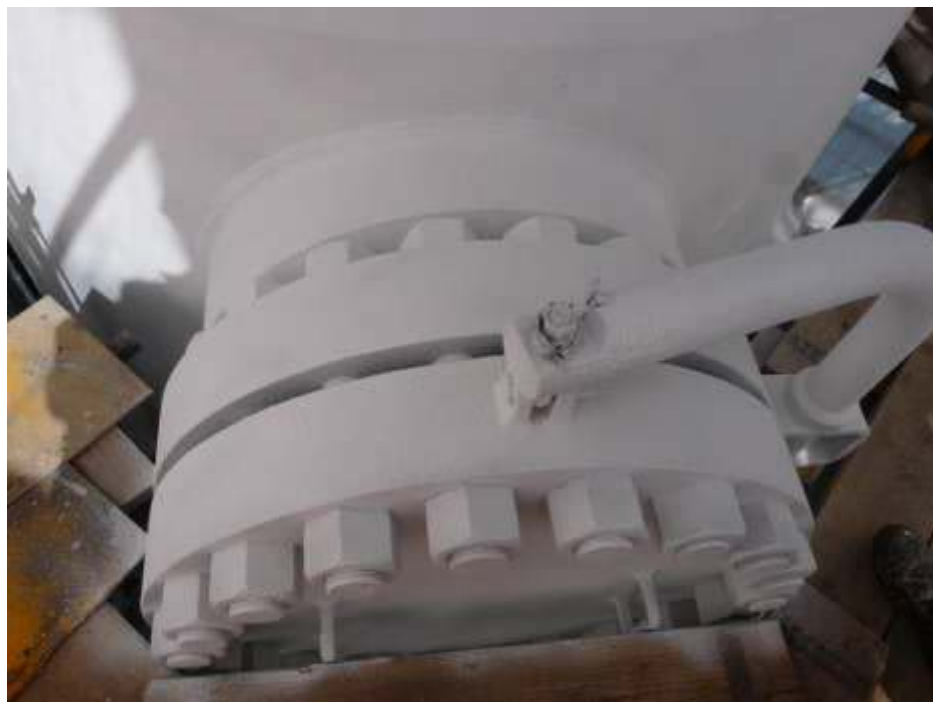
HOT SURFACE COATING applied on manhole

HOT SURFACE COATING was applied directly over manholes, trunnions and valves, to ensure a seamless insulation layer around the vessel which prevents insulation 'leaks' and (salt) water contamination of the treated surface. After the 10 mm thickness of the HOT SURFACE COATING layer was reached, the surface was smoothened for esthetical reasons. For this a trowel was used.

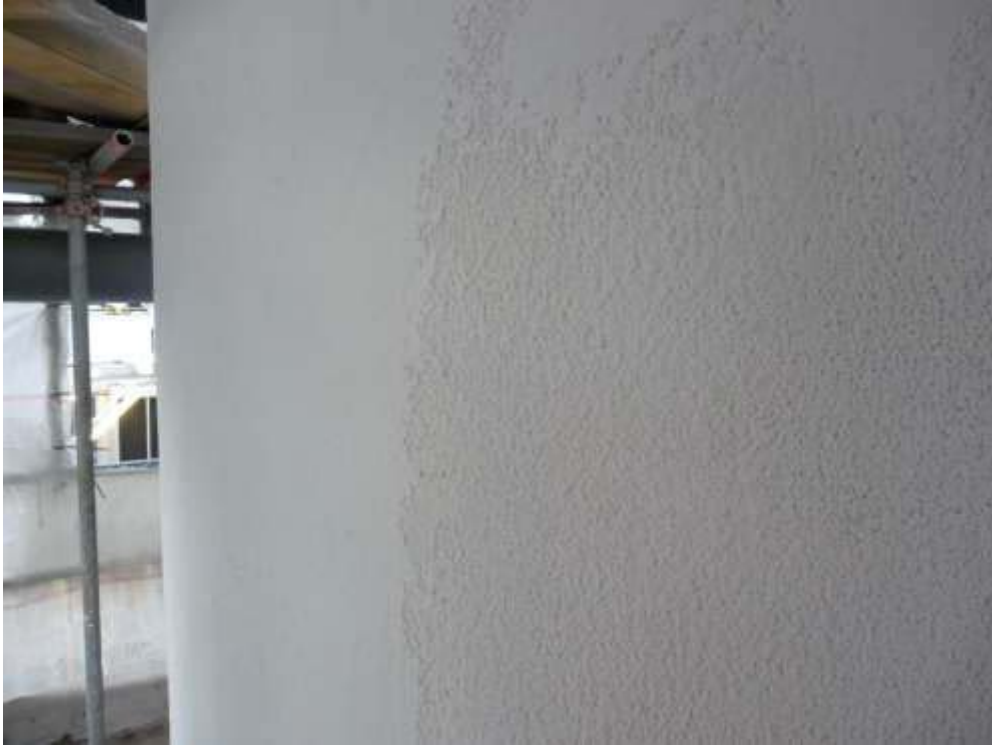
Surface partly troweled (left)

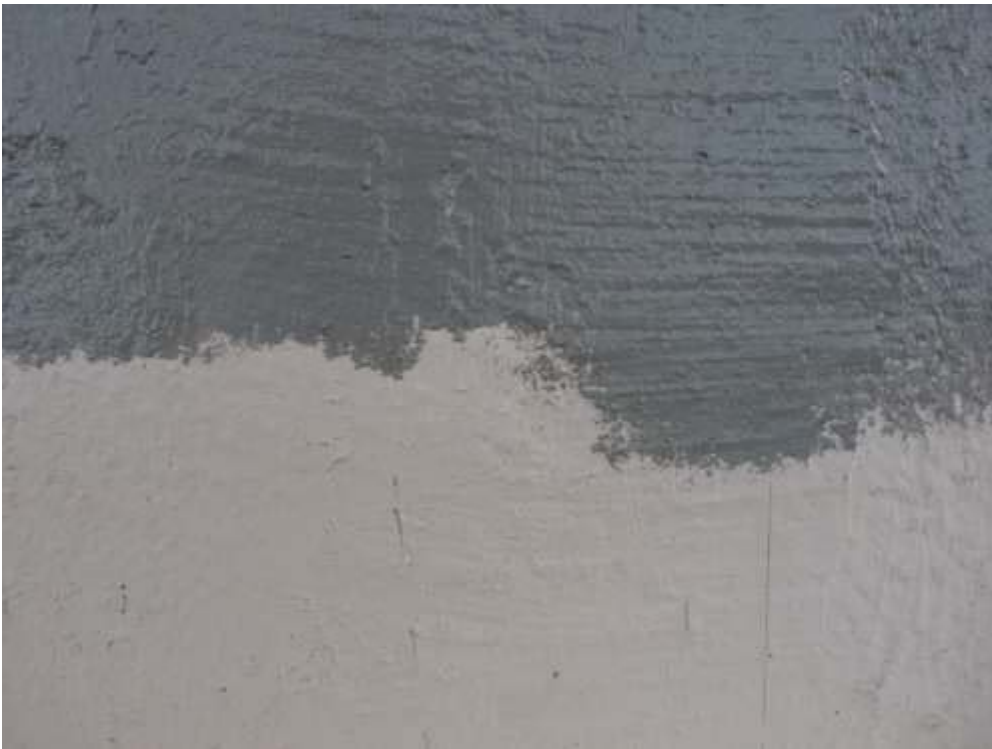
First layer ENDUROOF

Thereafter a protective top layer of ENDUROOF was applied to ensure a durable, watertight layer would prevent moisture penetrating the insulative layer and the treated surface of the vessel. (ENDUROOF is an elastic polyurethane roof coating with a 25 year water barrier certification.)

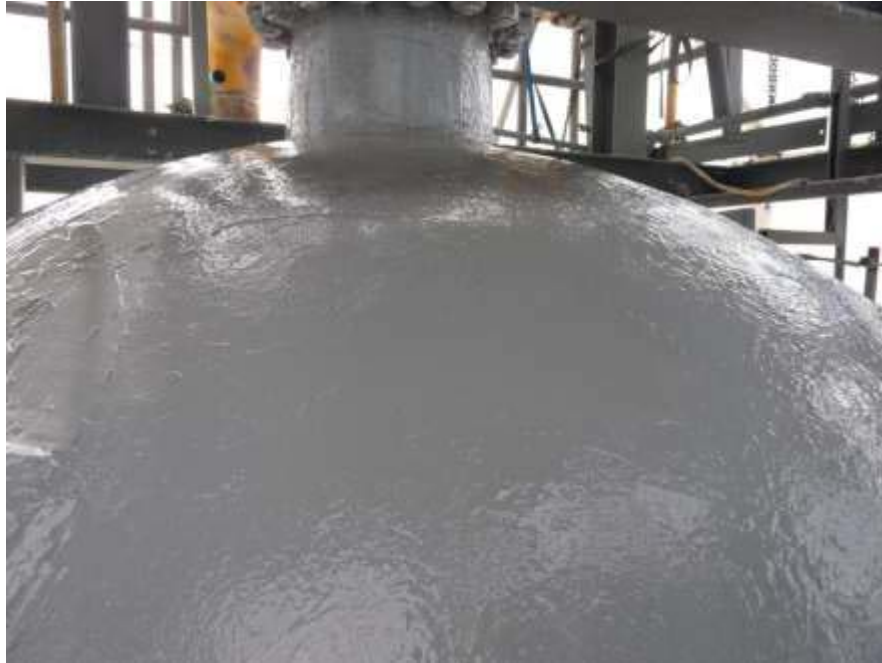
System completed with transparent coating ENDURO TOP-E

Finally, the complete system was top coated with the elastic protective polyurethane top coating ENDURO TOP-E which ensures a smooth finish, UV- and weathering protection of the system. Although this coating can be tinted in any desirable RAL color GDF chose to leave it transparent.

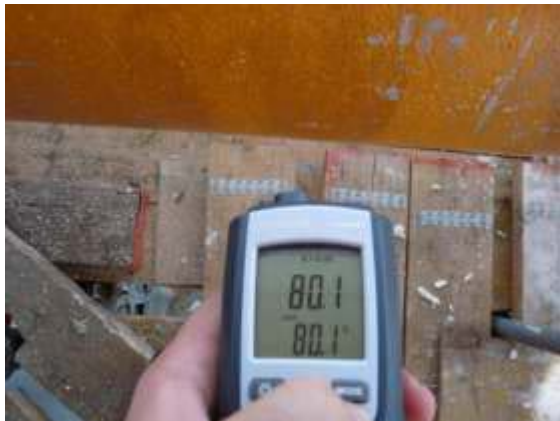
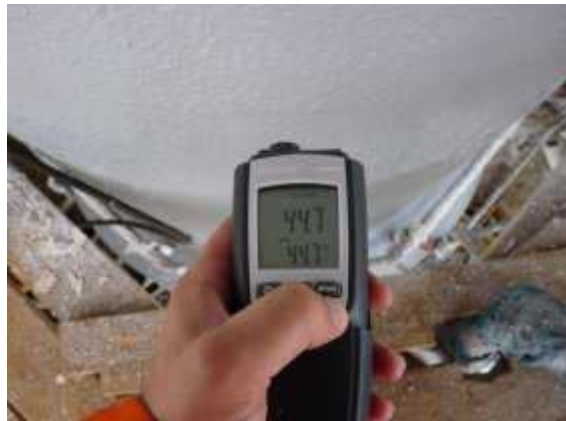
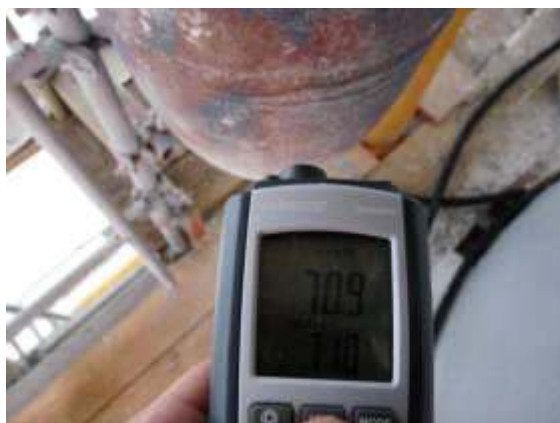
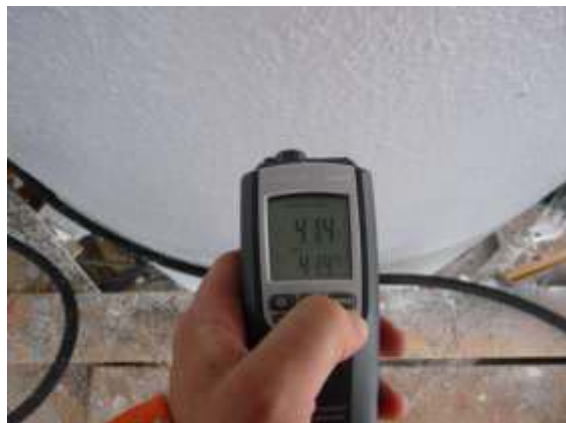
The vessel is insulated and protected against further corrosion for many years. The surface temperature of the vessel has decreased from +/- 70-80°C to a more acceptable level of +/- 40-45°C. Temperatures have been reduced by +/-40%, which is in line with the expected temperature reduction stated in the COT report where a +/-36% reduction of temperature has been measured with a temperature of 70°C. The advantage of this system compared to other more traditional insulation systems is that the system will keep its insulative value, doesn't degenerate and doesn't allow water to reach the treated surface, which will help preventing any corrosion under insulation.

Readings – Before and After (°C)
