## **BACON OVENS AT MEAT PROCESSING PLANT ILLINOIS**

## December 2016

This is a meat processing plant generating bacon products. Two of four oven units consisting of a base unit and 35 feet of 16"-18" duct, all stainless steel were insulated. The internal temperature of the units is approximately 350°F (176°C). The units are exhausting hot oven air as part of an oil recapture process allowing for water to escape in the hot air exhaust. The insulation will minimize condensation occurring inside the exhaust assembly. The objective is to bring the surface temperatures down to a maximum of 120°F (49°C). This will not only save energy, meet OSHA requirements for worker safety but also make for a better working environment. A system of HPC® COATING was applied first to reduce the surface temperature down followed by a coat of MOIST METAL GRIP® and 2 additional coats of RUST GRIP® to protect the HPC® COATING from daily cleaning with a caustic solution.

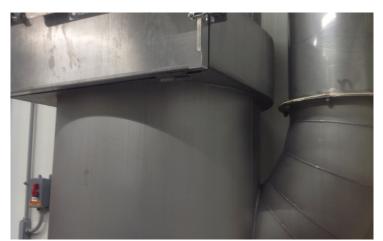
Preparing for the first coat of HPC® COATING by cleaning with citrus cleaner and water and ensuring a clean, dry and sound substrate ready to accept the coating system.

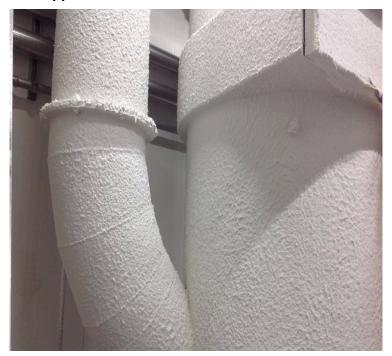
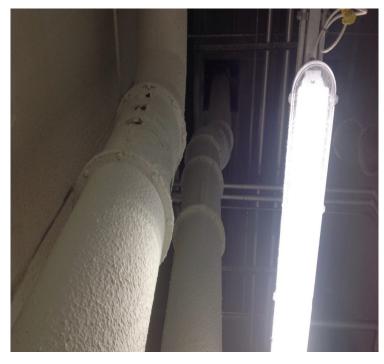
Full application of HPC® COATING 500 mils / 13 mm / 1/2 " DFT.

At the time of application the temperature of the exhaust gasses during operation were 334°F (168°C).

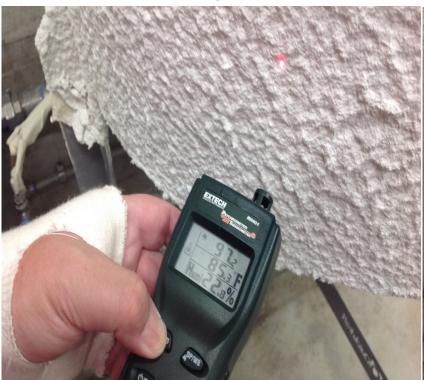
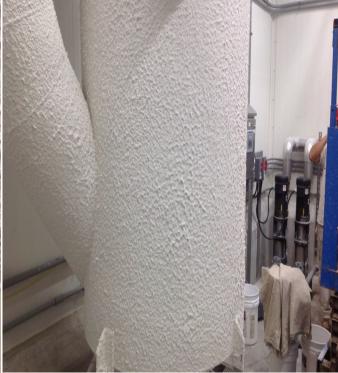
Surface temperature reduced to approximately 85°F (29°C). This not only saves energy, meets OSHA requirements for worker safety but also makes for a better working environment.

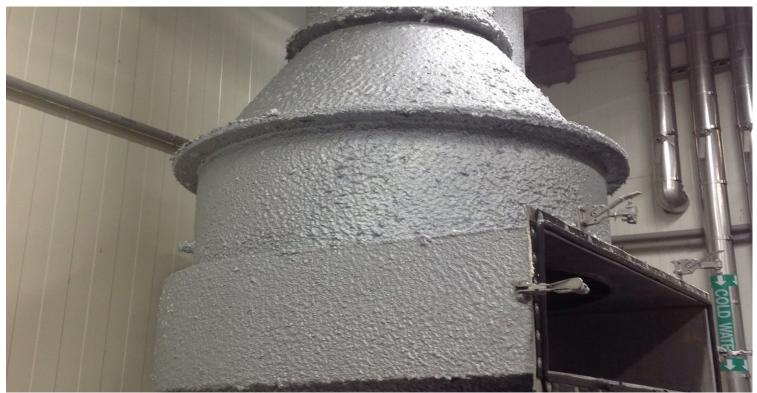
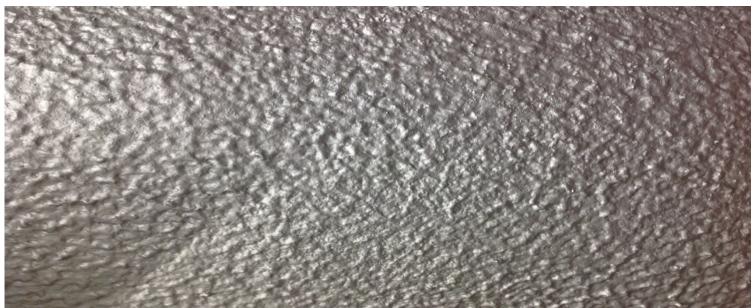
The HPC was sealed with a primer coat of MOIST METAL GRIP® which was allowed to cure for several days because of the holiday schedules and to insure full curing. The primer coat was then lightly sanded and 2 coats of RUST GRIP® were applied as the finish coat.
