## Coatings Solutions and SPI Solve a Major Heat and Maintenance Problem for Liberty County

During July of 2009, Coatings Solutions was engaged to coat the roof of the Liberty County Precinct 4 Maintenance Barn.

### SPI CASE HISTORY

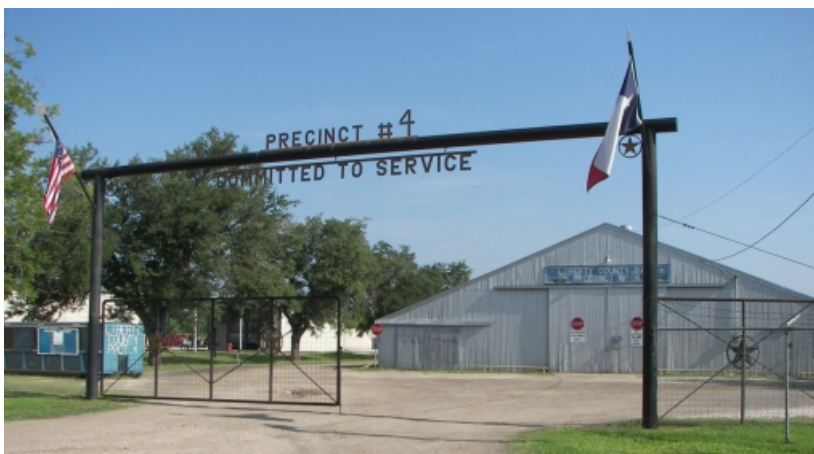
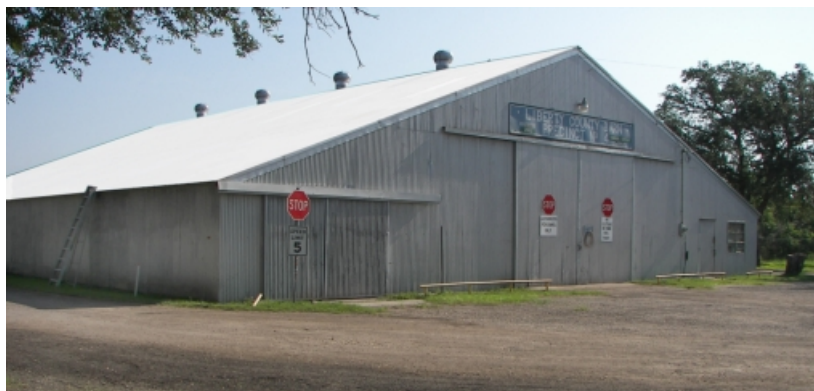
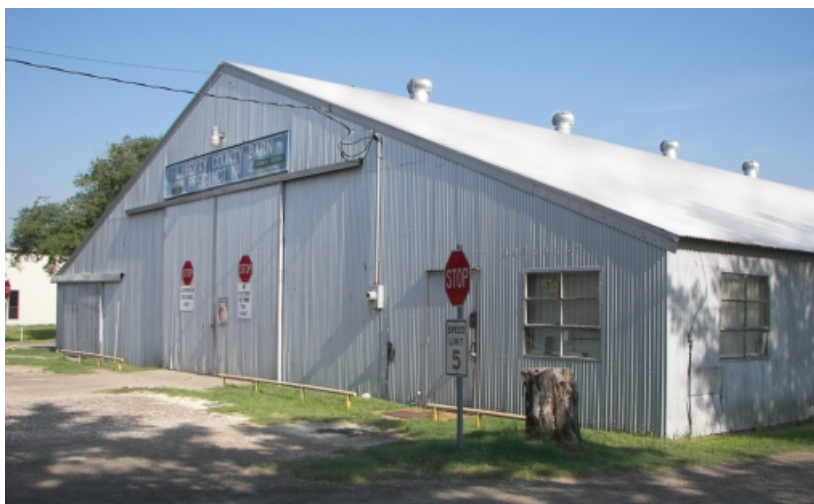
The building is over 50 years old. It is made of corrugated sheet metal over a tubular framework. The overall dimensions of the roof are 100 x 80 feet.

During the 50 years, Liberty County has never been able to find a workable or practical solution to dealing with the heat buildup. Over the many years, the roof started rusting and many of the hold down fasteners loosened. Plus, there were 18 fiberglass skylights that were exhausted and needed to be replaced with sheet metal.

The job took Coatings Solutions four days to accomplish. First, the entire roof was inspected and then power washed. The fasteners were secured, skylights covered and the coating of Rust Grip was applied. Next, the seams were taped, and then primed with SuperBase. Finally, the Super Therm was applied to complete the entire process.
